Engineering Evaluation of Bollard Fence

Rio Grande, Hidalgo County, Texas

United States of America v. Fisher Sand and Gravel Company, Civil Action No. 7:19-CV-403

August 2021

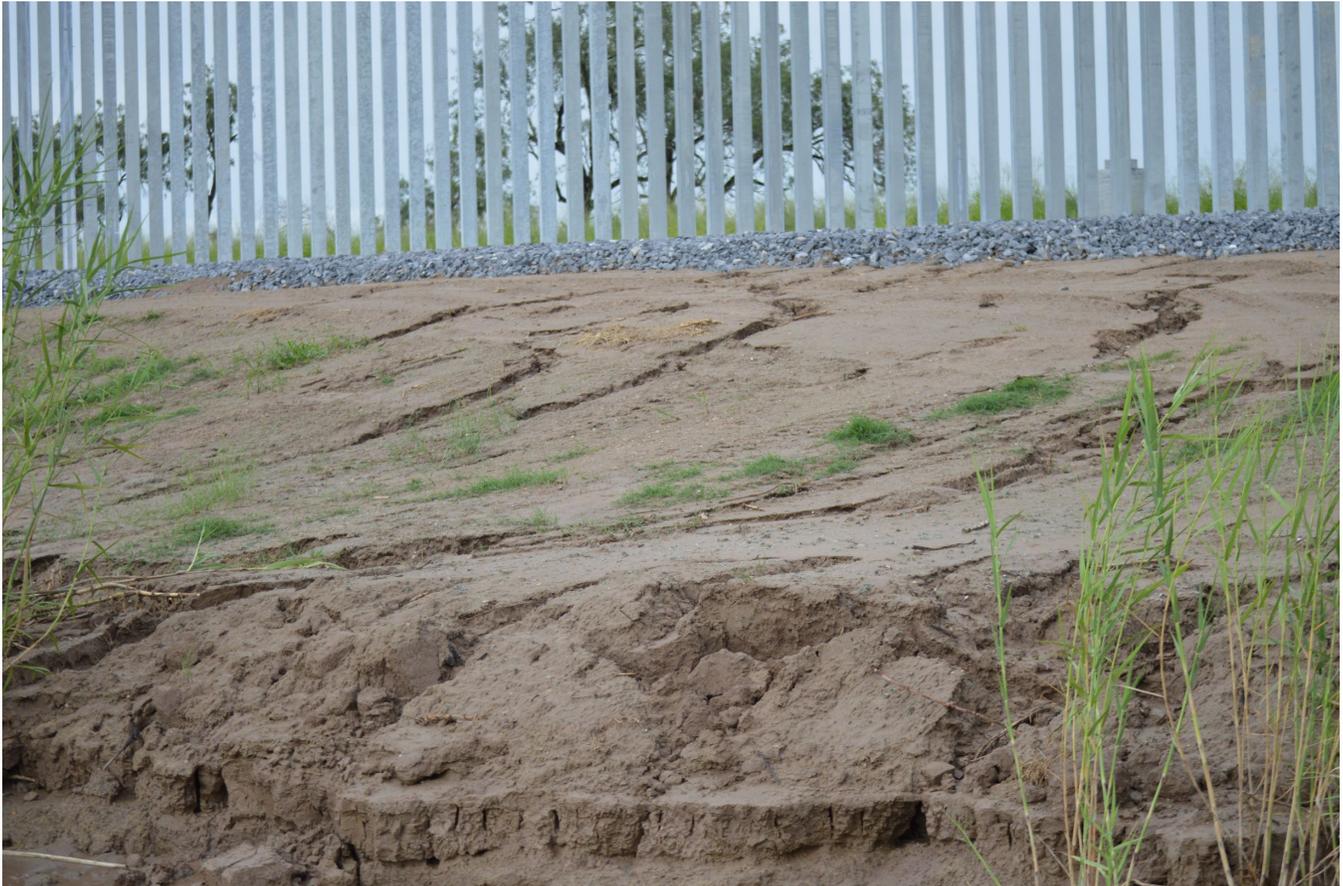
exacerbated bank erosion by some or all of the above-described mechanisms in comparison to pre-project conditions. Bank stabilization may be necessary to prevent river meandering and to ensure caving of the bank does not progress to the point of weakening the base of the bollard fence.

Figure 4.34. Severe erosion at base of fence

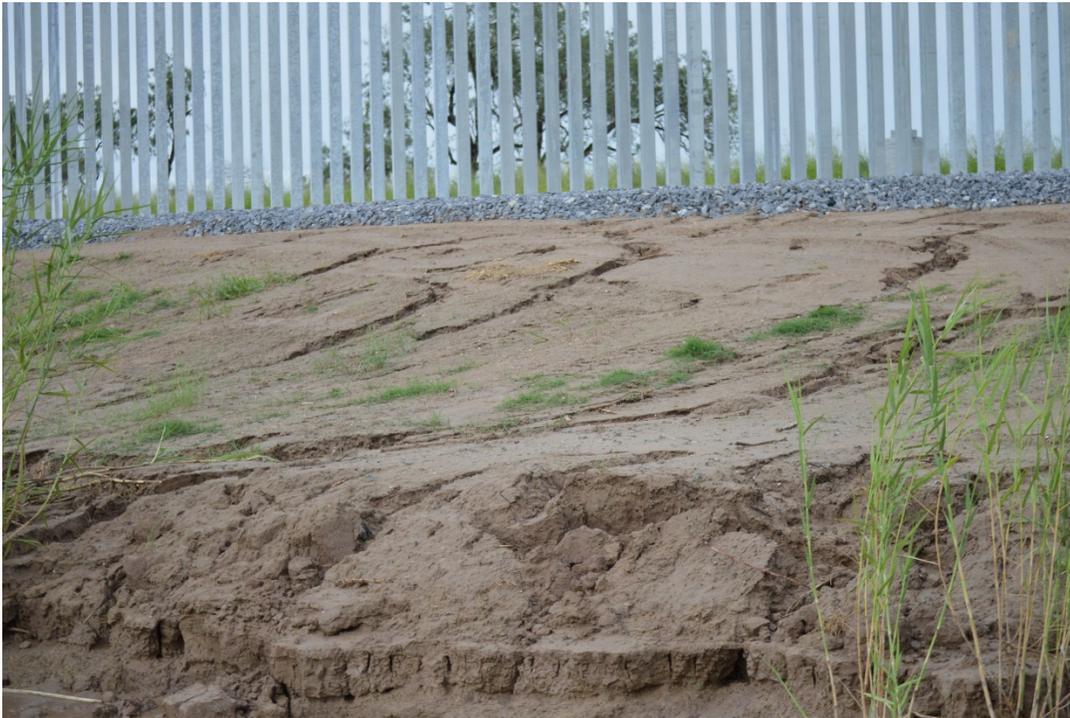
Figure 5.8. Rills and gullies characteristic of dispersive soil (source DOJ)

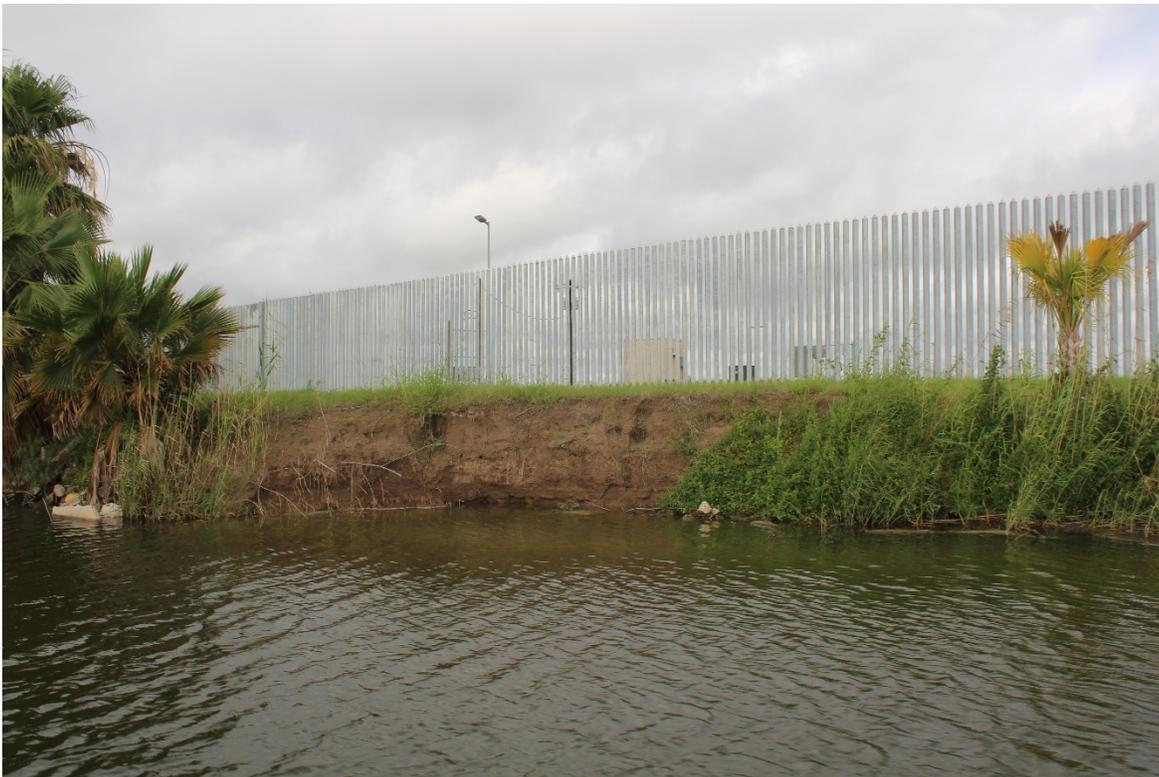
Figure 5.9 is a photograph showing severe bank erosion near the Fisher fence, which is caused by natural fluctuations in the river level, wave action, and boat wakes. The removal of existing bank vegetation without immediate replacement by properly designed erosion protection can lead to bank caving, which may eventually threaten the stability of the fence. Additional repair is warranted given the erodible nature of site soil; the presence of dispersive soil in certain areas; observed bank undermining by fluctuating river levels, waves, and boat wakes; and the possibility of high velocity water flow during floods. Repairs should include special details such as appropriately designed filters for dispersive soil.

Figure 5.9. Severe bank erosion caused by fluctuating river levels, wave action, and boat wakes (source DOJ)

Intervention to correct minor erosion problems is generally considered to be acceptable practice if 1) there is a predetermined plan for correction of problems; 2) there are resources available to make the corrections; and 3) there is a commitment by the owner to intervene when required. However, during major floods on the Rio Grande, access to the fence will be difficult and intervention may not be possible. Major flooding is likely to cause erosion from local turbulence around fence bollards, which could undermine the shallow foundations causing fence failure. For this reason, prudent practice would be to include adequate erosion protection during design and construction to reduce the likelihood of erosion and fence failure.

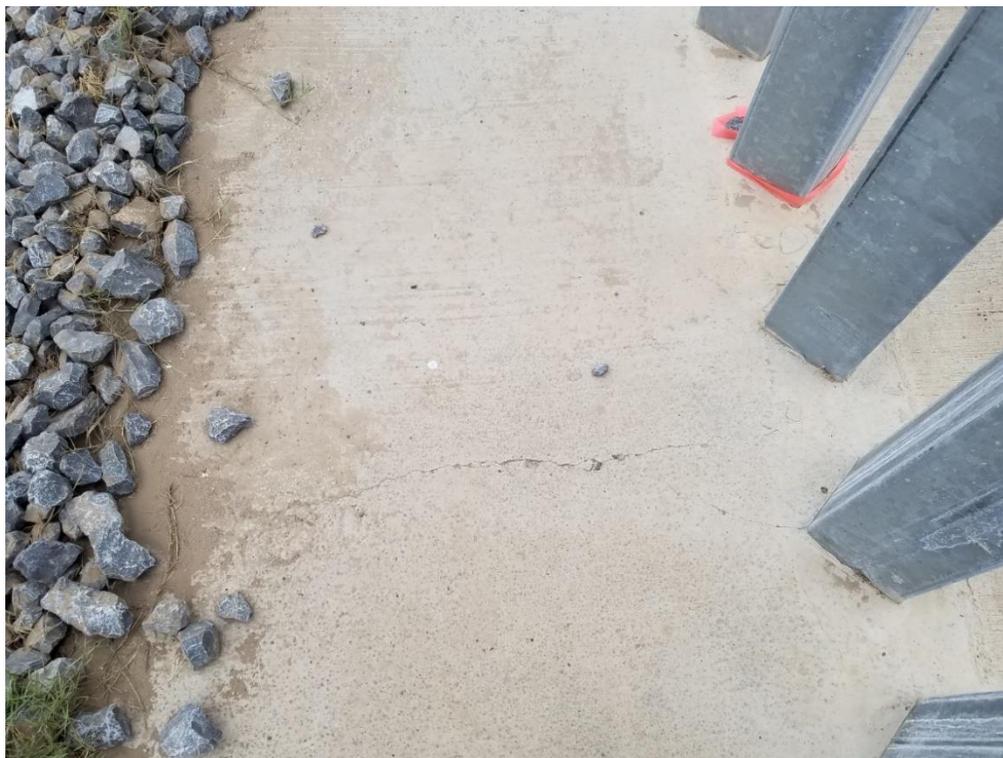
The surface condition of the concrete was observed to be fair to good, with minor cracking and joint separation detected at various locations along the fence alignment. Cracks in the fence footing appeared to be surficial only as shown on Figure 9, which is typical of shrinkage cracking that starts near the angle of the bollard and extends to the edge of footing in both directions as shown on Figure 10 and Figure 11. Cracks and Joint separation were also observed on the access road that abuts the fence footing as shown in Figure 12 and Figure 13.

Figure 9: Surface Cracking Near STA 152+50 from Bollard to Edge of Footing

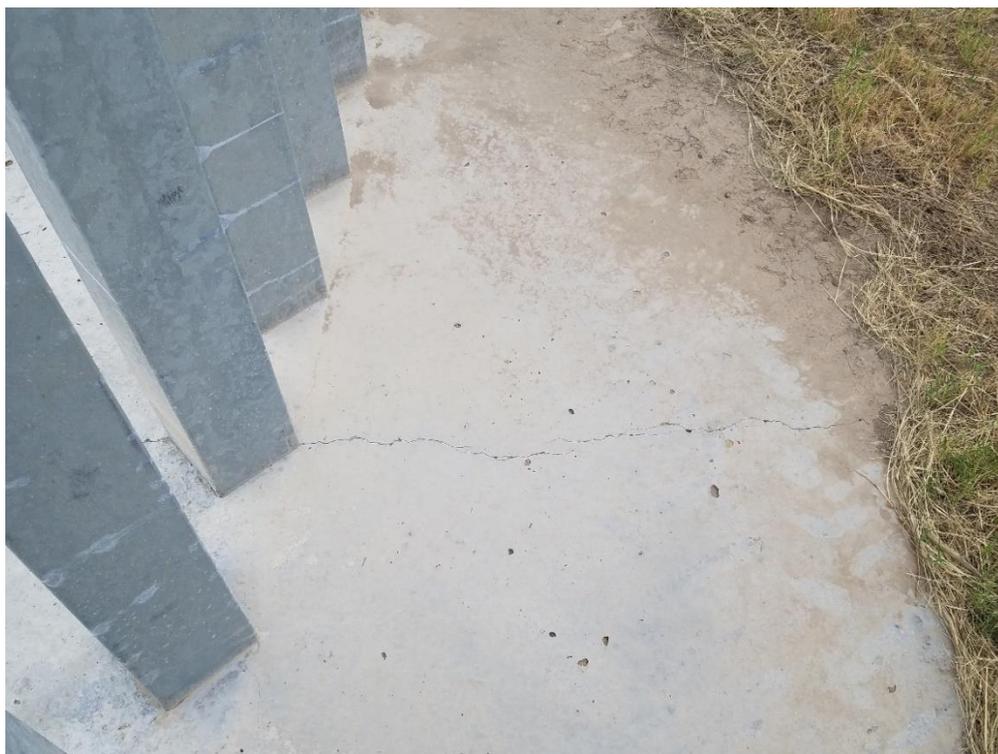
Figure 10: Surface Cracking Near STA 36+50 All the Way Across Footing and Around Bollard

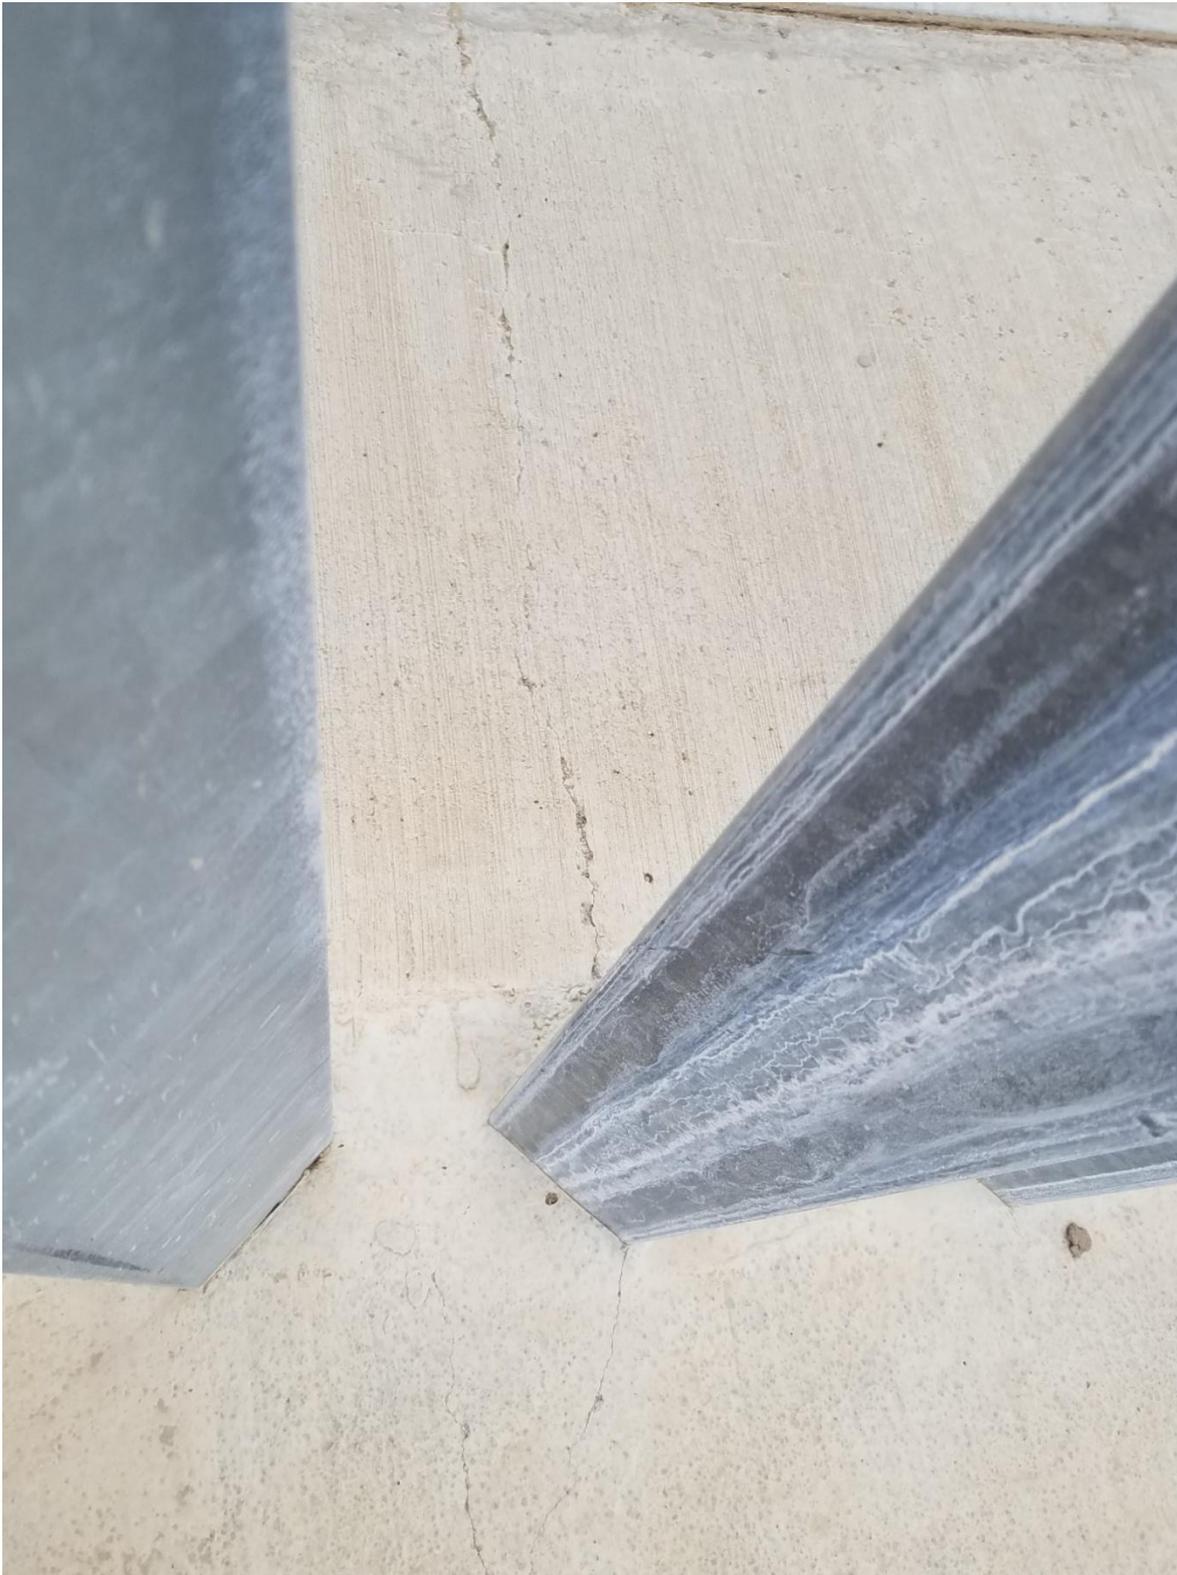
Figure 11: Surface Cracking Near STA 152+50 Around Bollard and to Edge of Footing

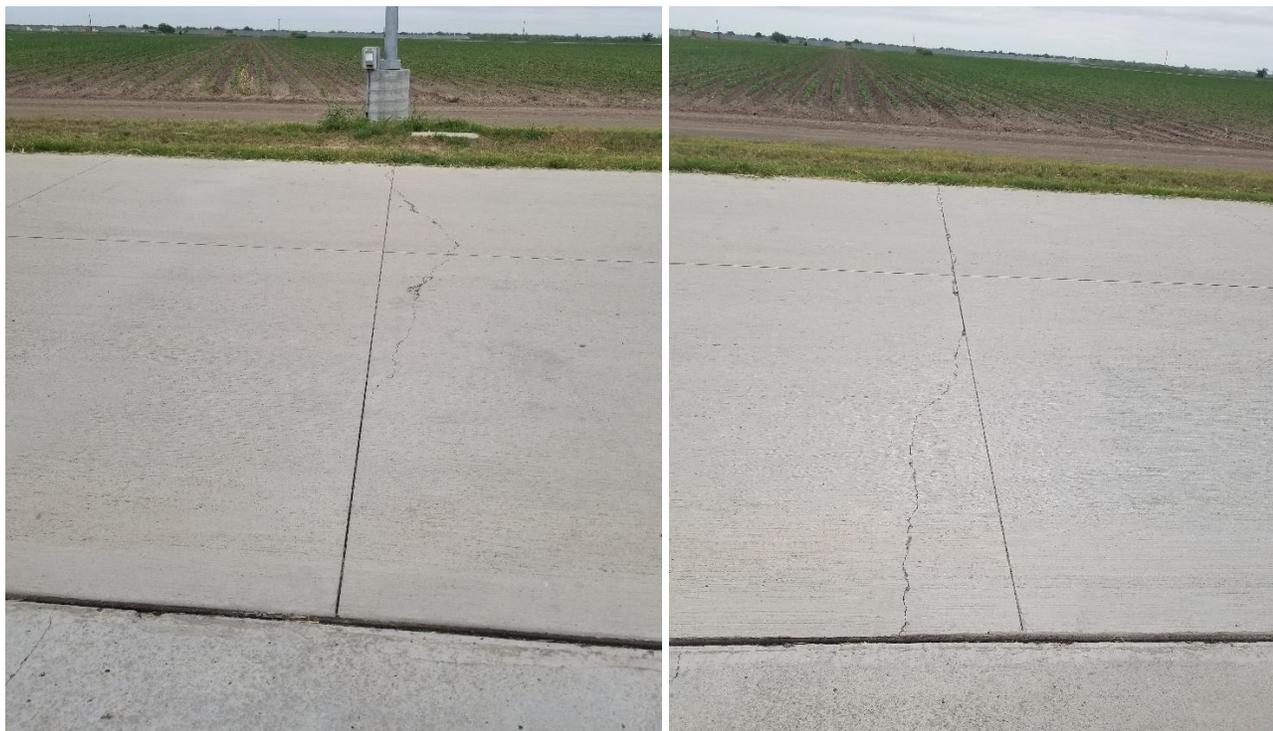
Figure 12: Typical Cracking of Concrete Surface along Access Road

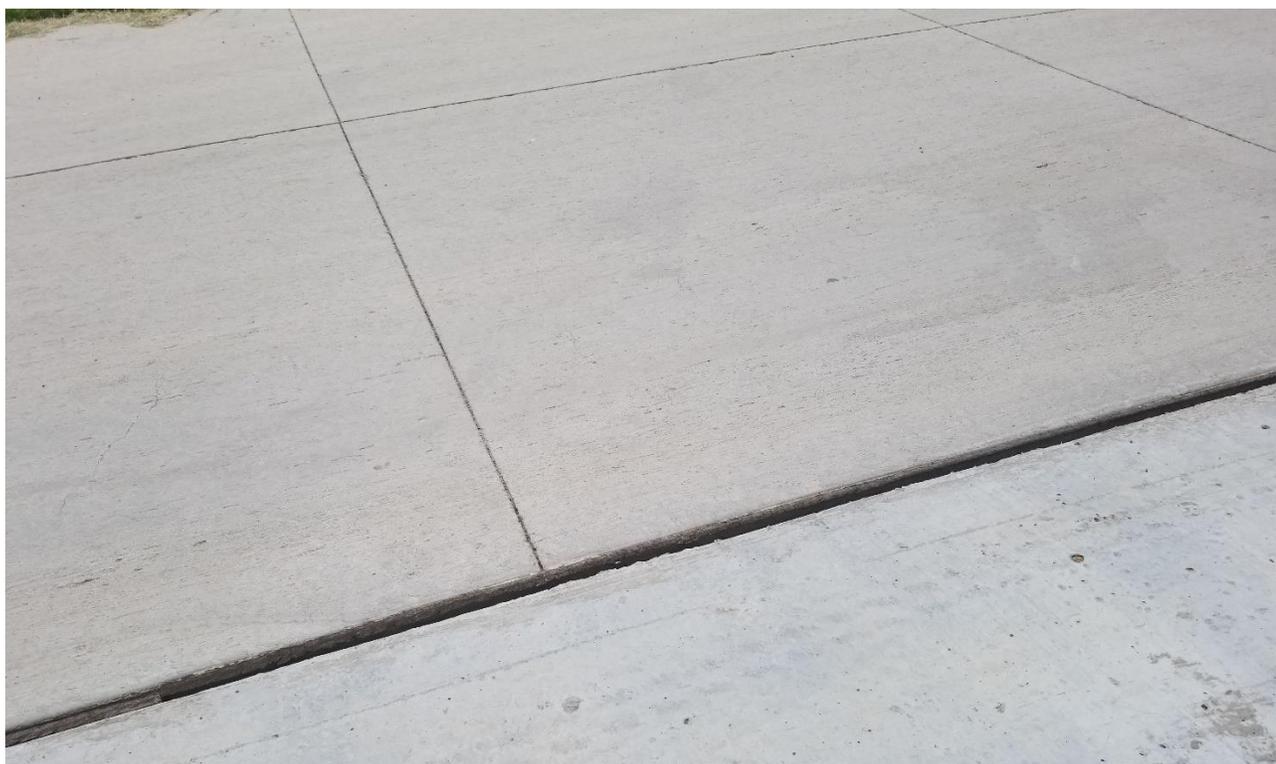
Figure 13: Typical Joint Separation along Access Road Abutment to Concrete Footing

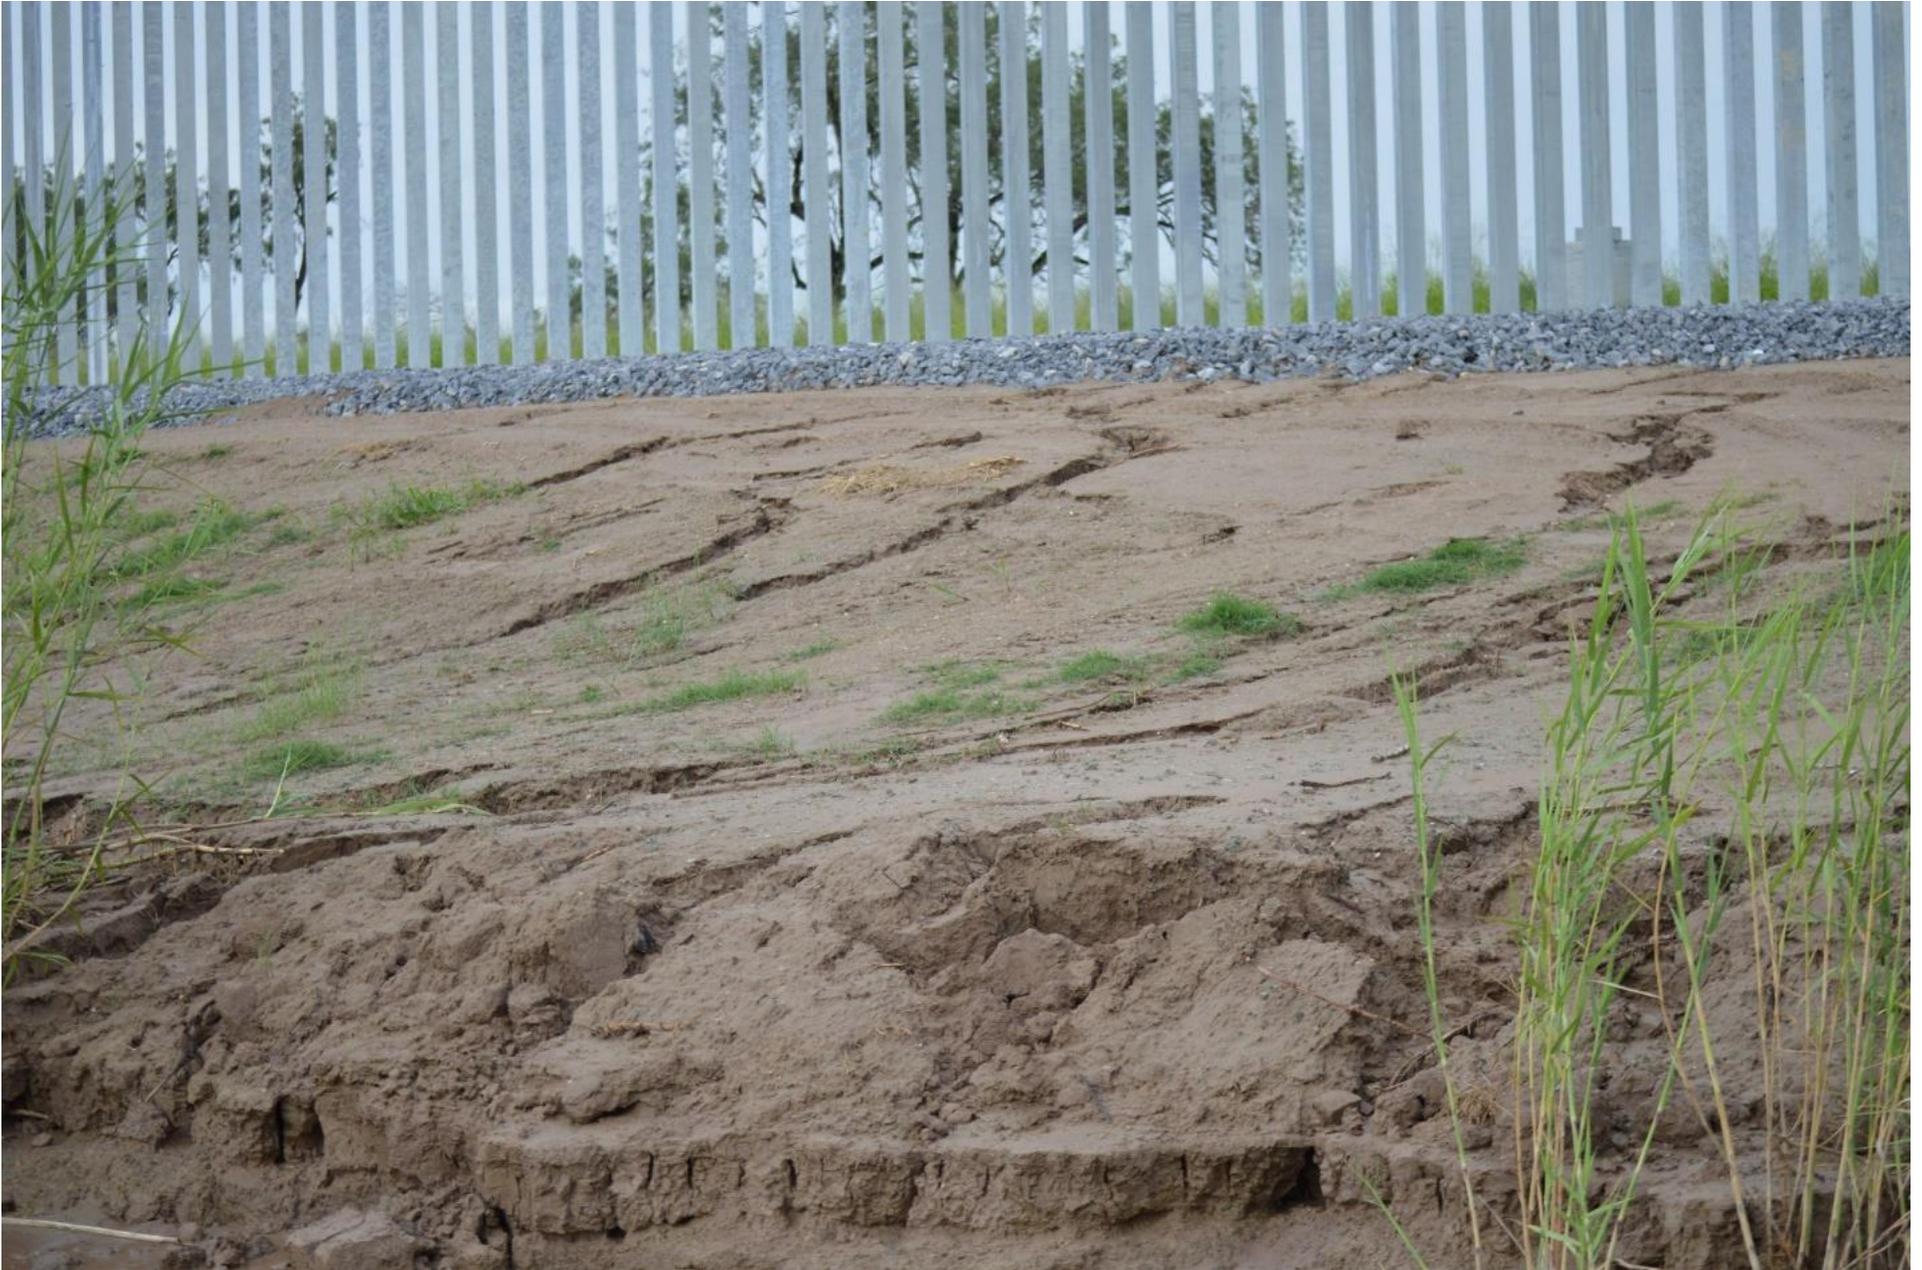
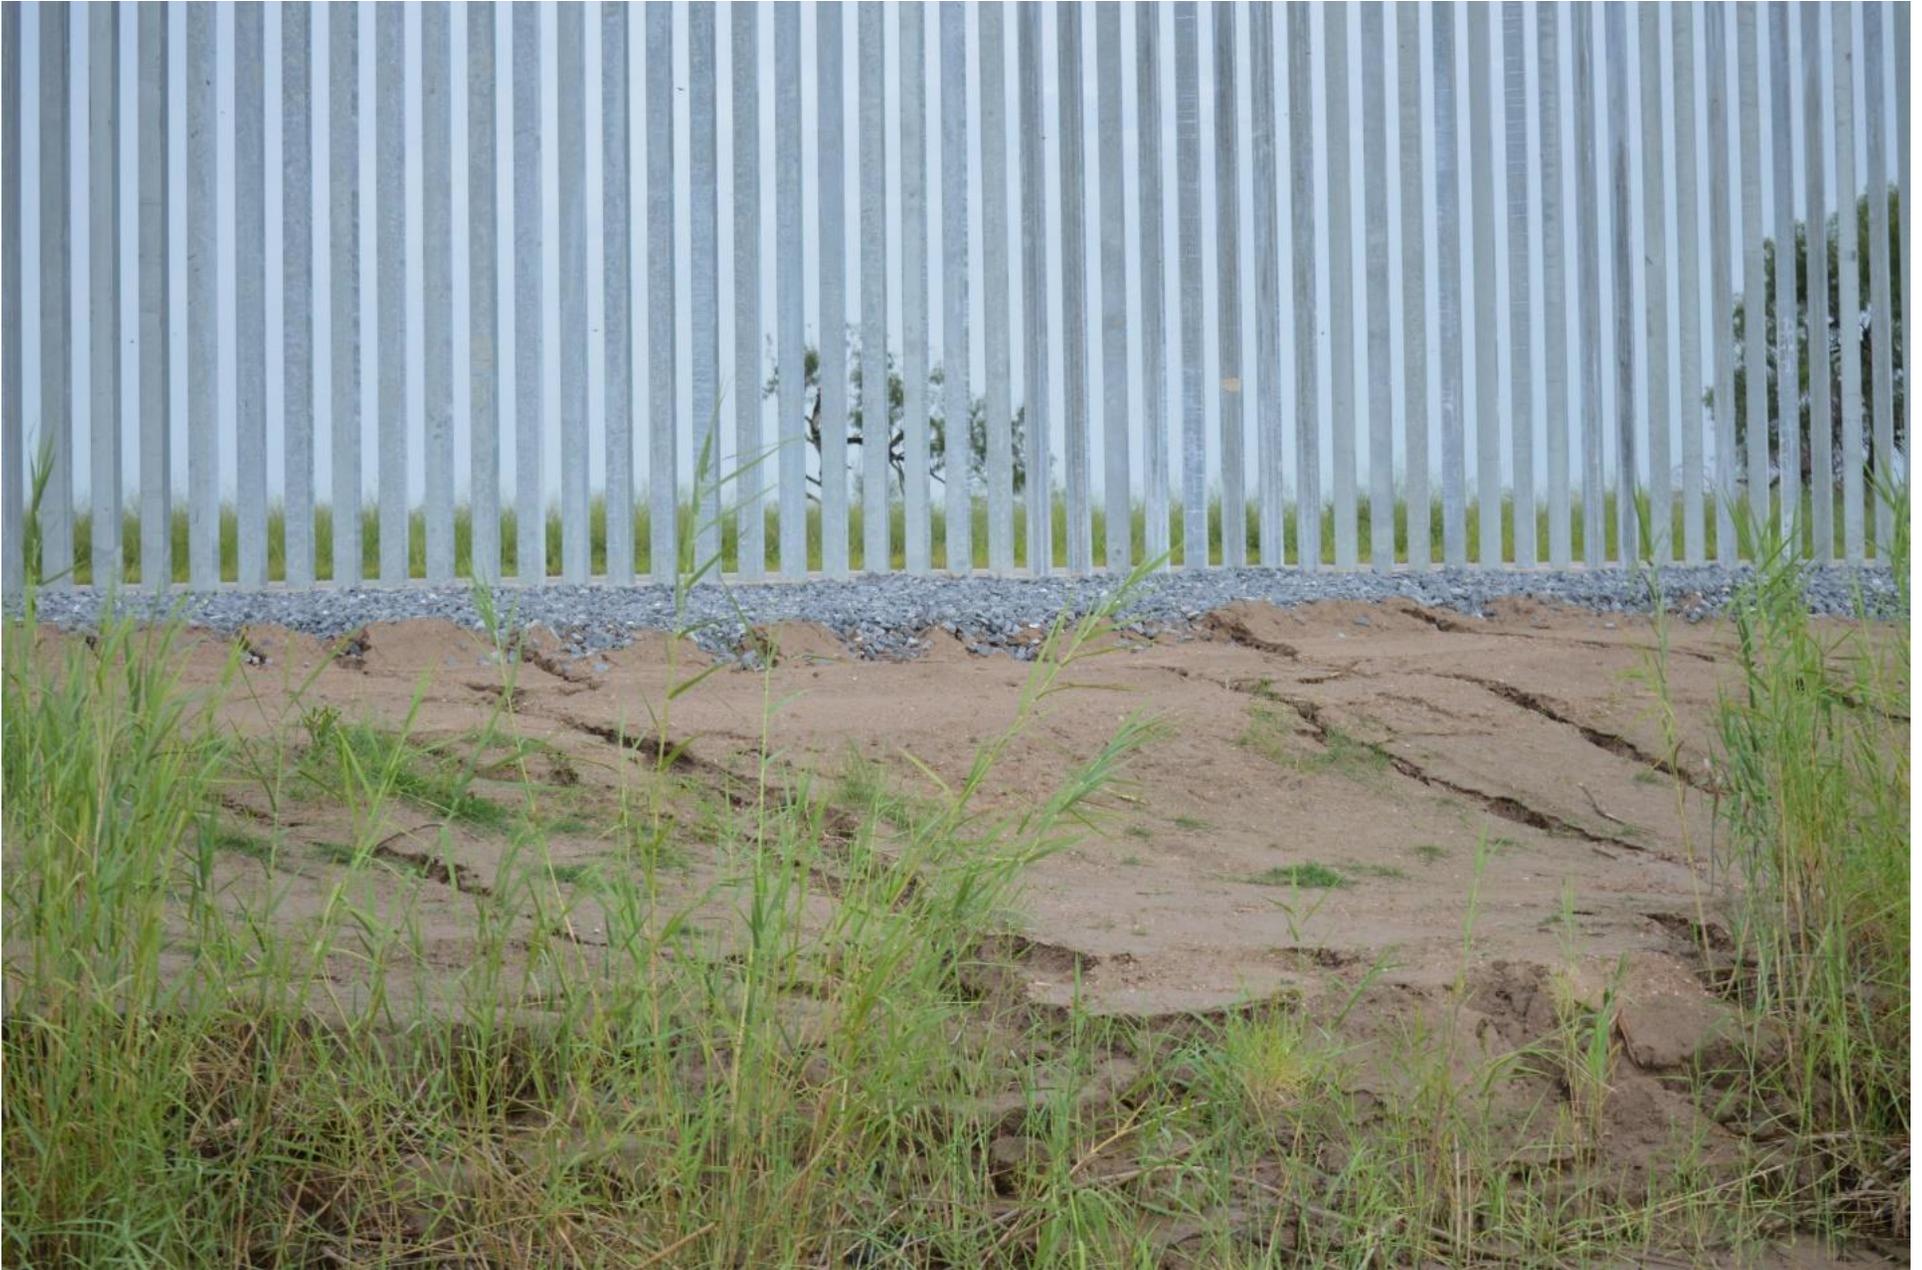
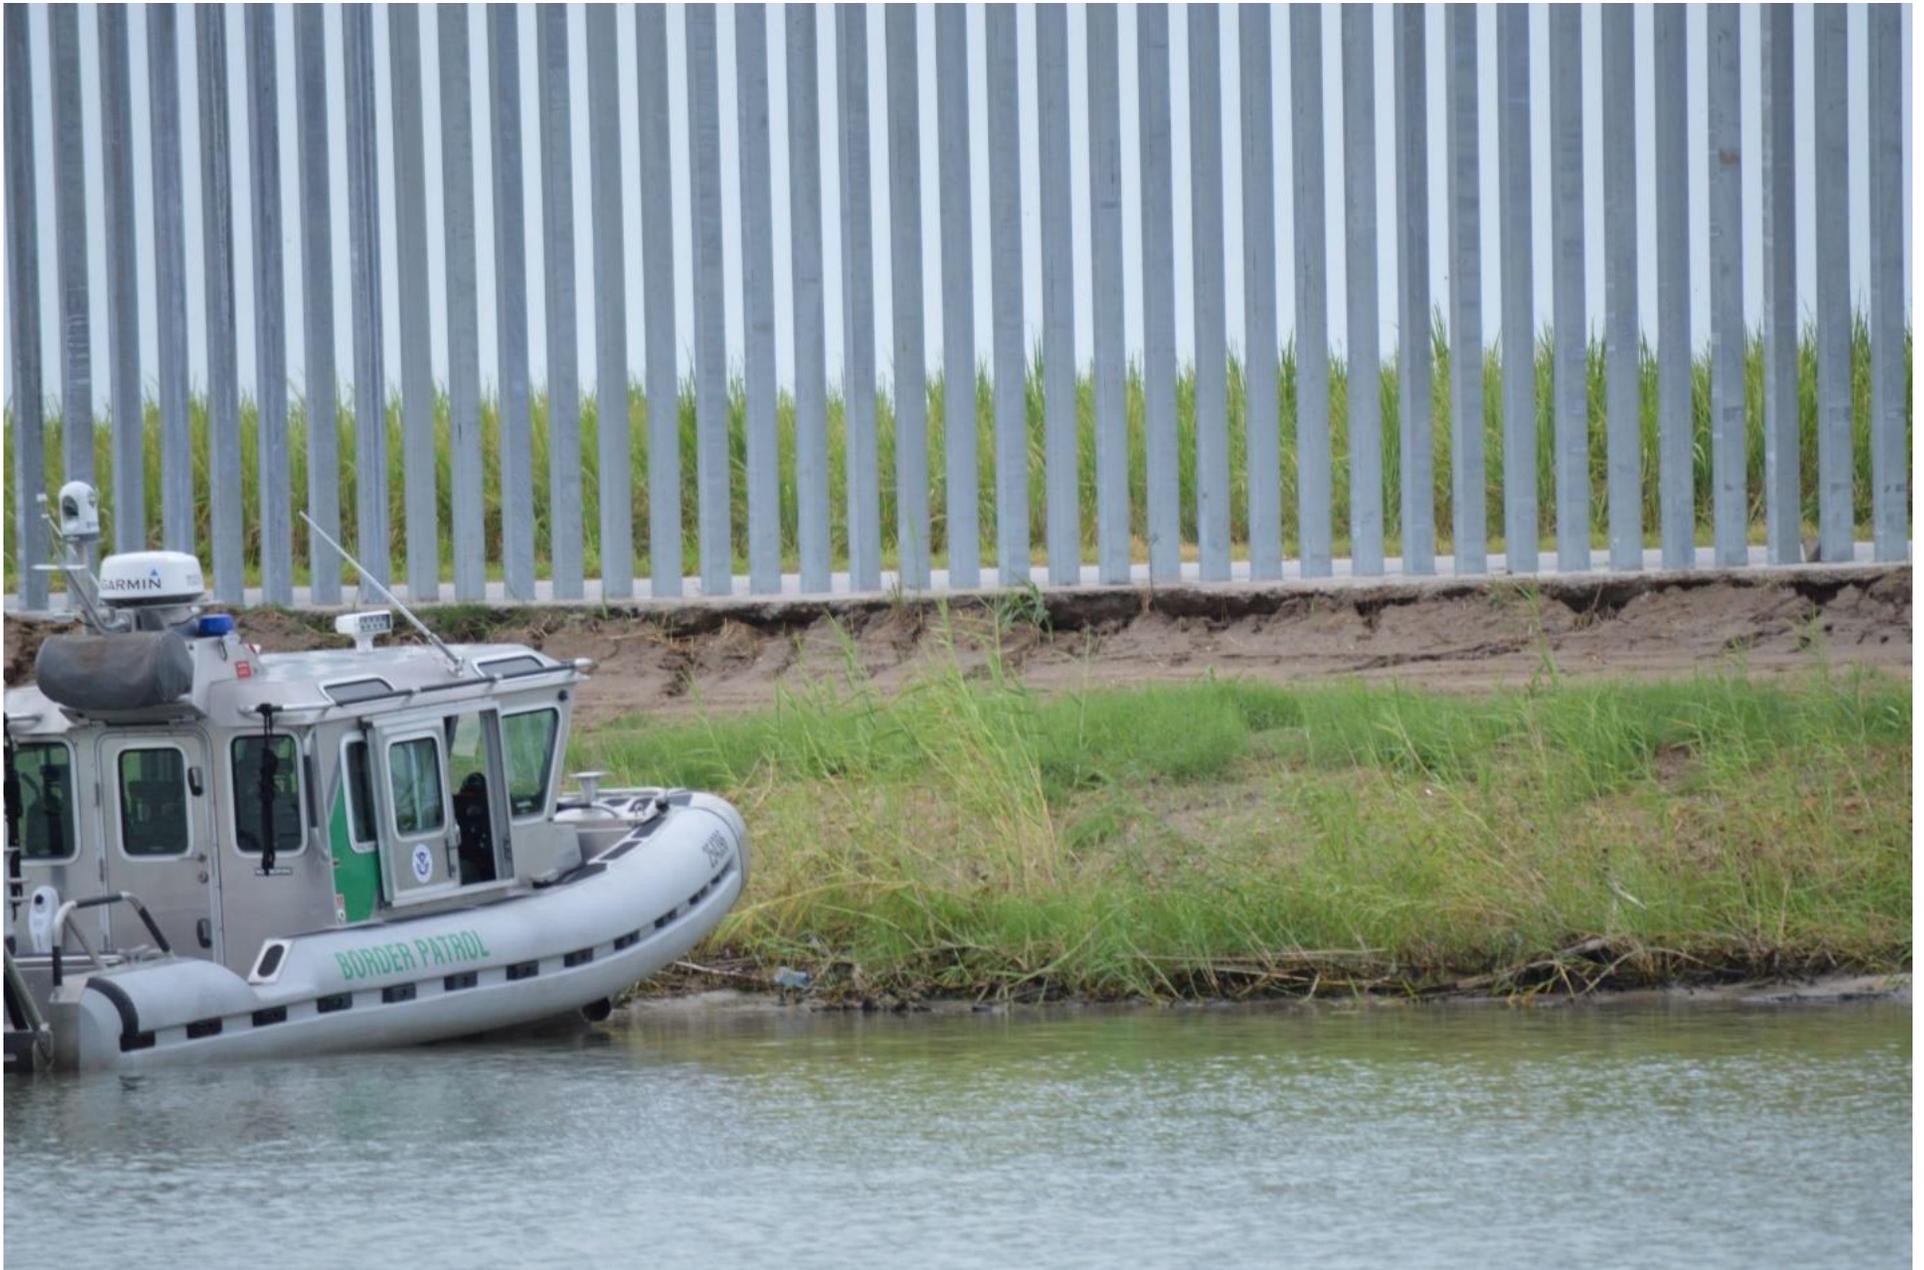
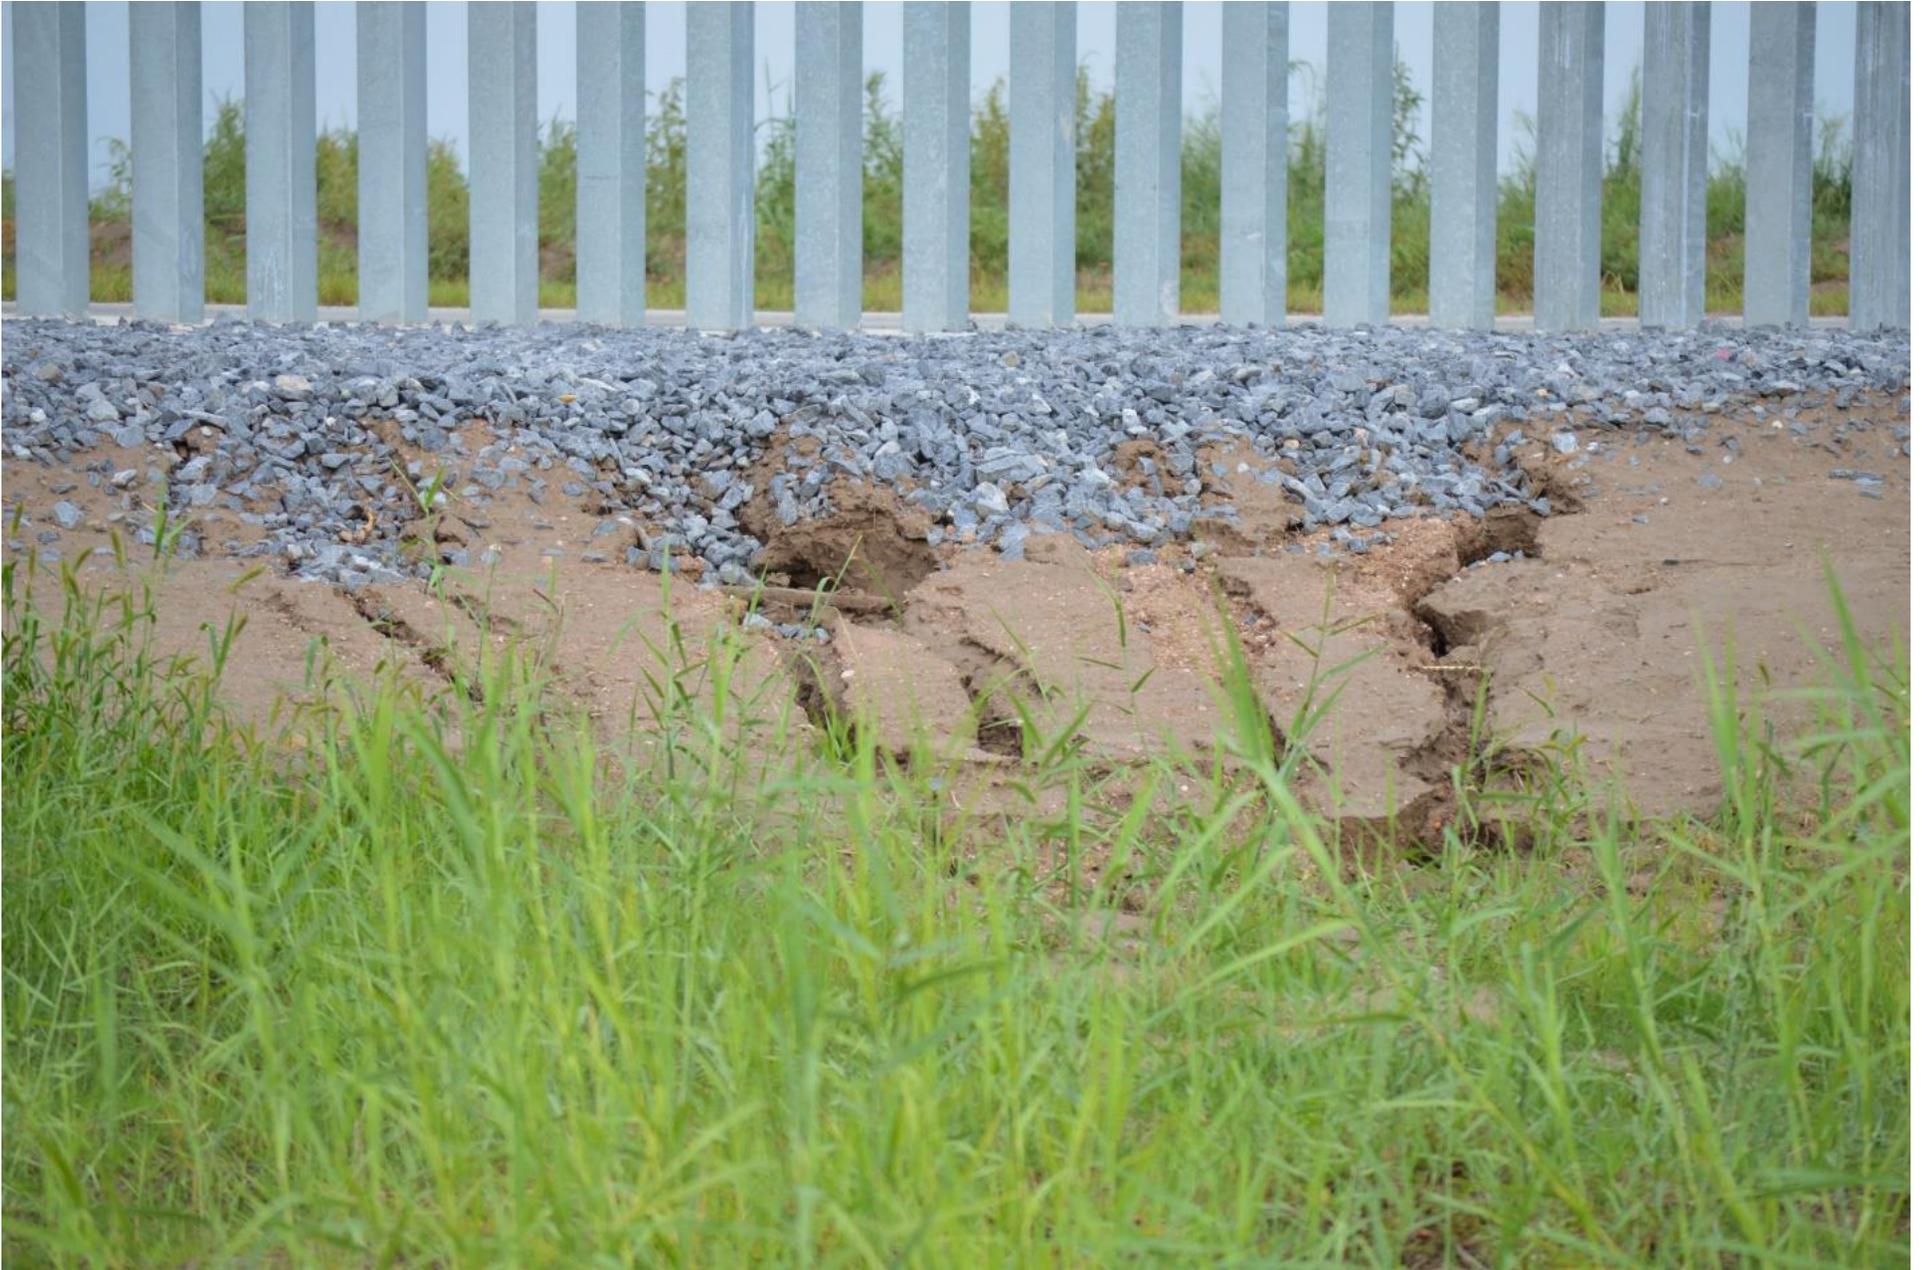
Photographs of Erosion Damage from August 2020
Provided by DOJ as received from Butterfly Center

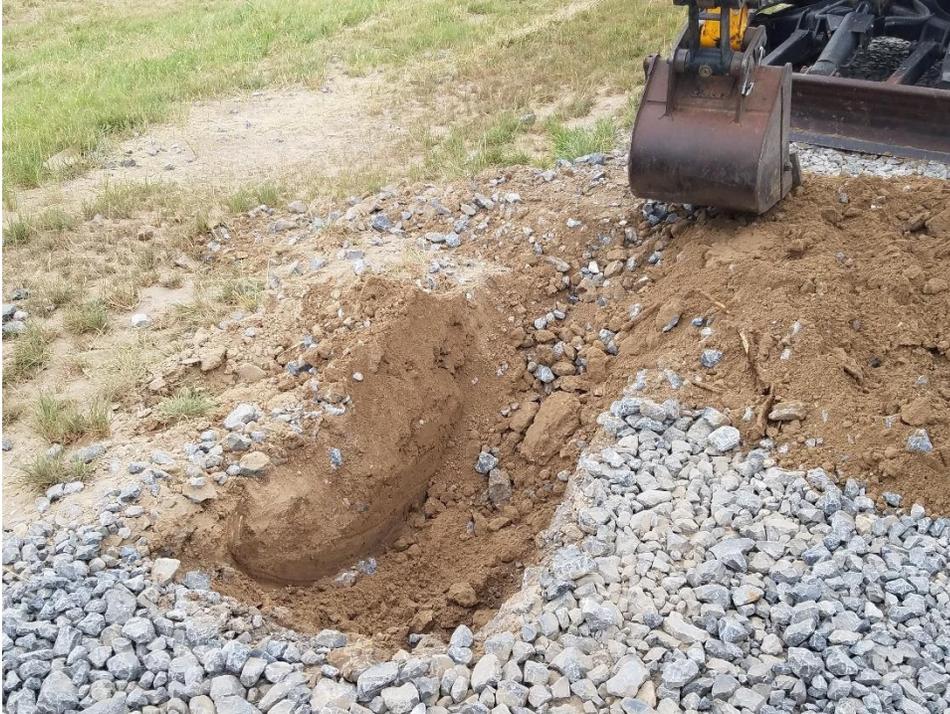
Photograph: 2

Description:
TP-1 excavation showing typical soil conditions.

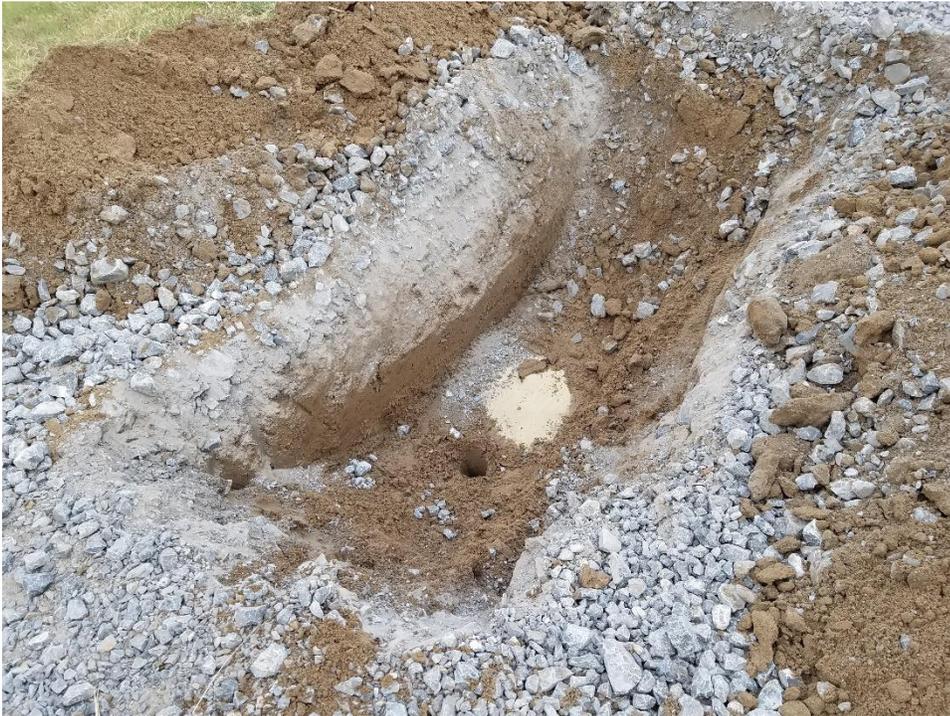
Photograph: 9

Description:
TP-2 excavation
showing typical soil
conditions at 3 feet
after sand cone test.

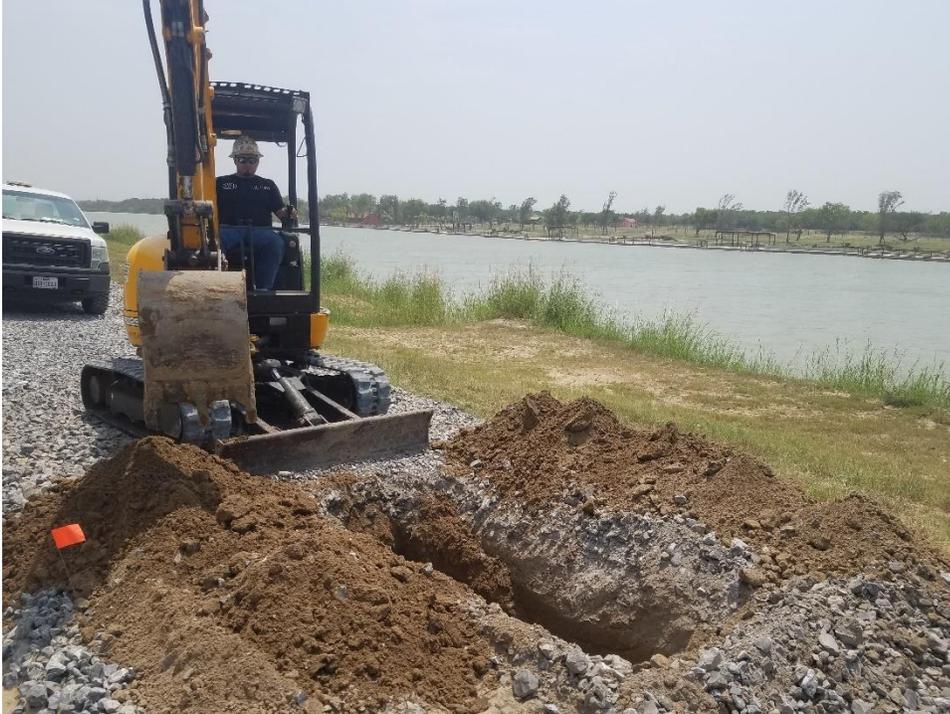
Photograph: 10

Description:
TP-2 excavation
looking southwest at
typical soil conditions.
