Engineering Evaluation of Bollard Fence

Rio Grande, Hidalgo County, Texas

United States of America v. Fisher Sand and Gravel Company, Civil Action No. 7:19-CV-403

August 2021

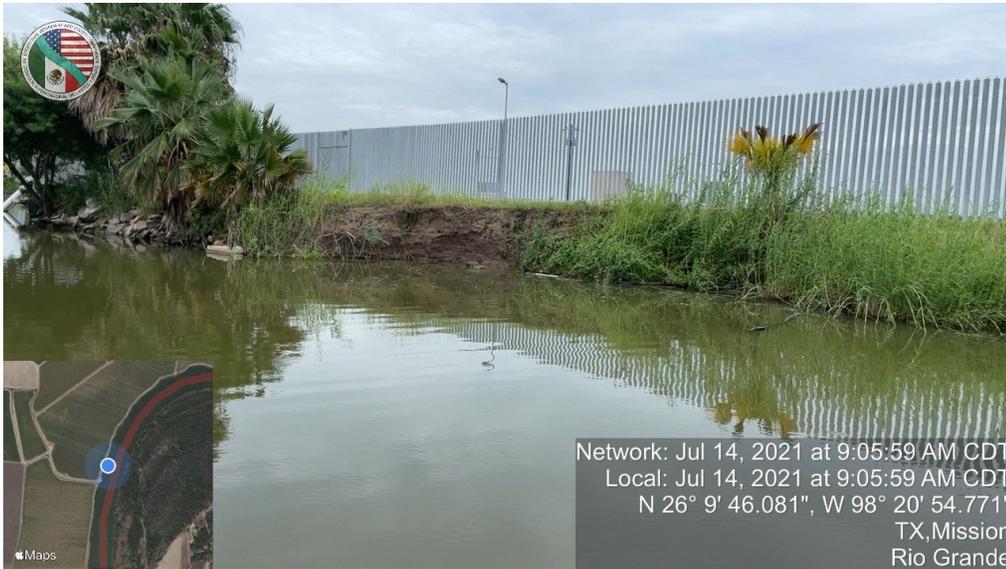
Figures 2.1 through 2.3 display photographs of varying degrees of bank caving and surface erosion taken by IBWC by airboat on July 14, 2021. Figure 2.4 shows one area with well-established vegetation and relatively large fence setback with no observable erosion. The photographs were taken following cumulative precipitation totals of 4 to 10 inches measured in the McAllen/Mission area the previous week, mapped in Figure 2.5.

Figure 2.1. Bank erosion near fence, northeast side of fence

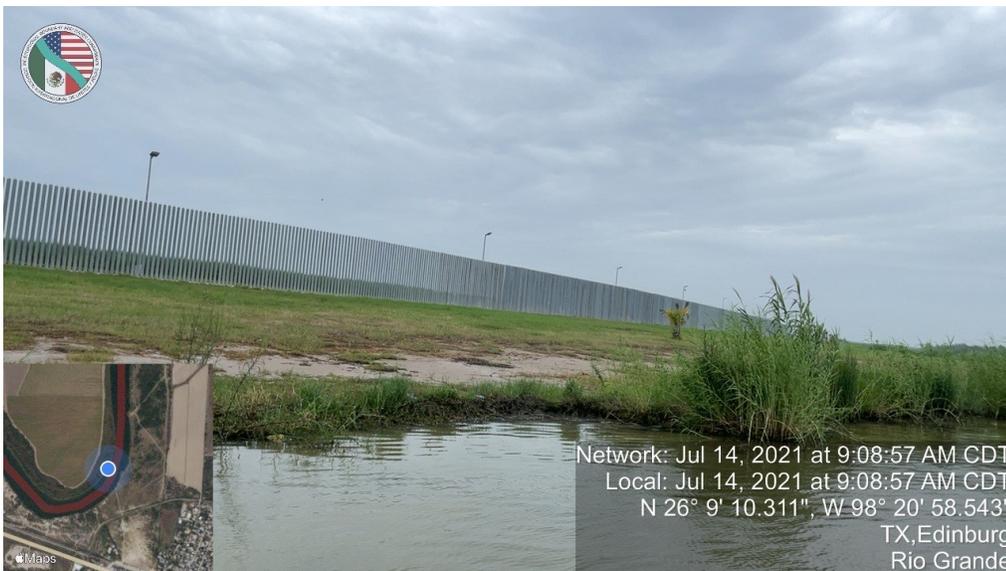
Figure 2.2. Surface erosion, southeast side of fence

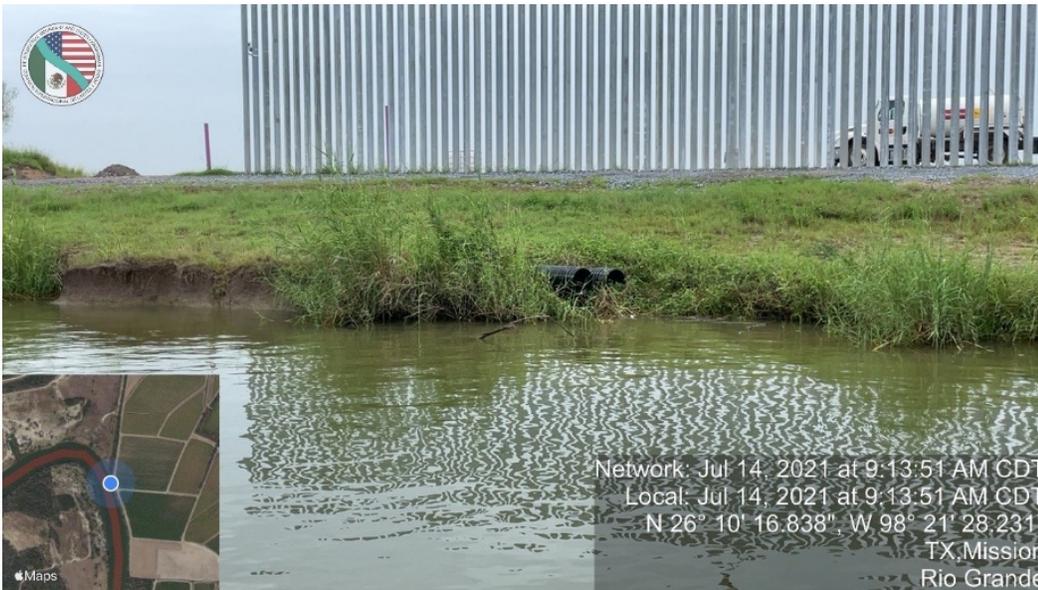
Figure 2.3. Bank caving, northwest side of fence

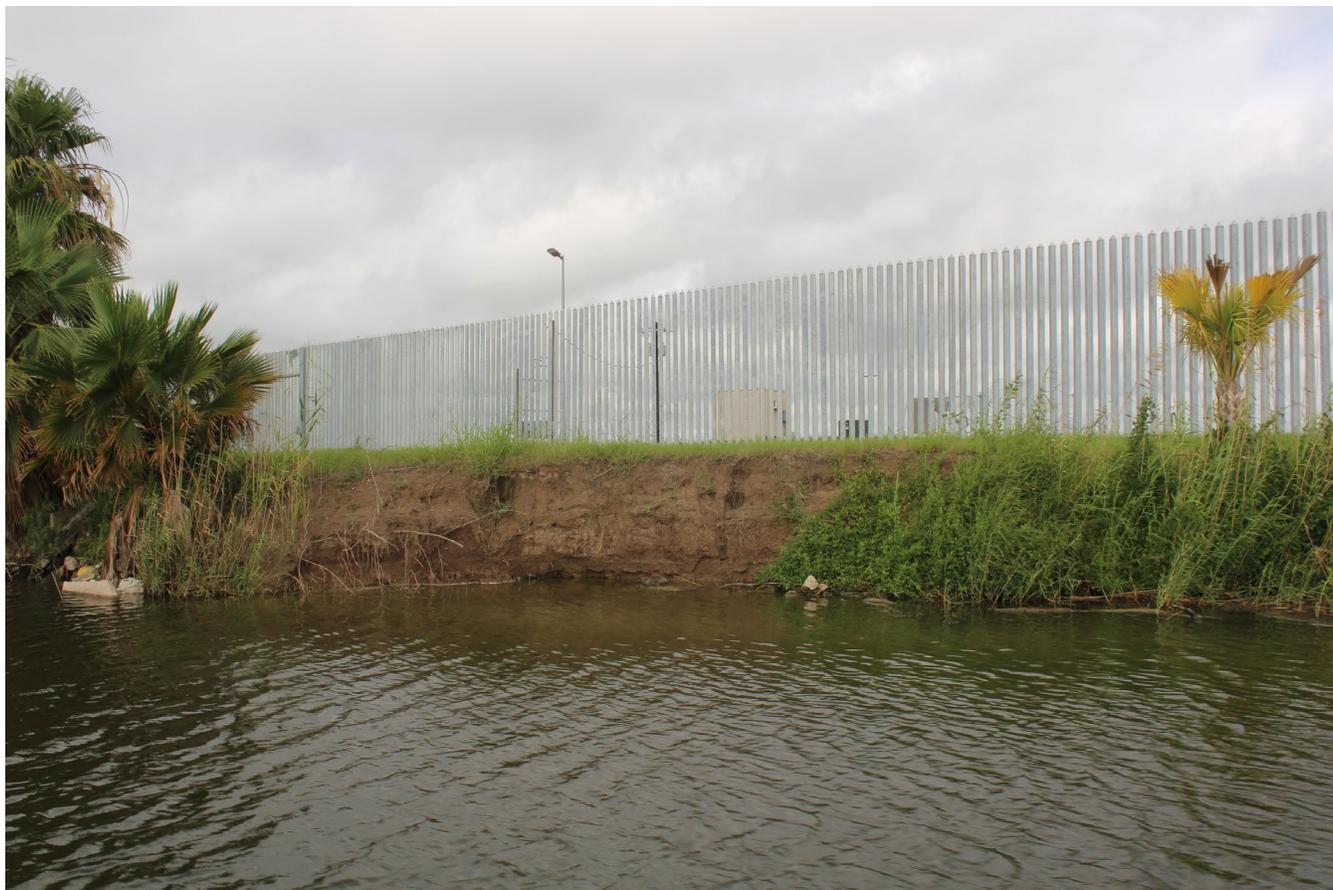
- Severe erosion of the base of the fence has occurred in some locations with rills and gullies as shown in Figure 4.34, indicative of high flow velocities through the fence openings from inside to the outside. As displayed in Figures 4.31 and 4.32, such conditions primarily occur along the eastern portion of the fence on the rising side of the flood hydrograph in this case. Without protective measures, for example armoring of the slope by riprap or soil reinforcement by natural vegetation, erosion of this type could expose and weaken the foundation of the fence over time.

Figure 4.34. Severe erosion at base of fence

Severe erosion of the base of the fence has occurred in some locations with rills and gullies indicative of high flow velocities through the fence openings from inside to the outside, primarily occurring along the eastern portion of the fence on the rising side of the flood hydrograph. Without protective measures, erosion of this type could expose and weaken the foundation of the fence over time.

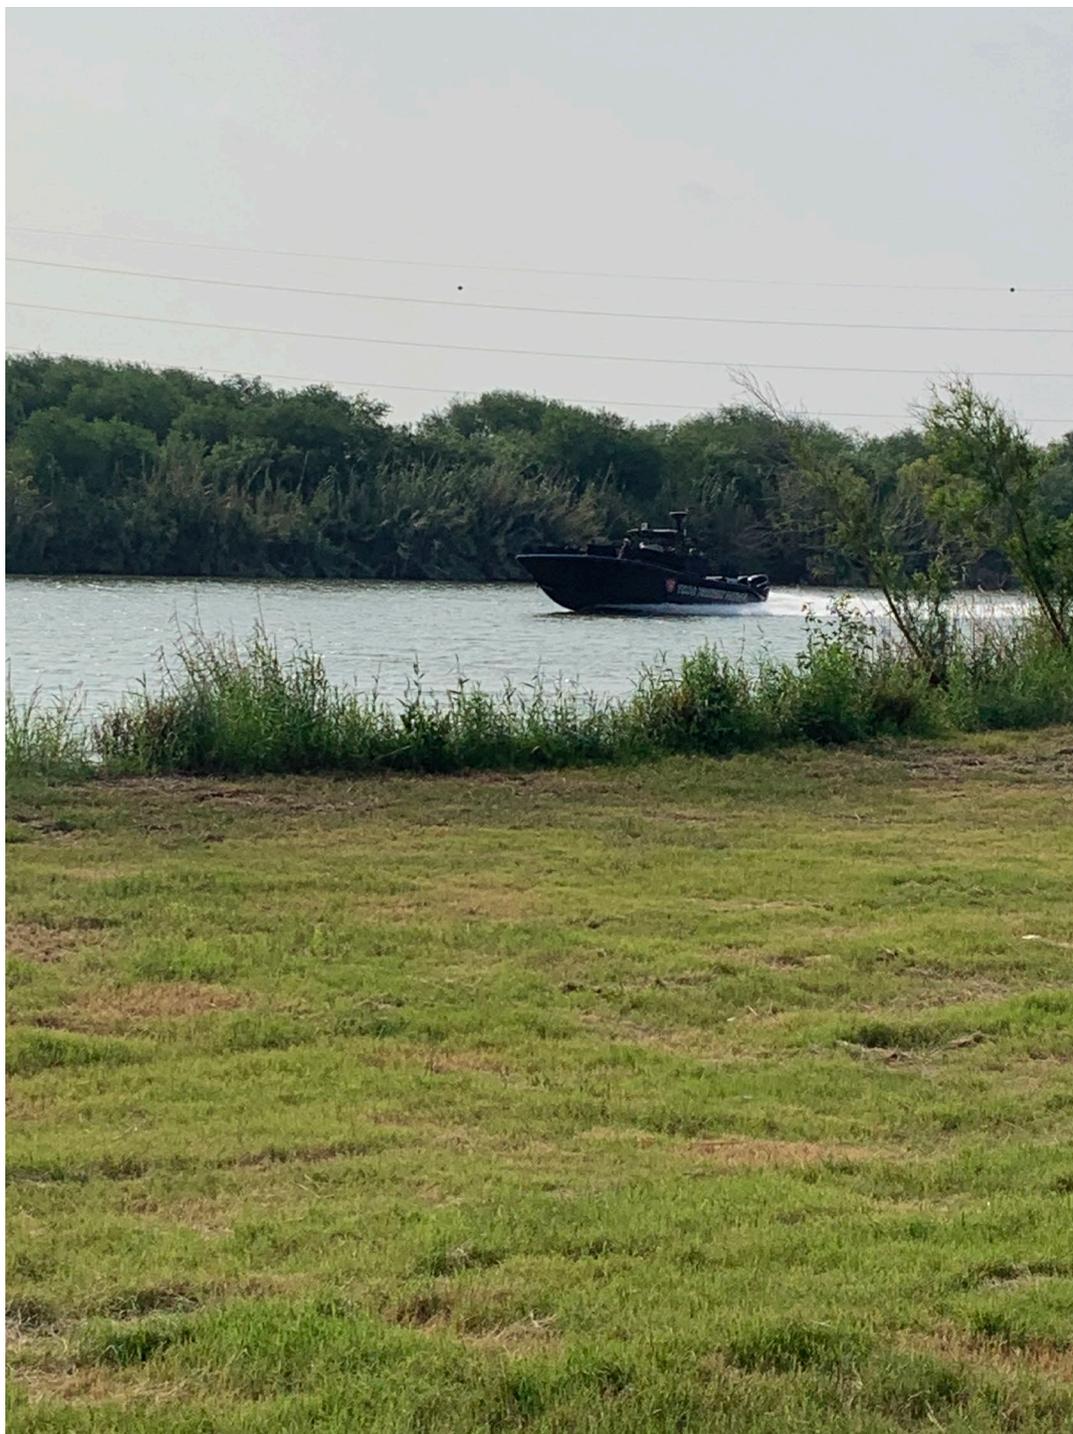
- Large areas of vertical sloughing and caving of the bank have occurred, as shown in Figure 4.35. Bank erosion of this kind is not caused by high velocity flow, but by alternate and frequent saturation and drying of the riverbank, which can be caused by (1) average daily river stage fluctuations of 0.5 feet upstream of Anzalduas Dam, and (2) wakes generated by frequent high-speed river patrol boats, an example of which is shown in Figure 4.36. Riverbanks along both the western and eastern portions are equally subject to caving. Boat as well as wind-generated waves can also result in structural loading of the fence due to wave forces. The raising and steepening of the bank and removal of natural vegetation during fence construction may have

Figure 4.35. Severe bank caving on river side of fence

Since construction of the fence, large areas of vertical caving of the bank have been observed. With average daily river stage fluctuations of 0.5 feet upstream of Anzalduas Dam and wakes generated by frequent high-speed river

patrol boats, the raising and steepening of the bank and removal of natural vegetation in construction of the fence may have exacerbated bank erosion. In addition, wind-generated waves during high-water conditions could add to structural loading of the fence due to hydraulic head and flow velocity.

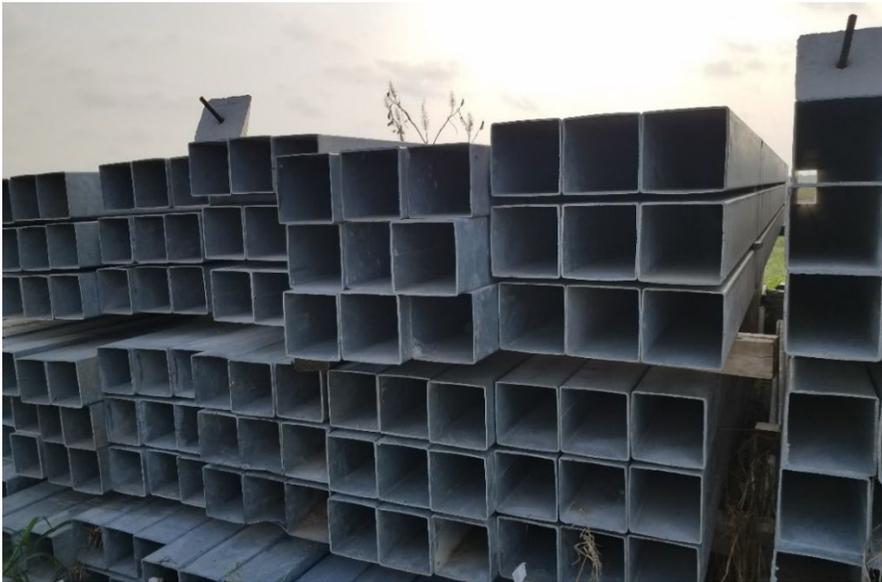
A surplus of steel bollards used to construct the fence section is stockpiled at the site as shown in Figure 6.6. These bollards were inspected during the investigation.

Figure 6.6. Surplus of steel bollards

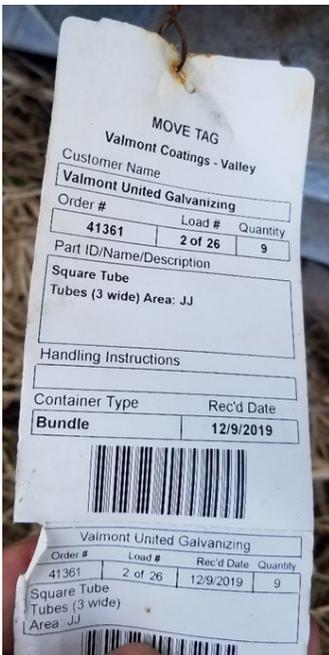
The dimensions of the 6-inch by 6-inch tube sections were verified, and shop tags were included with record of galvanizing shipping details as shown in Figure 6.7. NDT was used to confirm the 1/8-inch thickness of bollards in place on the fence at locations every 1/4 mile along the fence alignment as documented in Appendix B.

Figure 6.7. Shop tag with record of bollard galvanizing

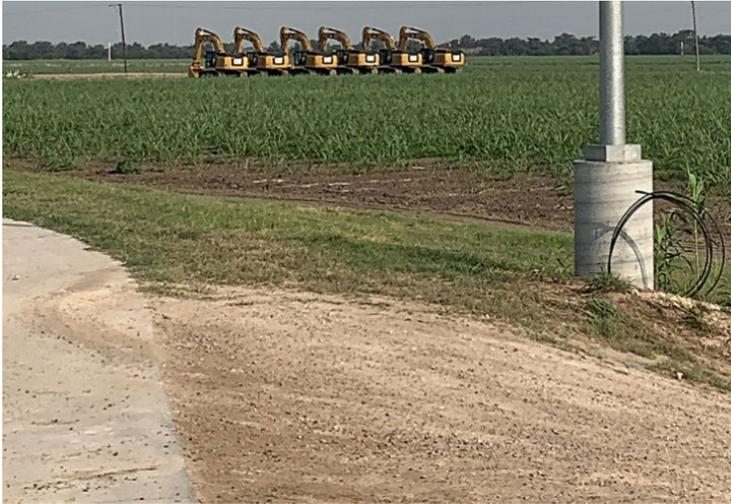
A light/camera monopole founded in a precast concrete shaft foundation is shown in Figure 6.8. The light pole foundation is designed as 4 feet embedded into the ground with 2 feet exposed above ground as shown in Figure 6.1; however, the exposed height was at times higher due to variance in the finished grade with respect to

the typical system cross section. The light/camera pole is also galvanized steel. No details were provided of the light pole anchor detail into the concrete foundation.

Figure 6.8. Precast shaft founded light/camera monopole

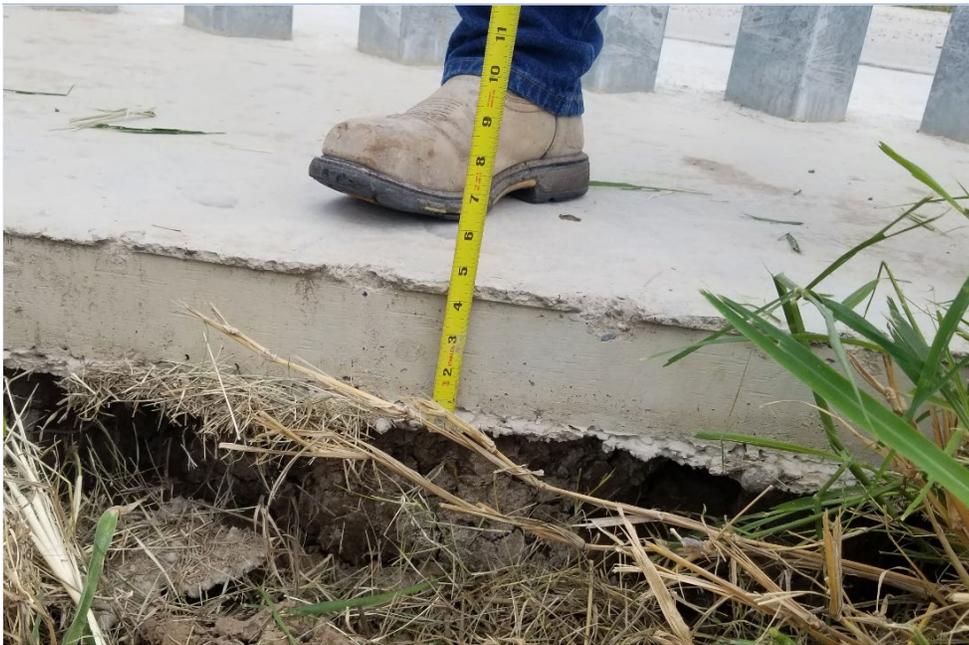
As part of our field investigation, we measured the thickness of the flange of the T-shaped footing at five locations along the fence alignment. Near the upstream end of the fence, we observed the flange to be 1 foot thick as indicated by the foundation design in Figure 5.4. However, at four other locations, we measured the flange to vary from 4.5 to 10 inches thick (refer the Site and Subsurface Investigation Report in Appendix B).

The overall width of the base foundation was verified to be 8 feet as shown on the plans (see Figures 6.1, 6.4, and 6.5). However, the thickness at some locations where the edge of the foundation was exposed due to erosion was less than the 1 foot shown on plans (see Figures 6.1 and 6.5). Figure 6.9 shows a non-conforming thickness of 4½ inches.

Figure 6.9. Non-conforming thickness of base foundation

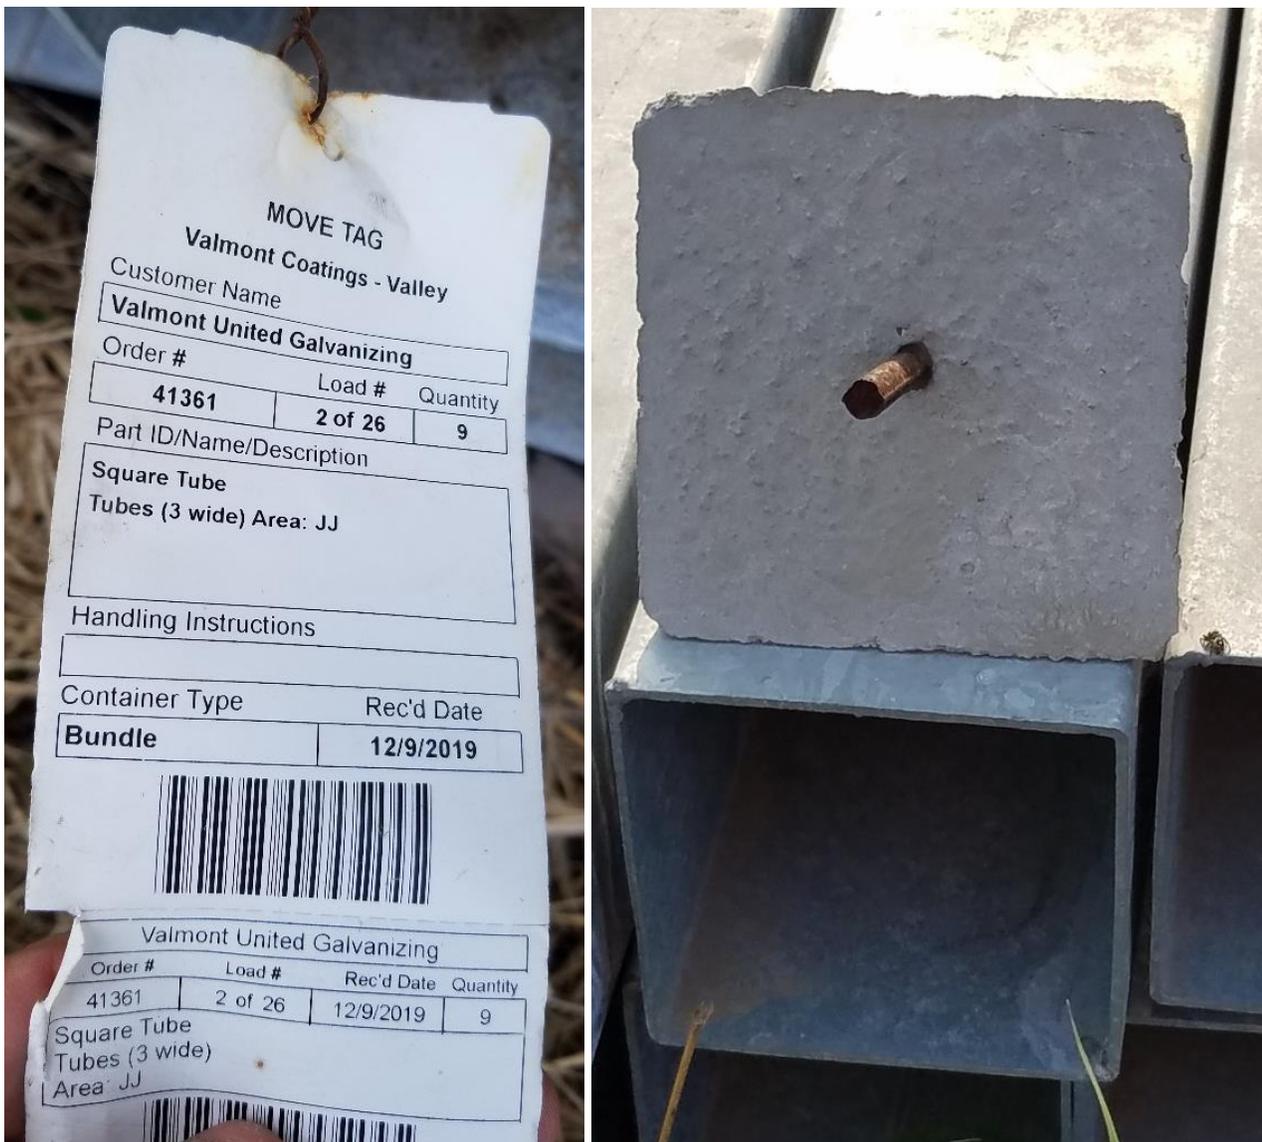
Mr. Fisher reported that the fence was constructed as shown on the plans provided (details shown on Figure 1). An exception is that the bollards were not grouted solid as shown on the plans, and instead were backfilled with an unspecified grade “pea” gravel. No material specifications, quality control test results, or field reports were provided regarding the backfill of the bollards and no field verification was completed for this investigation. Pre-cast concrete caps were grouted to the top of the fence bollards using a rebar dowel. Shop tags providing records of galvanizing and photographs of example materials are shown on Figure 3.

Figure 3: Shop Tag from Galvanizing, Tube Steel, and Concrete Cap with Dowel

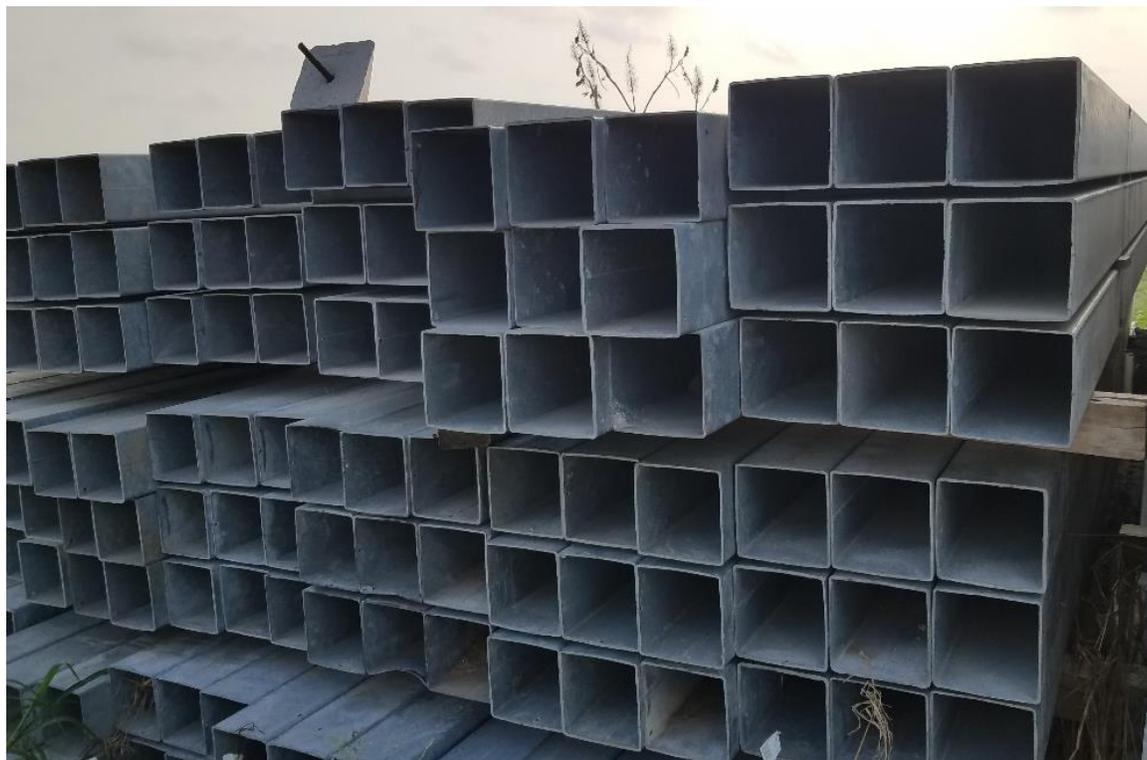
Surplus steel bollards used to construct the fence section are stockpiled at the site as shown on Figure 4, and the dimensions of the 6-inch by 6-inch tube sections were verified. A photograph of typical completed fence near STA 156+00 at the upstream limits is shown on Figure 5.

Figure 4: Surplus Steel Bollards Stockpiled on Site

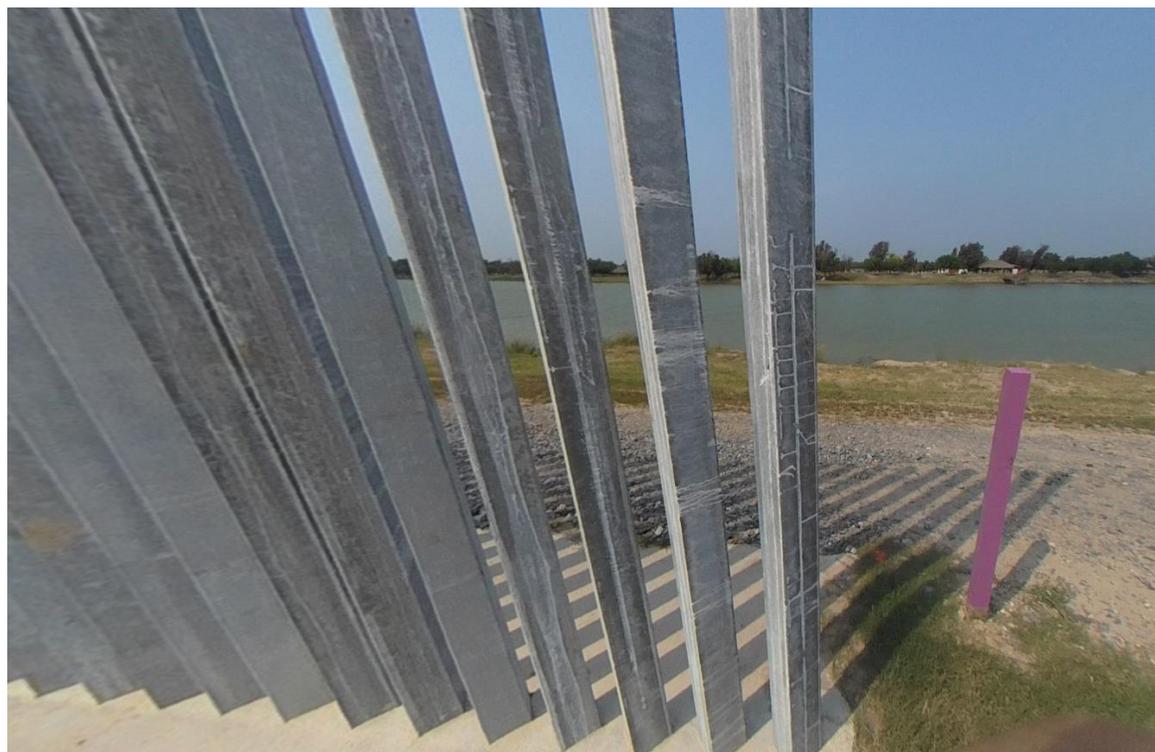
Figure 5: Constructed Bollard Fence Near STA 156+00 at Upstream Limits

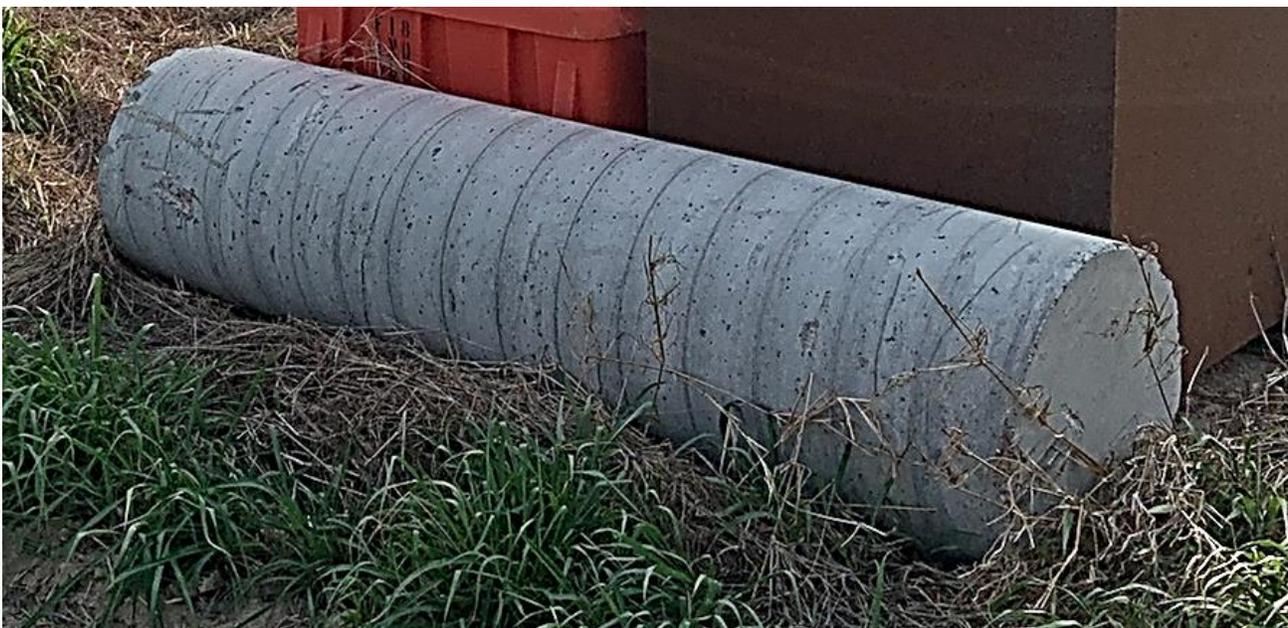
Figure 7: Pre-cast Concrete Footing for Utility Pole Installation

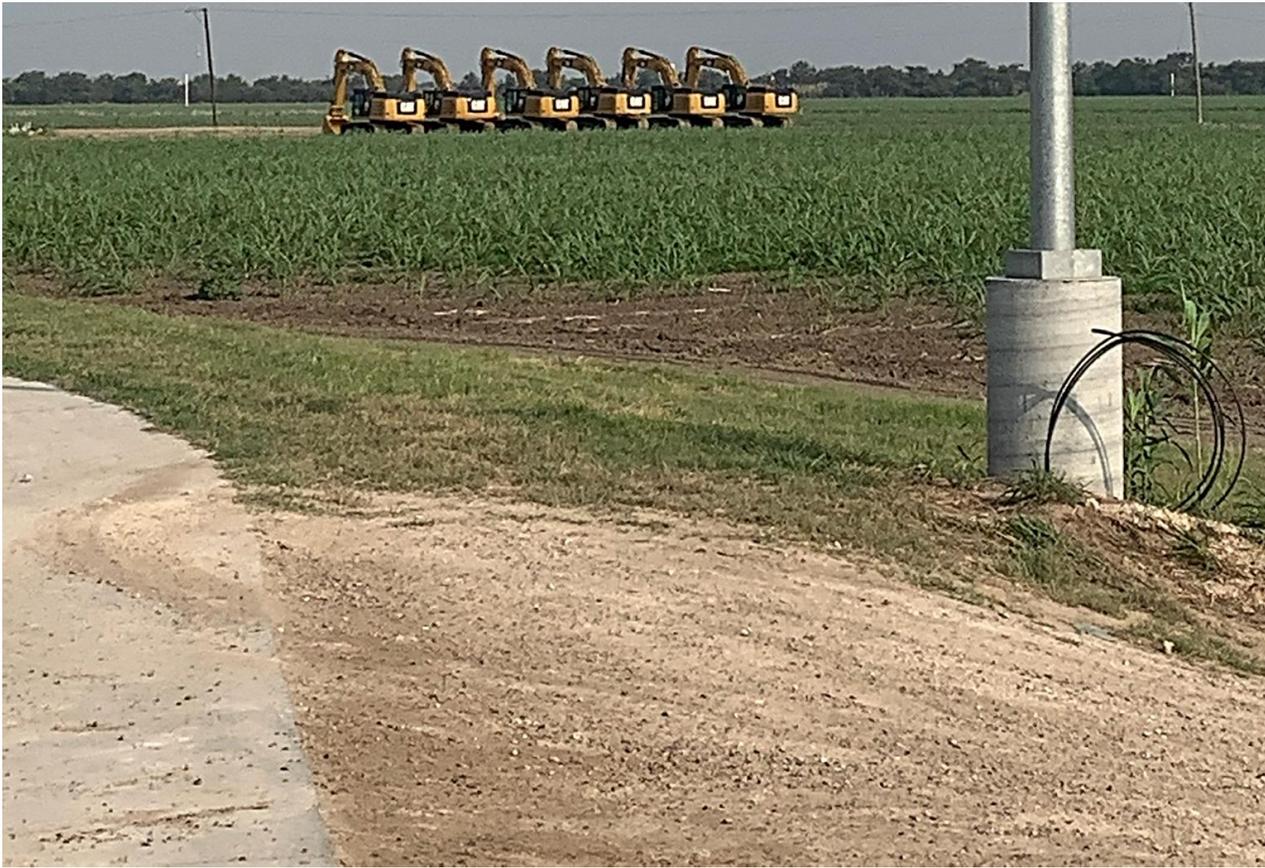
Figure 8: Utility Pole at the Edge of the Road Near STA 0+00

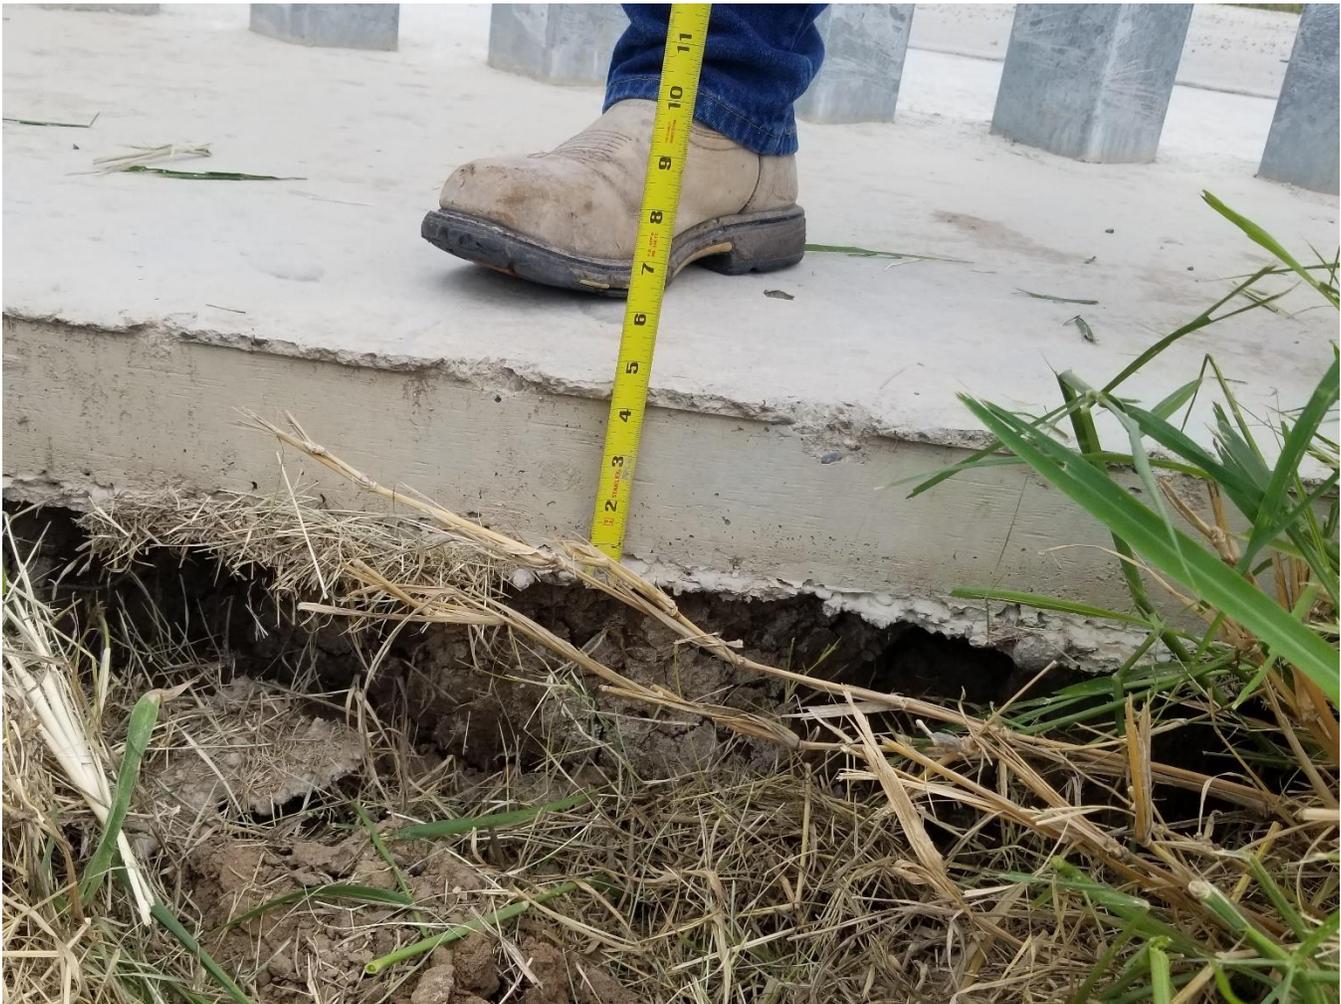
The depth of the concrete footing shown in the design (Figure 1) is 1 foot up to the steel bollards, where the depth increases to 3 feet for the embedment of the bollards. The edge of the footing on the riverside of the fence was evaluated at five locations along the alignment to confirm the depth of the concrete. This evaluation indicated that the edge of the concrete is not a uniform depth of 1 foot, with one location measuring as little as 4.5 inches as shown on Figure 14. One location evaluated near STA 156+00 did measure a full 12 inches as shown on Figure 15.

Figure 14: Footing Depth Measurement of Riverside Edge Near STA 0+00

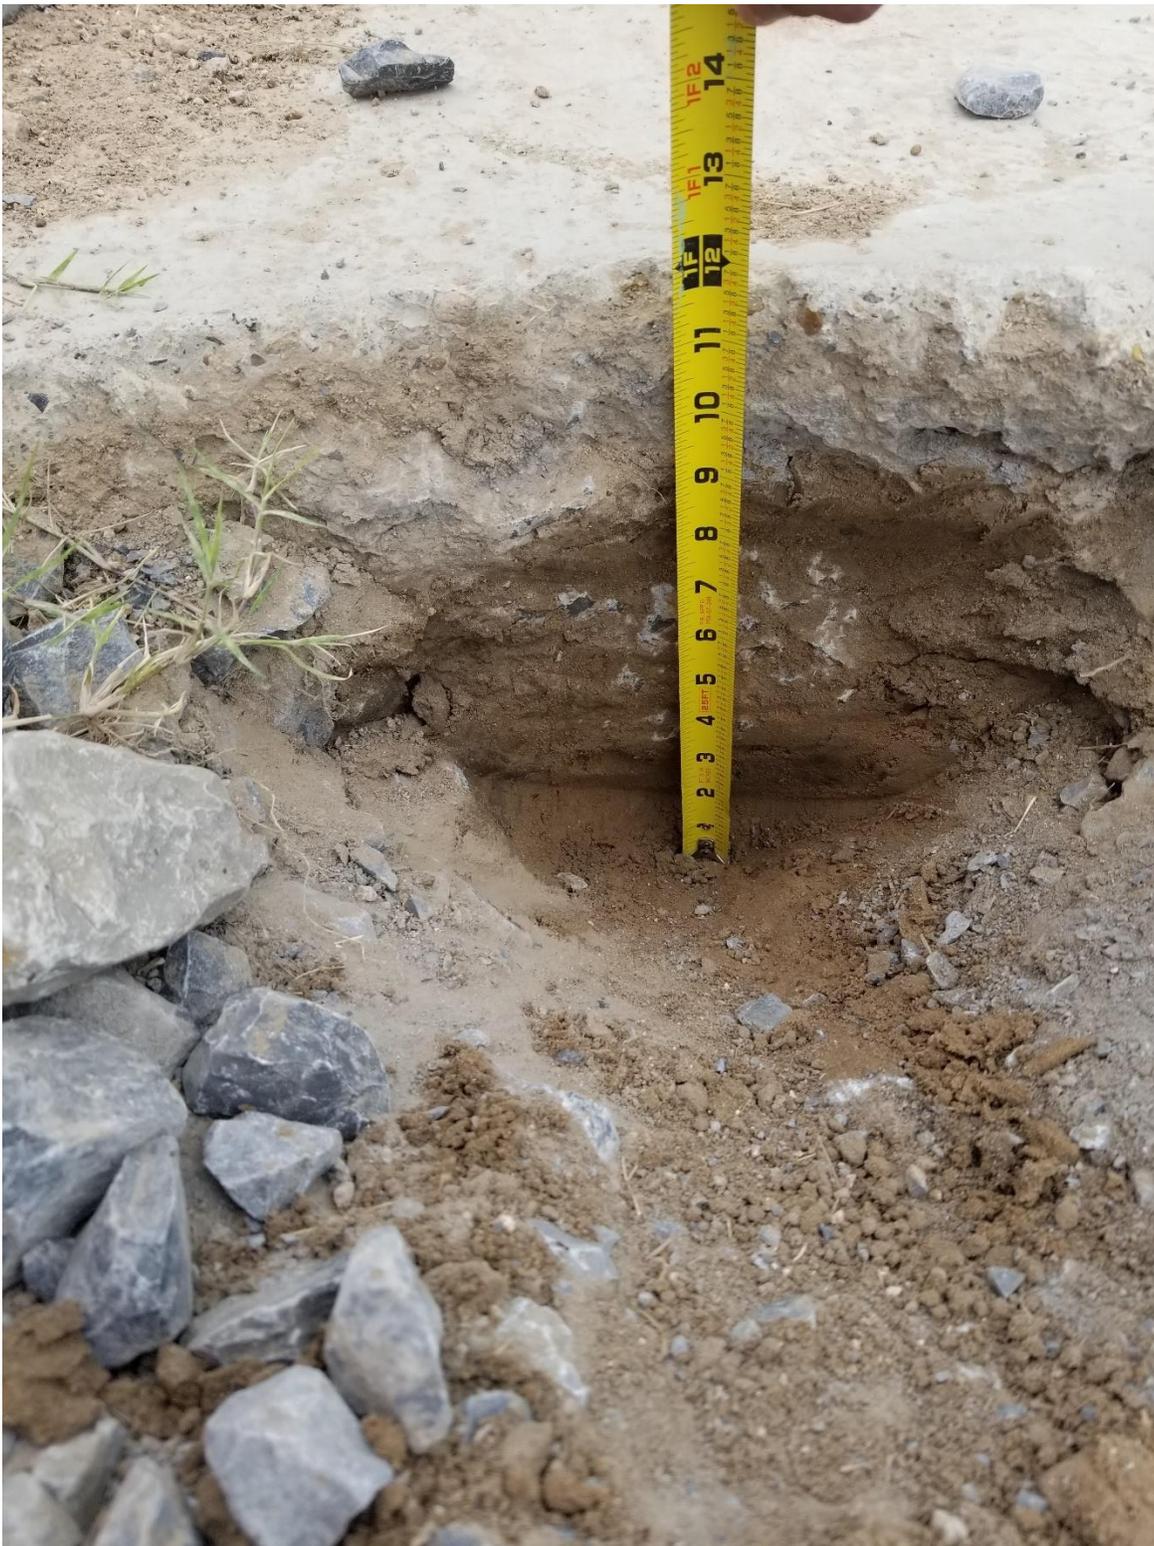
Figure 15: Footing Depth Measurement of Riverside Edge Near STA 156+00

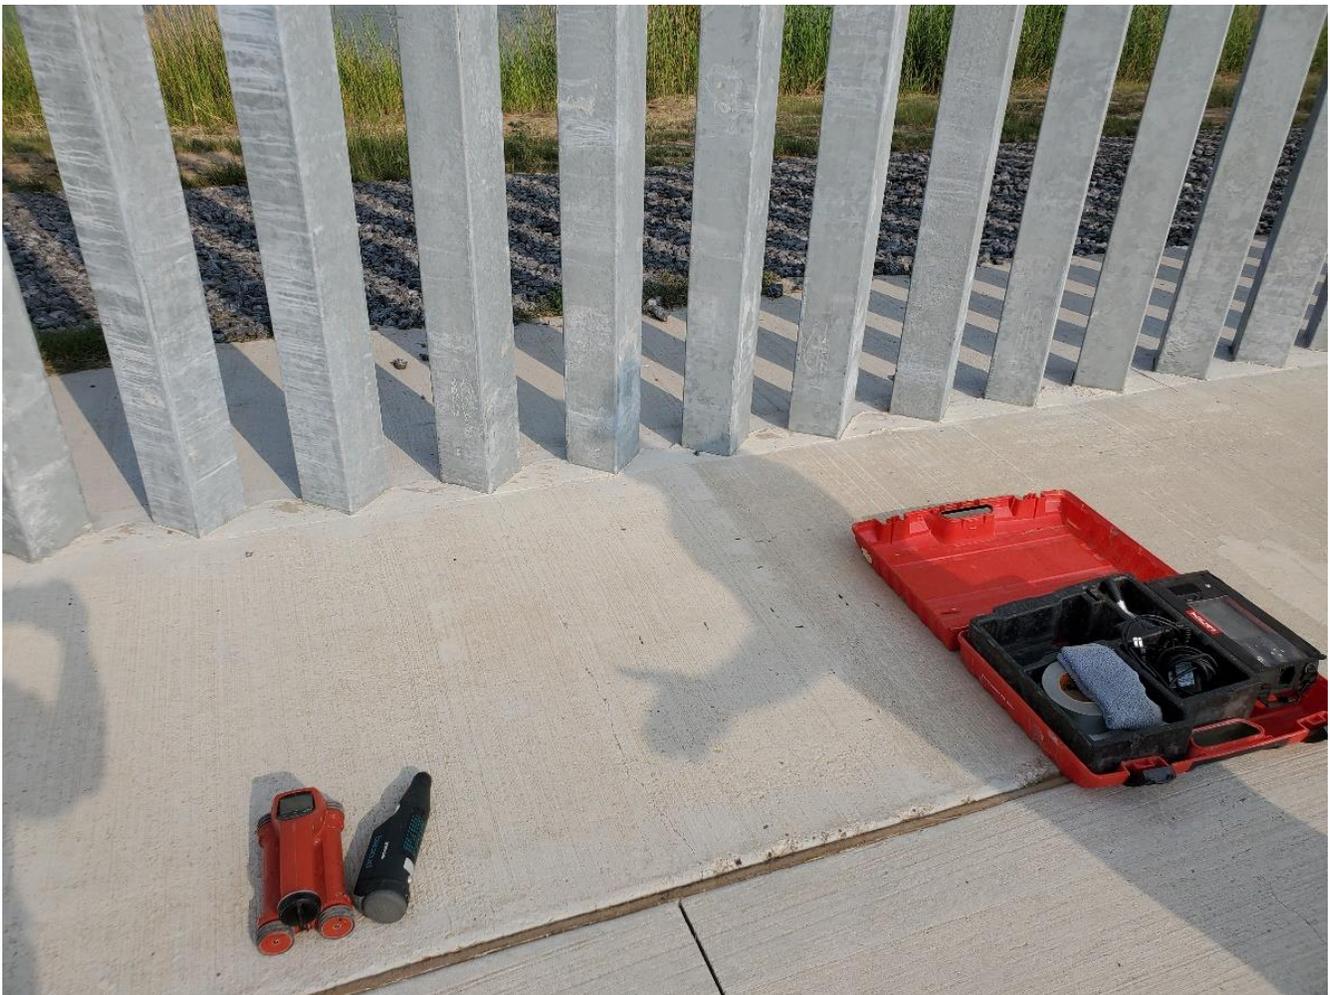
Terracon used NDT to measure the concrete strength with a rebound hammer and the spacing of reinforcement with a ground-penetrating radar (GPR) as described in Attachment 2. Tests were conducted at approximately every ¼ mile, for a total of 12 test locations. Results indicate that the concrete at test locations has a compressive strength of approximately 4,500 psi per the design. GPR scans indicate that the reinforcement is #5 rebar at approximately 5 inches on center in both directions per the plans, as shown on Figures 16 through 18 and reported in Attachment 2.

Figure 16: Typical GPR Test Location for Rebar Spacing and Concrete Strength

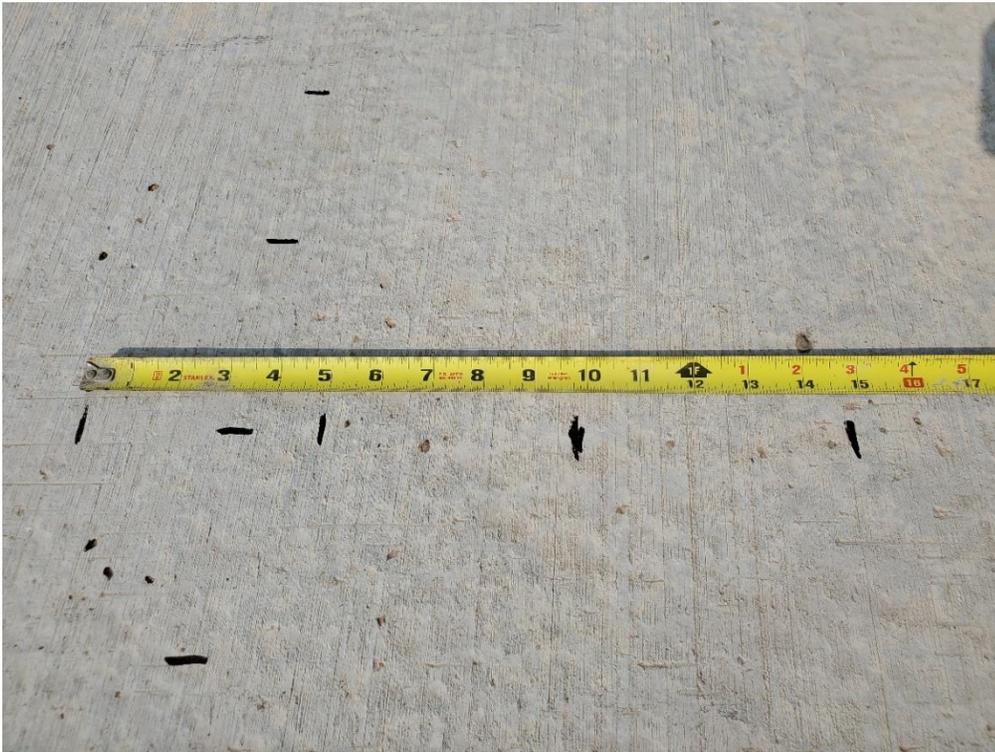
Figure 17: Rebar Spacing along footing at Approximately Every 5 Inches on Center as Determined by GPR

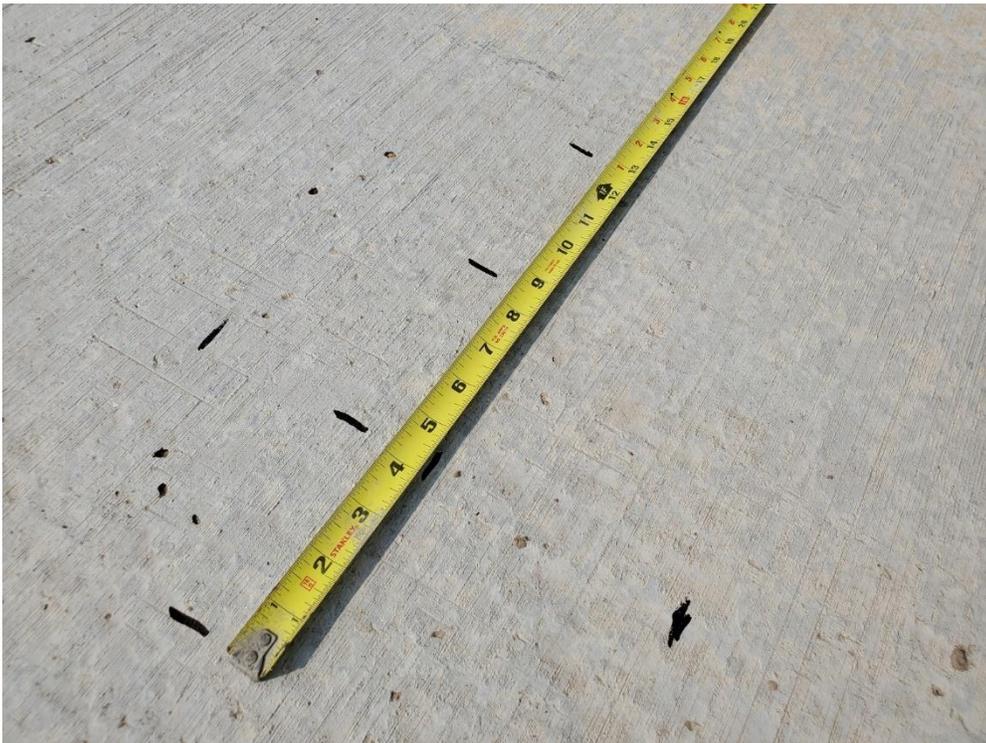
Figure 18: Rebar Spacing across footing at Approximately Every 5 Inches on Center as Determined by GPR

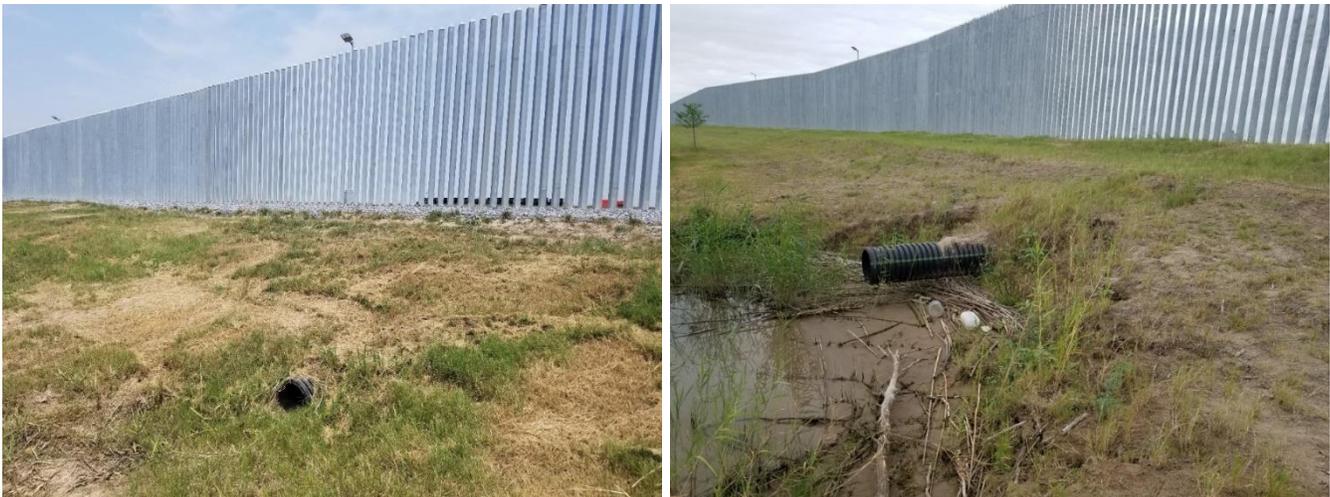
Surface water is conveyed underneath the fence foundation via corrugated high-density polyethylene (HDPE) pipes as shown on Figure 19. The design details and locations for the drainpipes were not provided for this investigation. Surface water travels as sheet flow across the road and fence footing to drain on the ground surface to the river. This surface flow has caused rills to be formed as observed along the edge of the fill material on the riverside of the fence, as shown on Figure 20. Historical information from August 2020 (included in Attachment 1) documented major rill erosion damage on the riverside of the fence following major storms that caused flooding along the river. At the time of the current investigation, most of the damage had been repaired and covered with grass; however, the rills could be seen as ground surface rutting and bare areas with limited grass cover.

Figure 19: Drainage Culverts Installed for Fence Construction

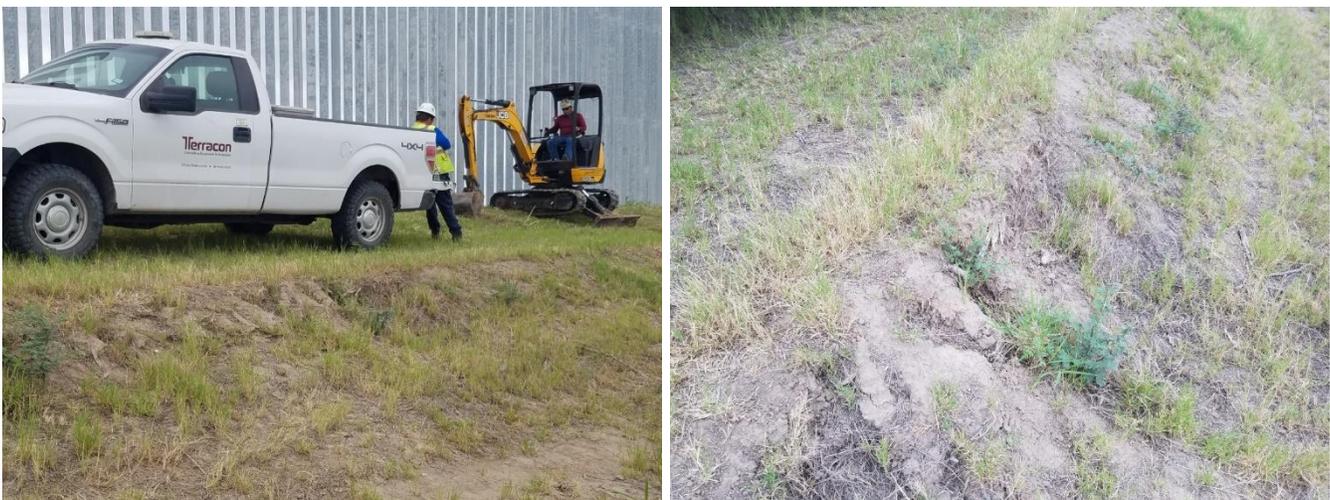
Figure 20: Typical Surface Erosion Rills on Riverside of Fence

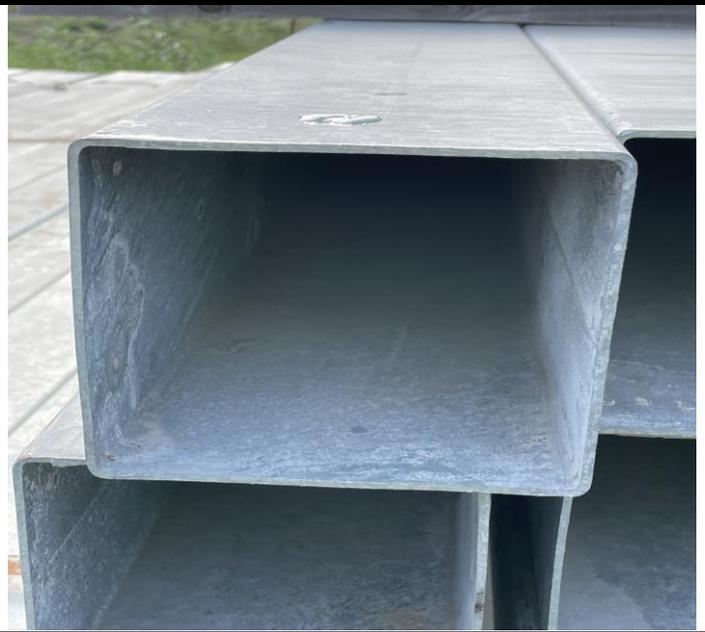
End View of Fence Bollard

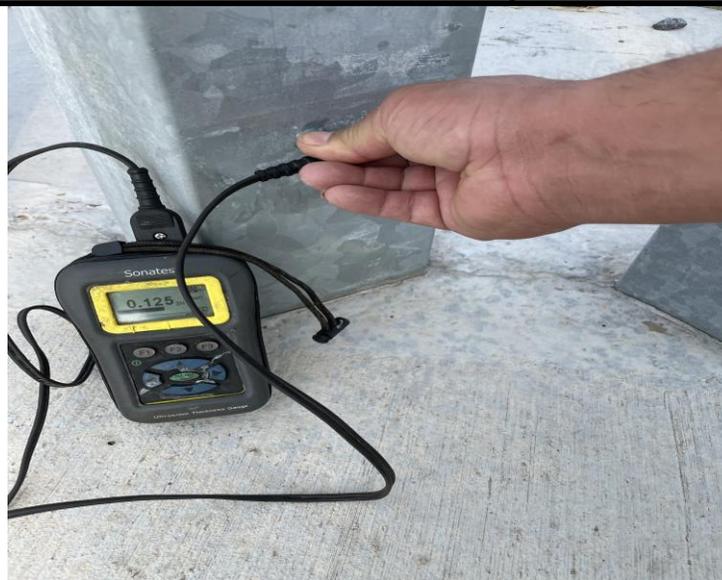
Fence Bollard Thickness Reading .125"

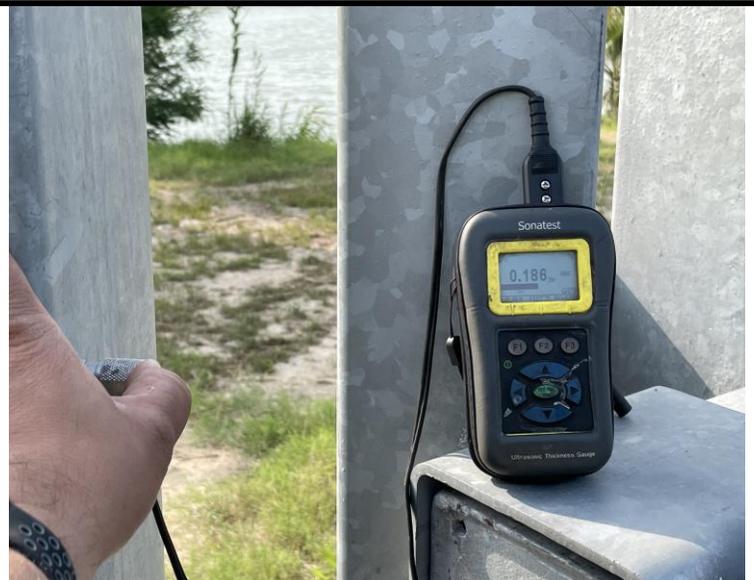
Gate Structure .186"

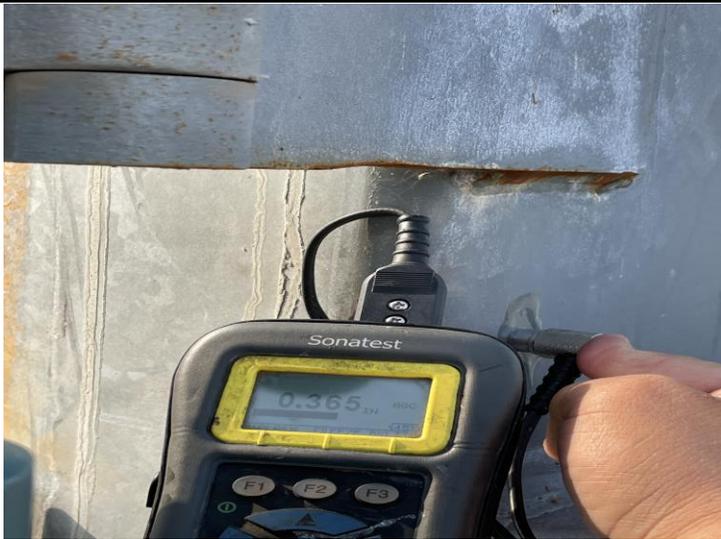
Gate Column .365"
