Engineering Evaluation of Bollard Fence

Rio Grande, Hidalgo County, Texas

United States of America v. Fisher Sand and Gravel Company, Civil Action No. 7:19-CV-403

August 2021

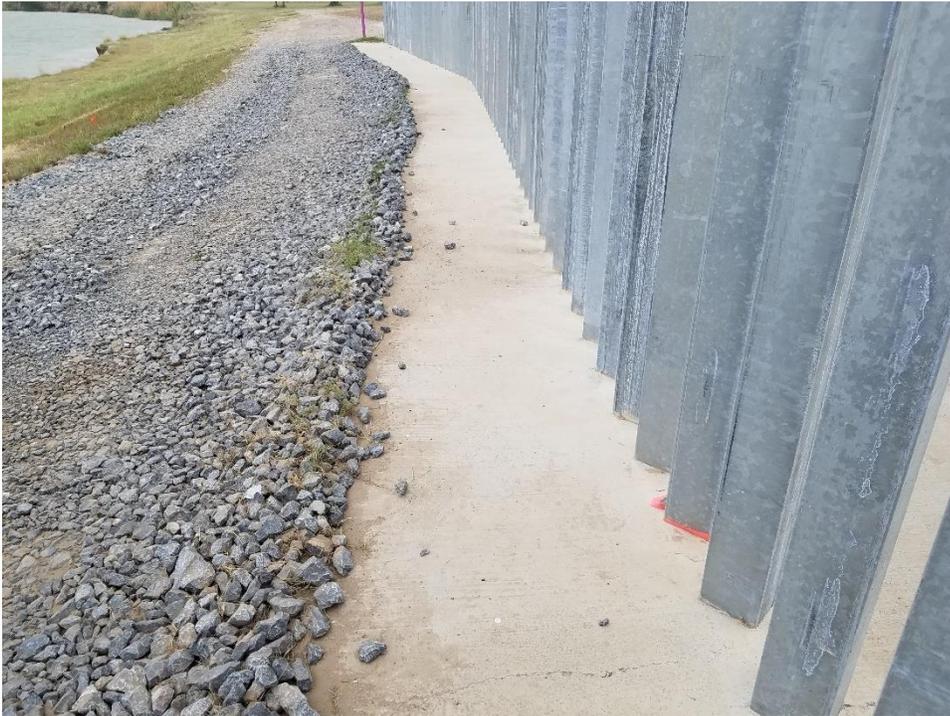
Photograph: 1

Description:
Upstream Wall limit near STA 156+00 where TP-1 was excavated, looking north at fence footing and aggregate base.

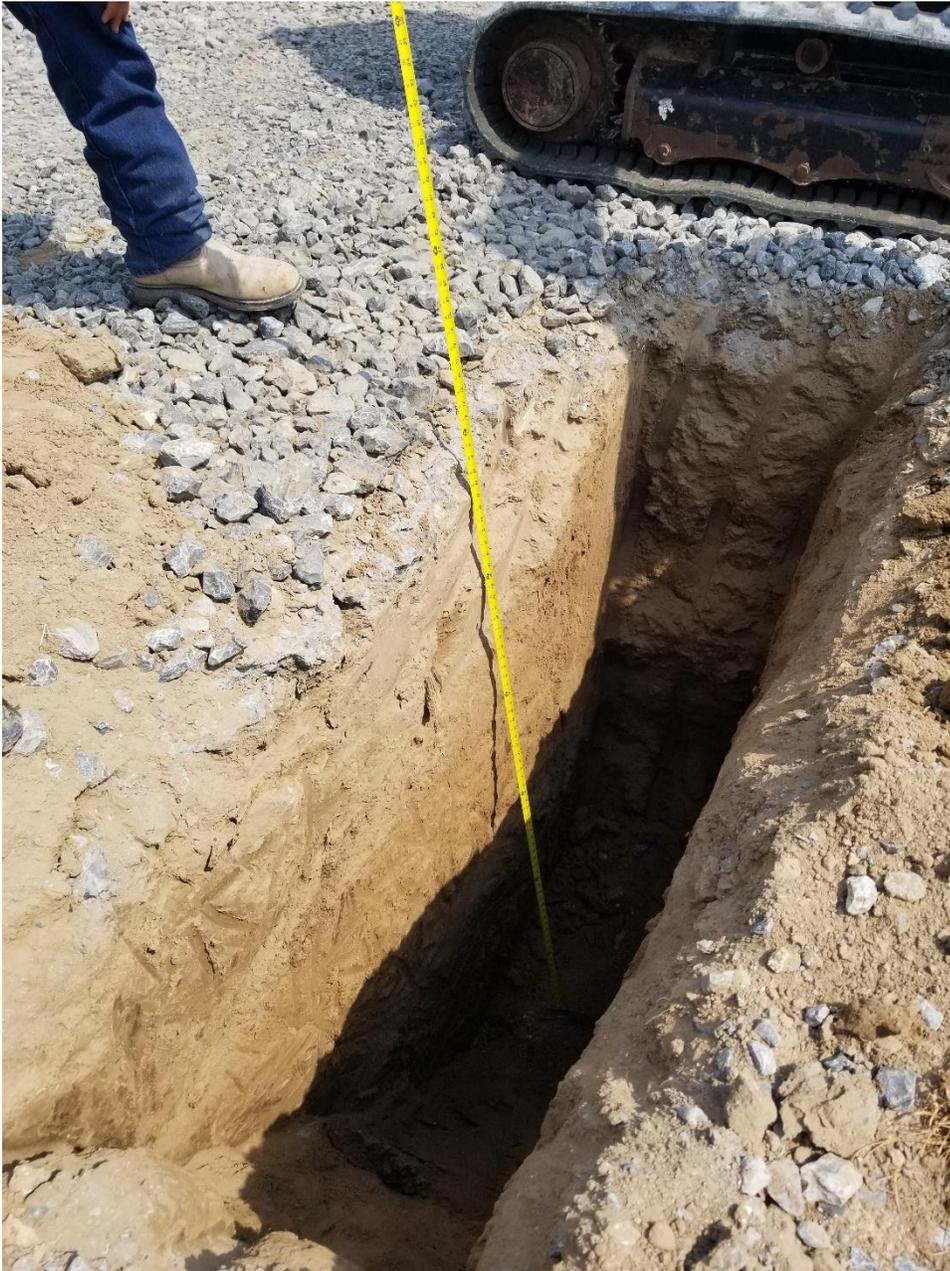
Photograph: 3

TP-1 excavation showing measurement of depth (sounding) and typical soil conditions.

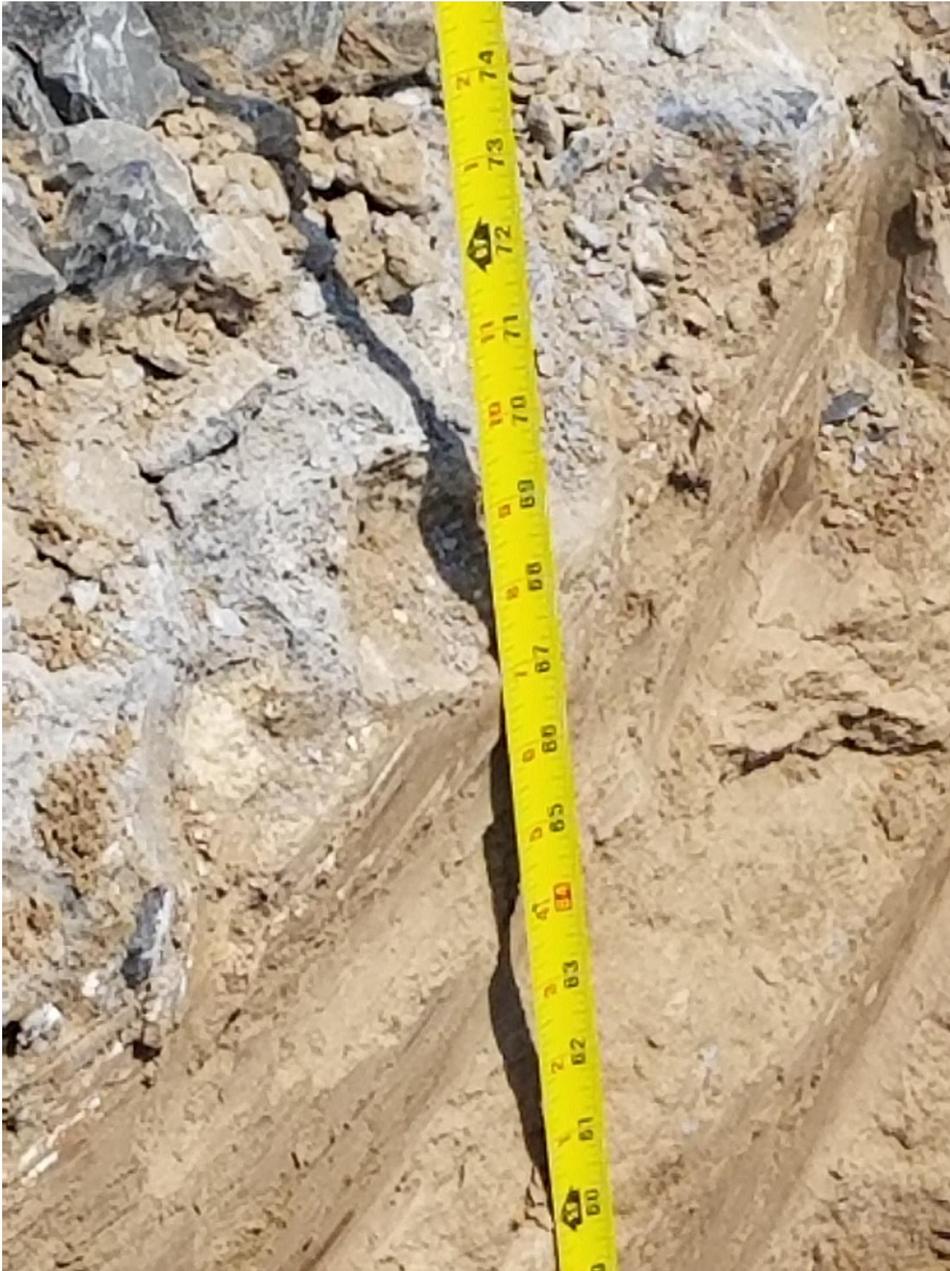
Photograph: 4

Description:
TP-1 excavation
showing depth
sounding and details of
soil and base materials.

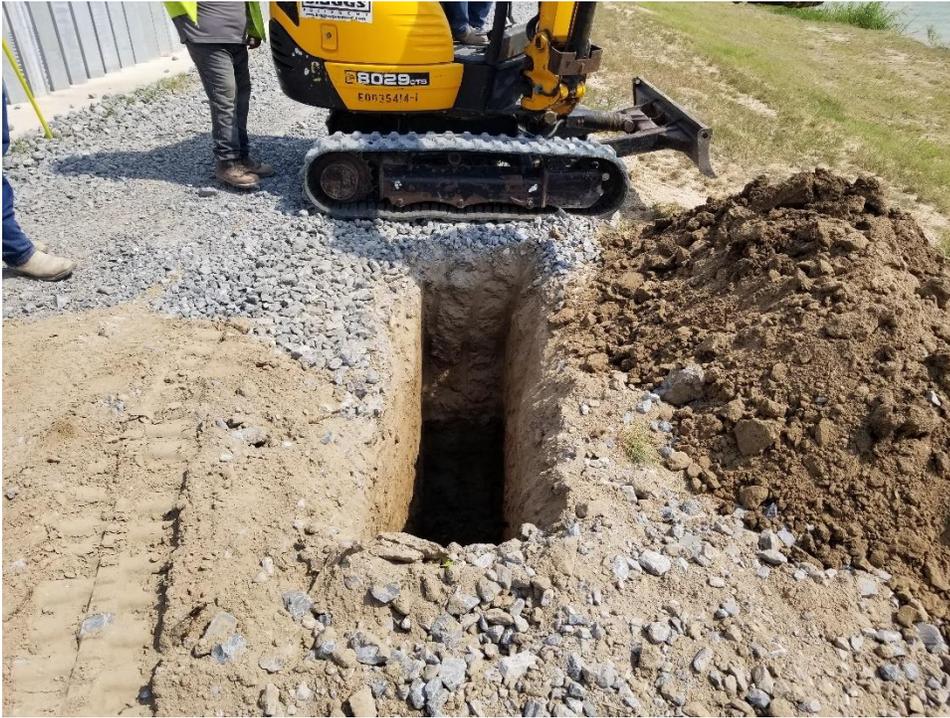
Photograph: 5

Description:
TP-1 looking south at
excavated trench.

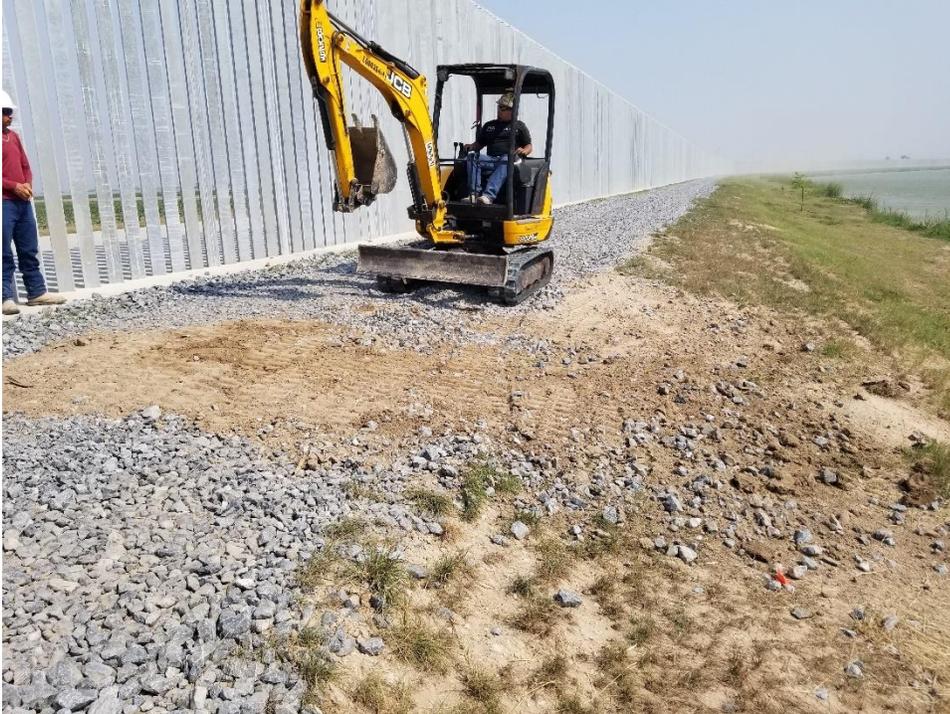
Photograph: 6

Description:
TP-1 looking southeast
at backfilled trench.

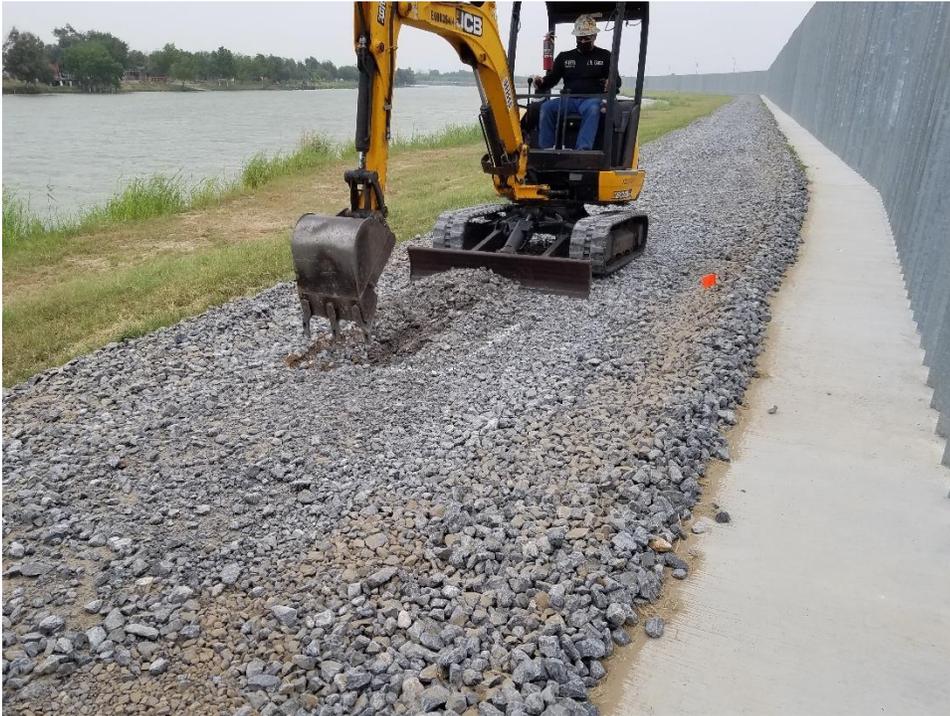
Photograph: 7

Description:
TP-2 excavation near
STA 139+50 looking
northwest at footing
and aggregate base.

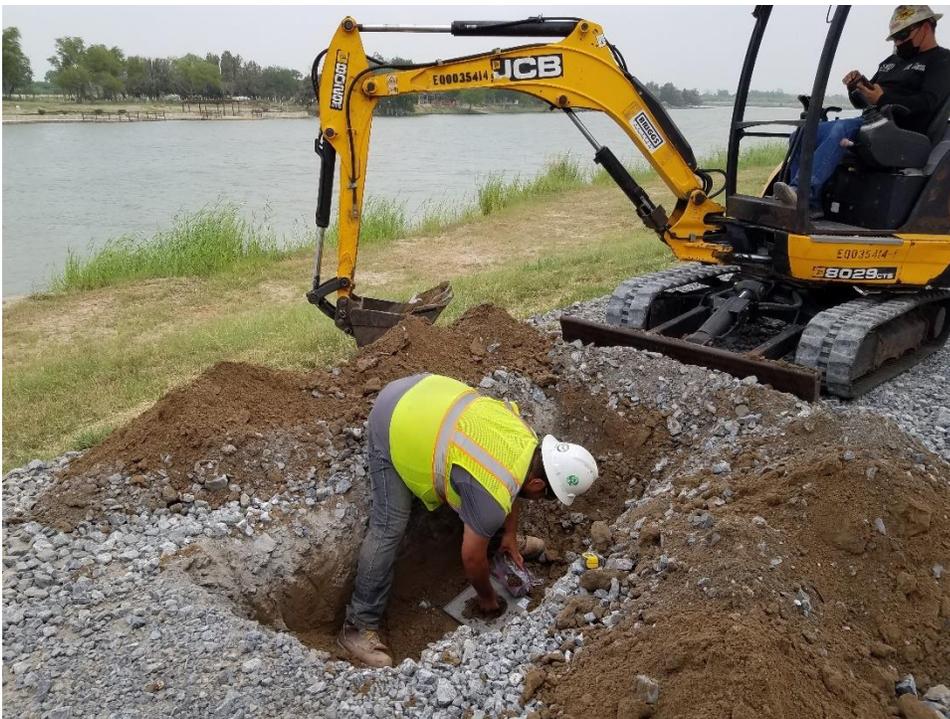
Photograph: 8

Description:
TP-2 excavation
showing sand cone test
at depth of 3 feet bgs.

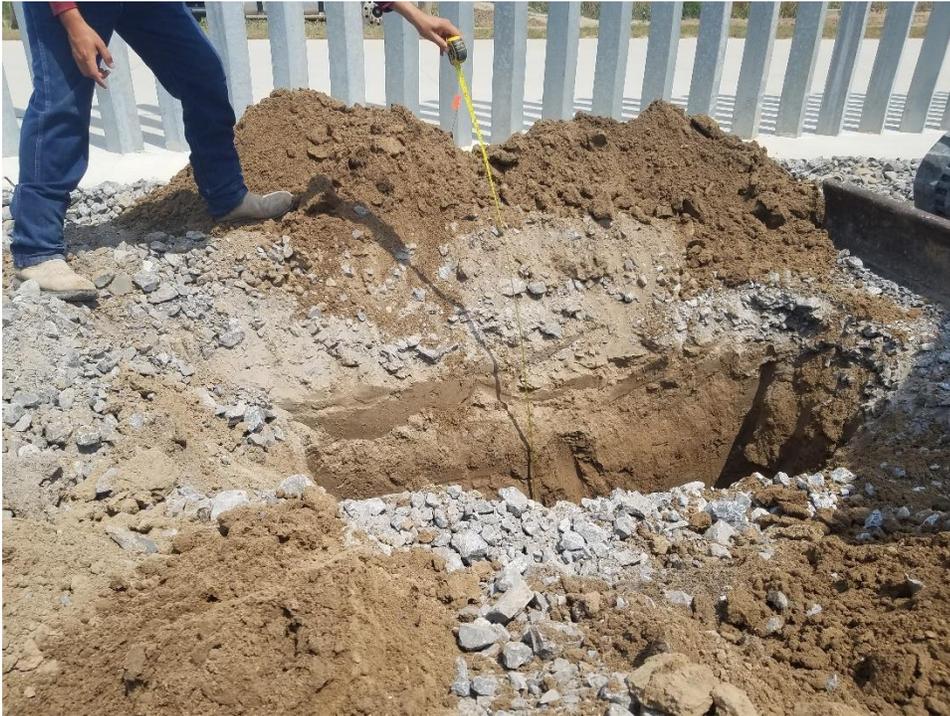
Photograph: 11

Description:
TP-2 excavation
showing soil conditions
and depth sounding.

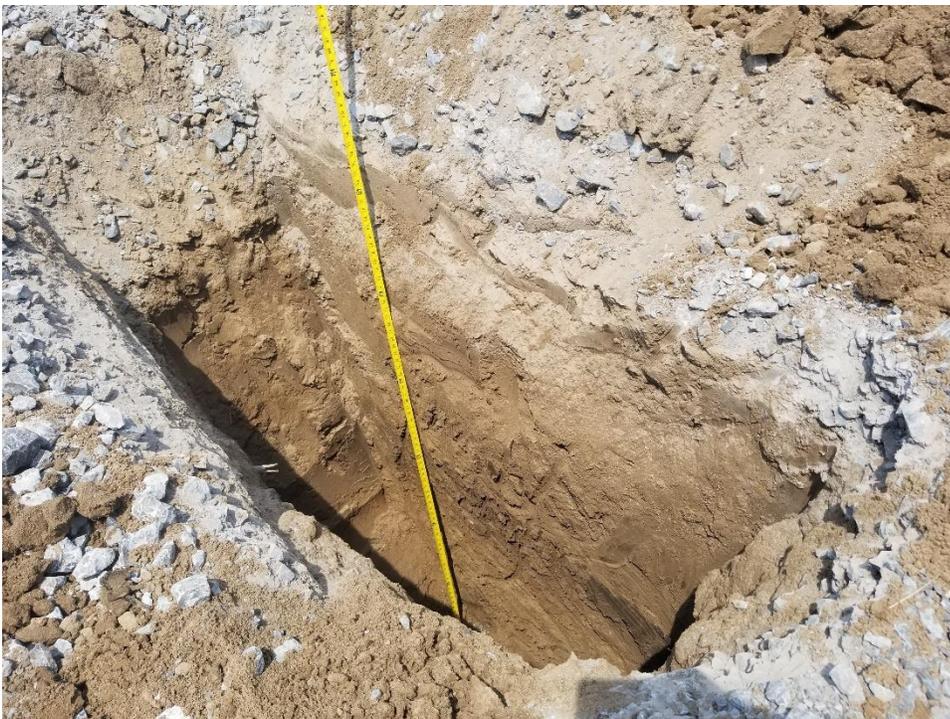
Photograph: 12

Description:
TP-2 excavation
showing typical
conditions of trench.

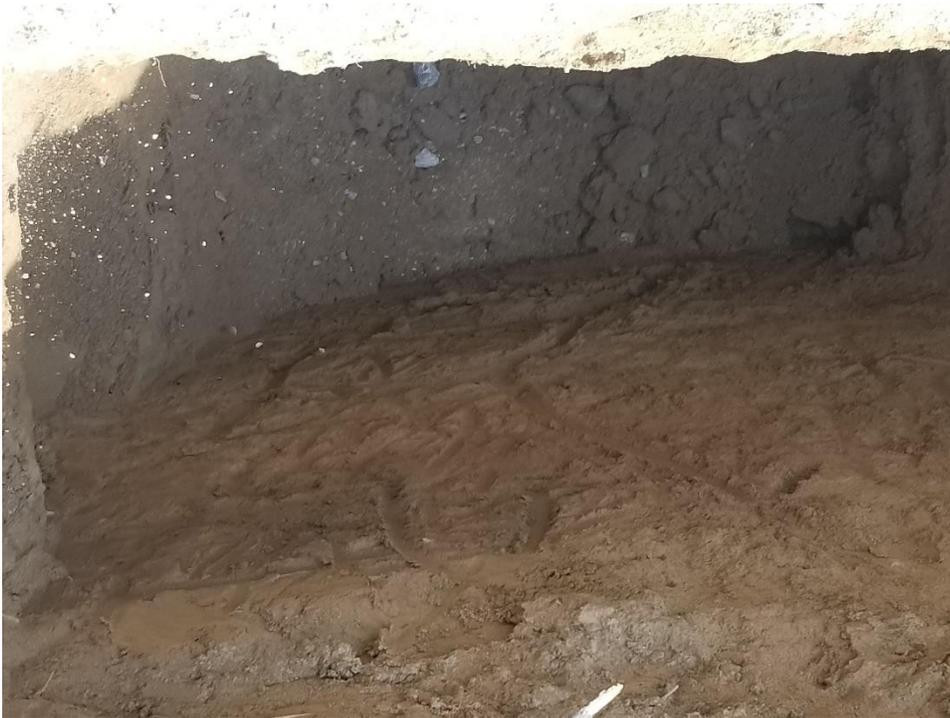
Photograph: 13

Description:
TP-2 excavation at termination depth of 7 feet bgs showing soils and trace groundwater entering trench.

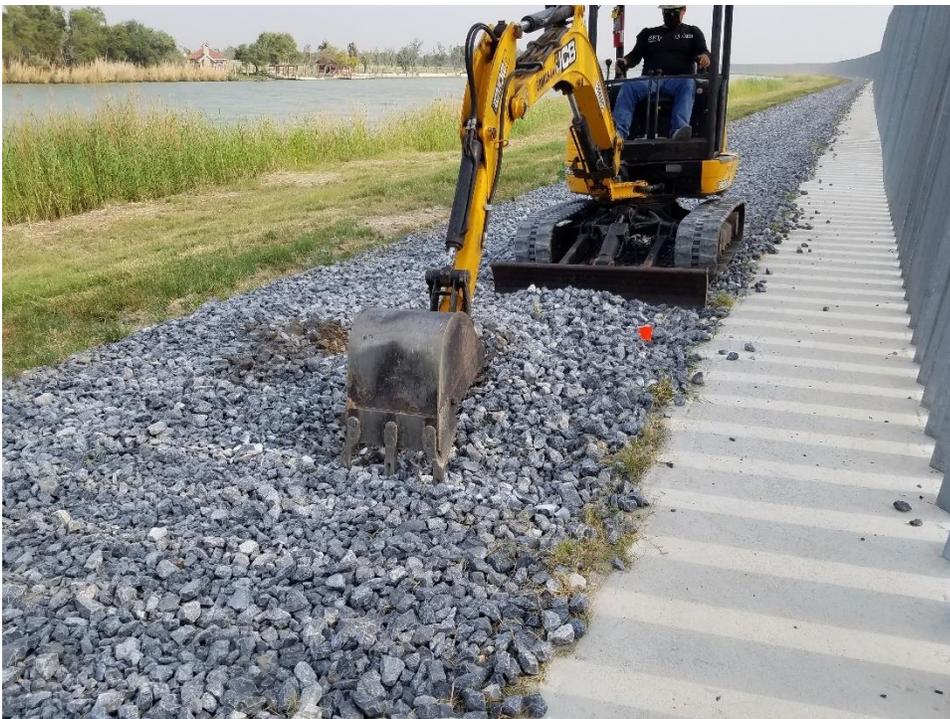
Photograph: 14

Description:
TP-3 excavation near STA 125+00 looking north at footing and aggregate base.

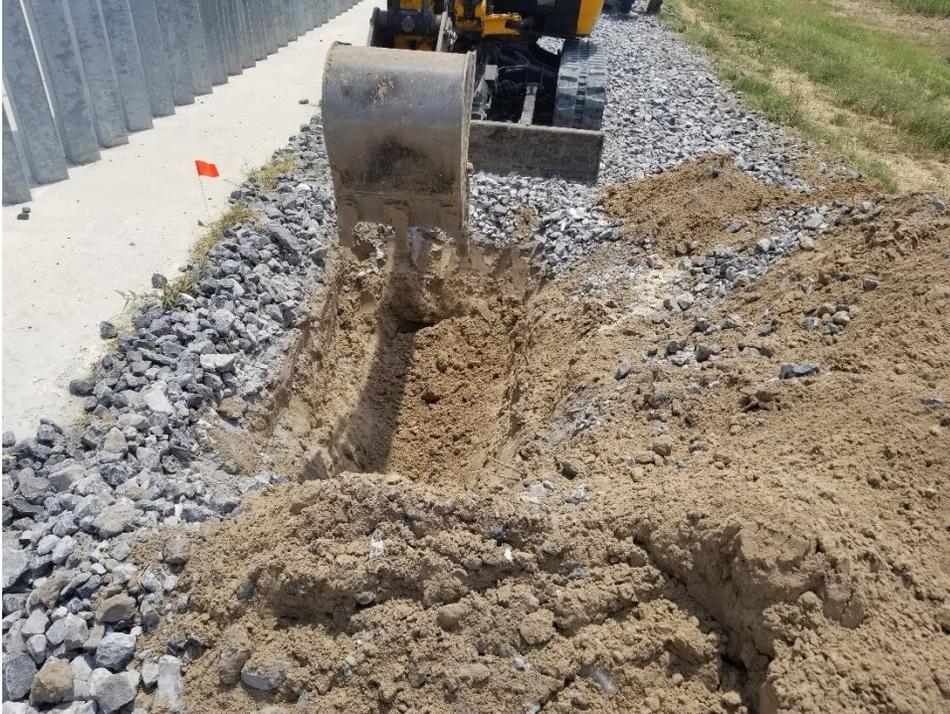
Photograph: 16

Description:
TP-3 excavation
looking south showing
typical soil materials.

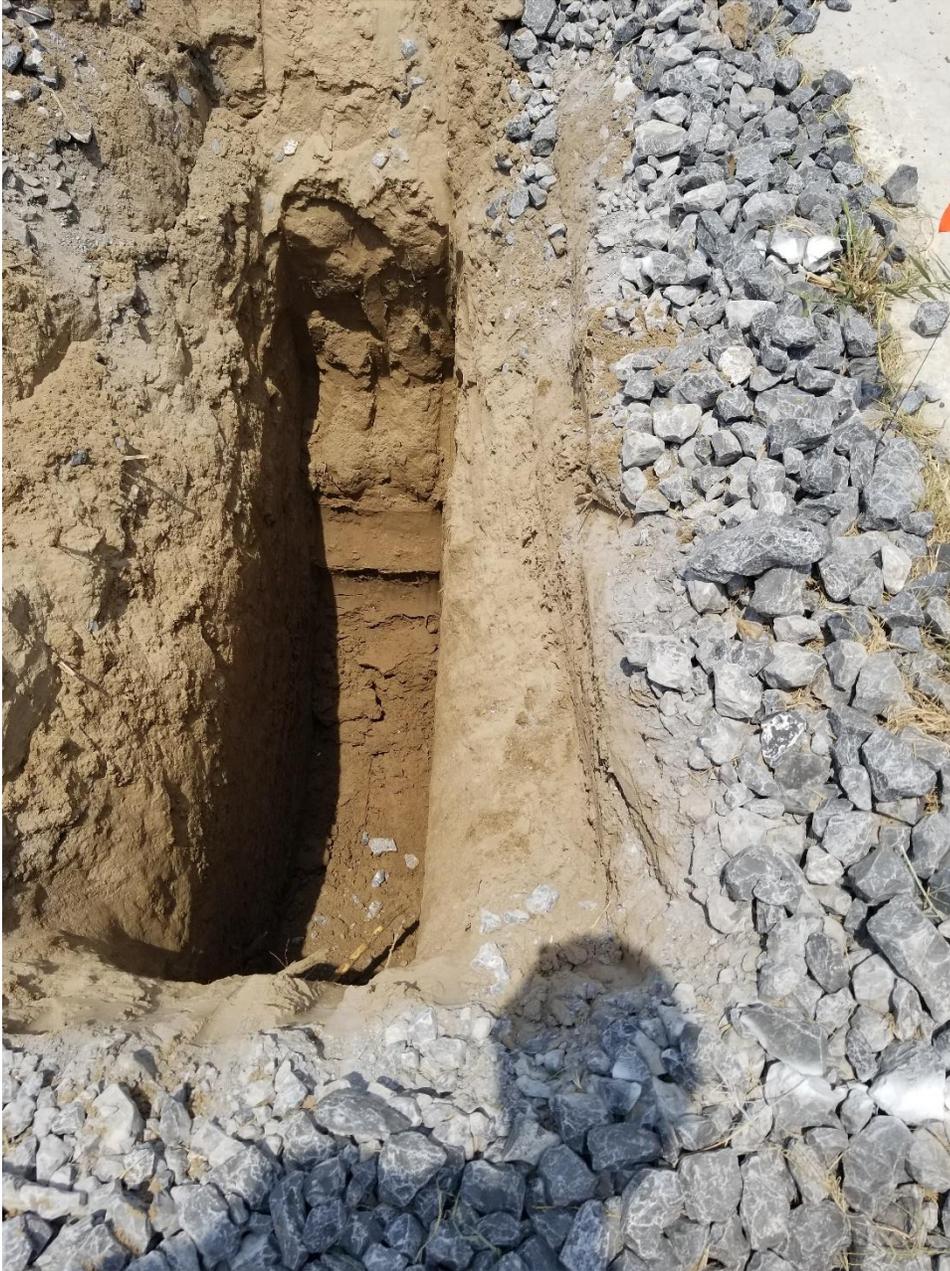
Photograph: 17

Description:
TP-3 excavation
showing typical
subgrade conditions.

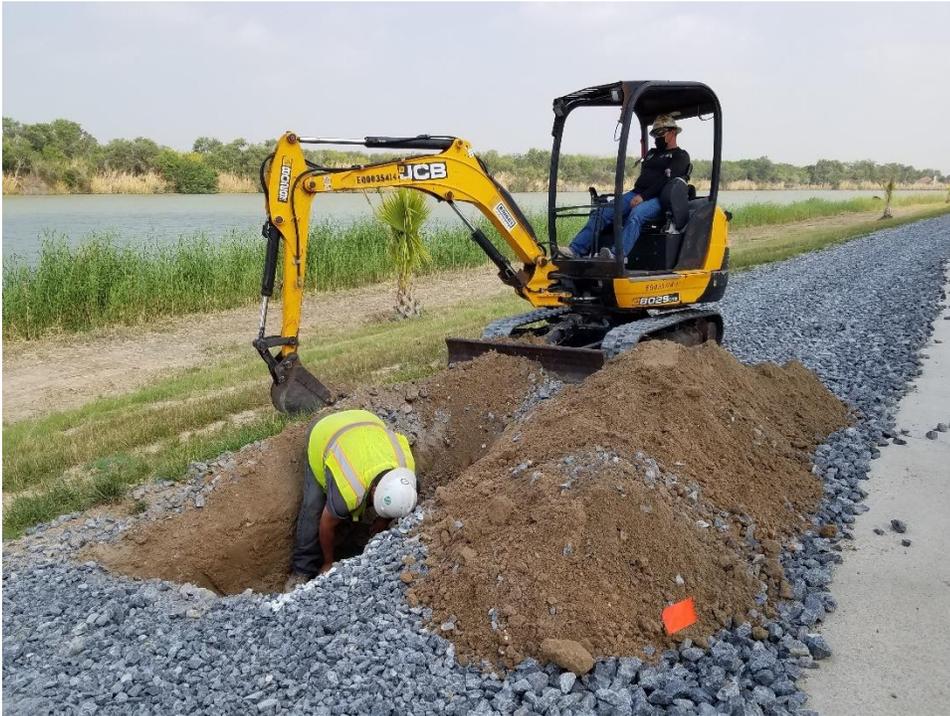
Photograph: 19

TP-4 excavation near STA 115+00 looking northwest at typical soil conditions at 3 feet bgs.

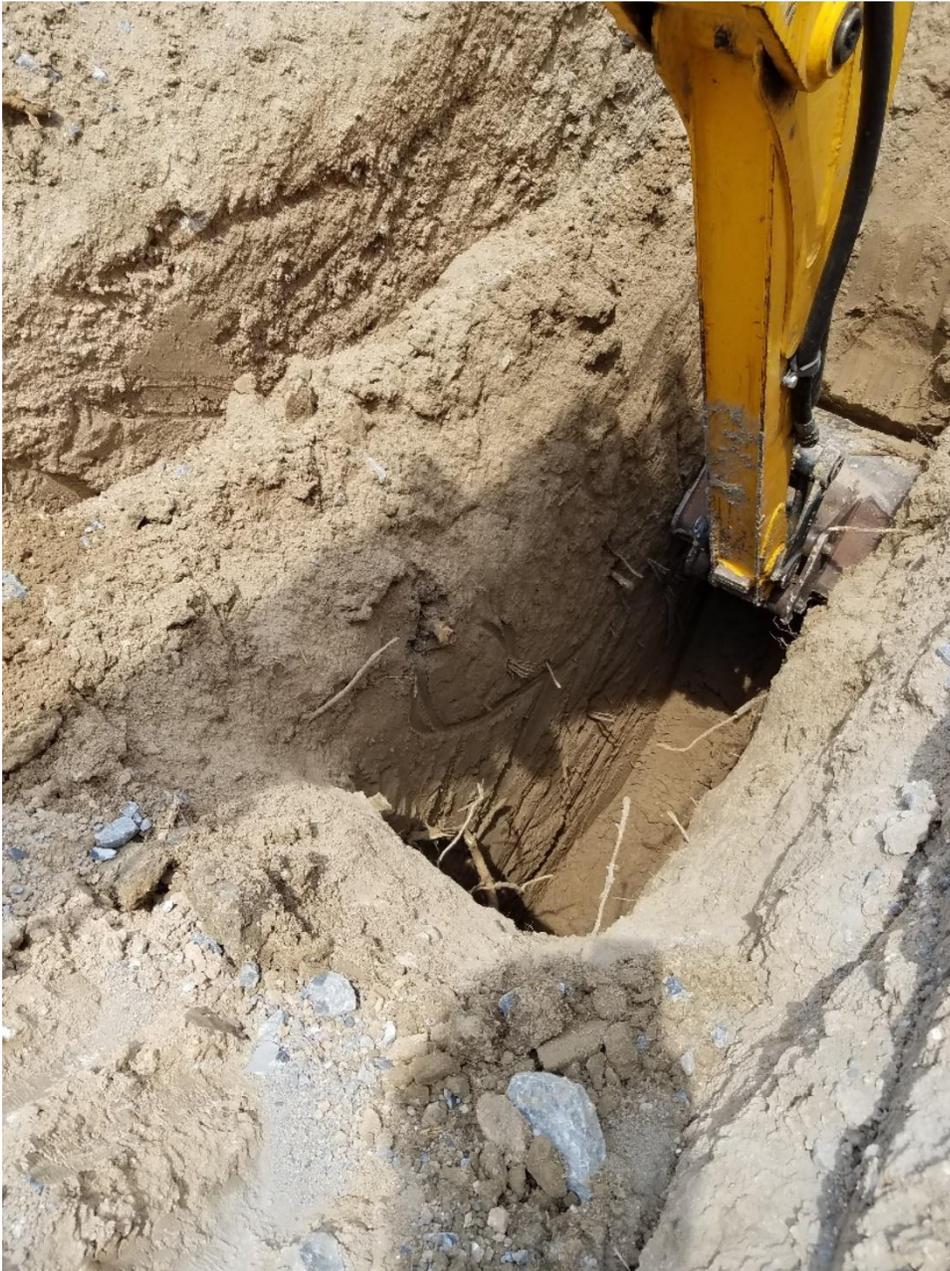
Photograph: 21

Description:
TP-4 excavation
showing roots
encountered at depths
below 3 feet bgs.

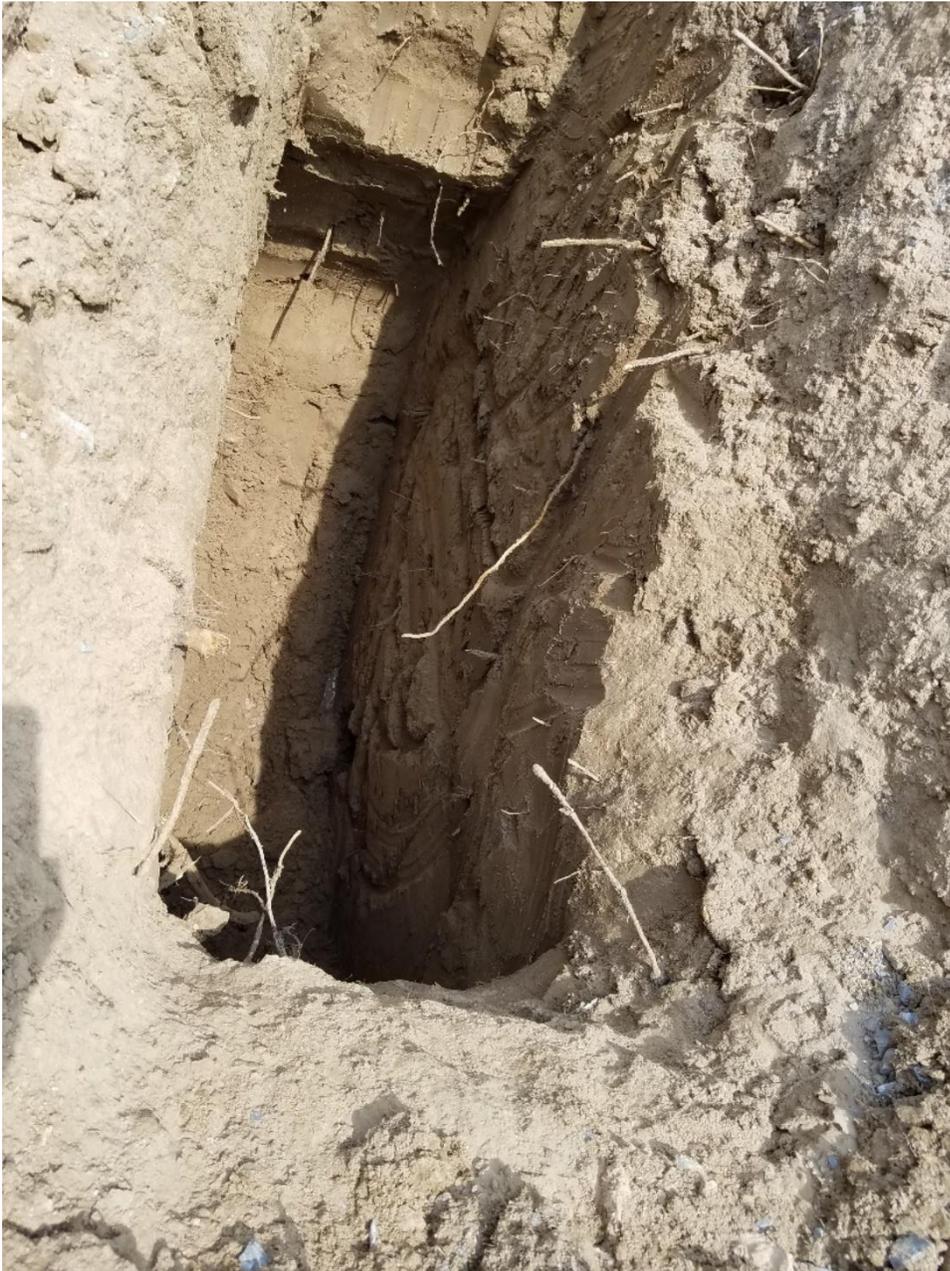
Photograph: 22

Description:
TP-4 excavation
showing soil conditions
and groundwater at
bottom of trench.

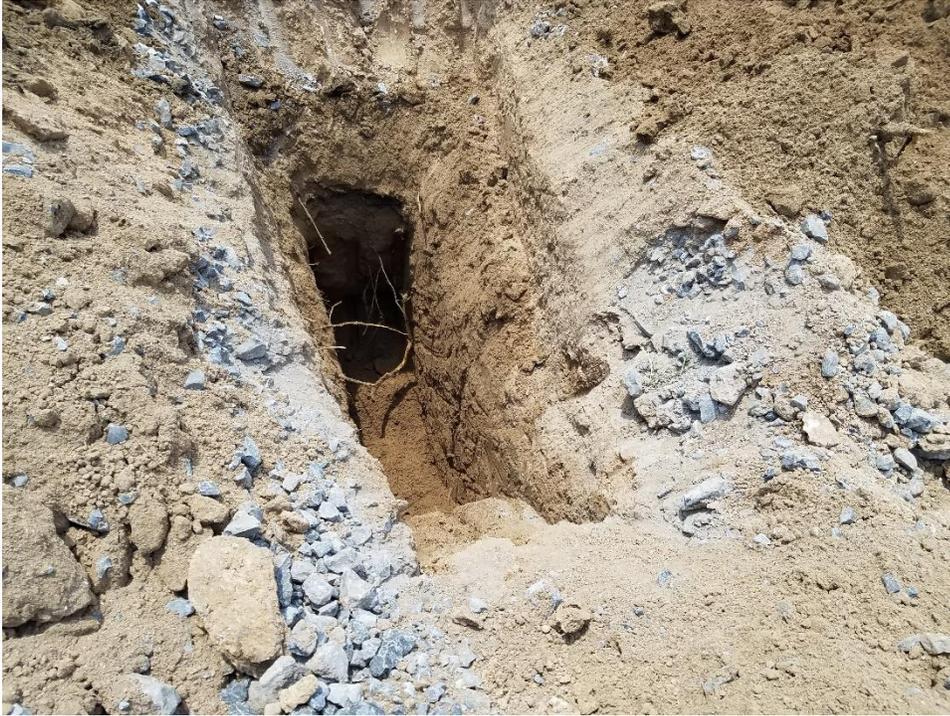
Photograph: 23

Description:
TP-4 showing typical conditions for excavated trench.

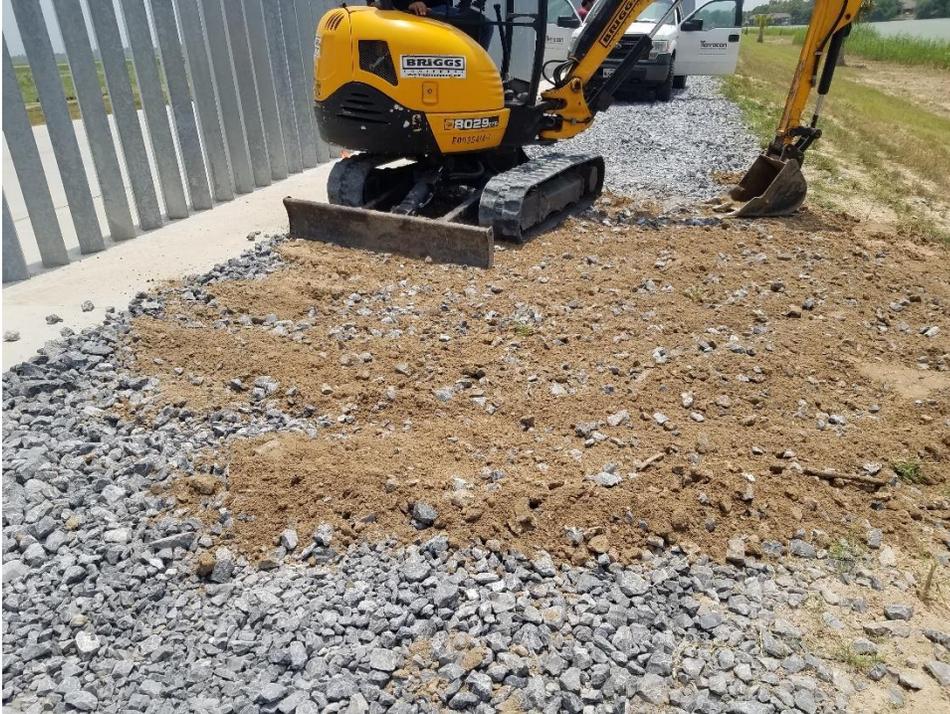
Photograph: 24

Description:
TP-4 looking southeast at backfilled trench.

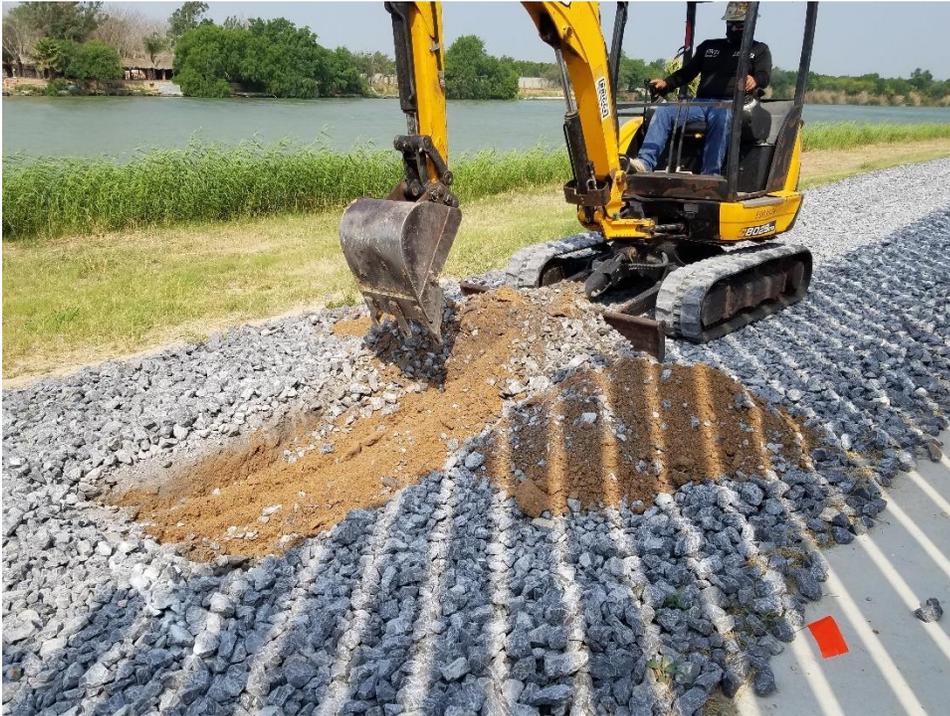
Photograph: 25

Description:
TP-5 excavation near
STA 101+00 looking
northwest at typical site
and soil conditions.

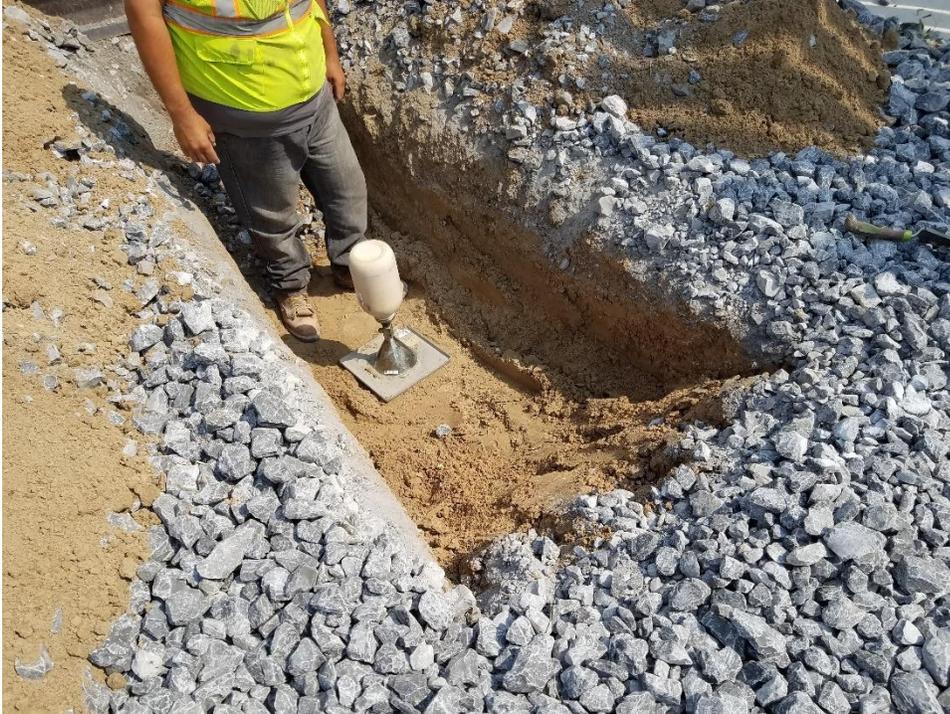
Photograph: 26

Description:
TP-5 excavation
showing sand cone test
at depth of 3' bgs.

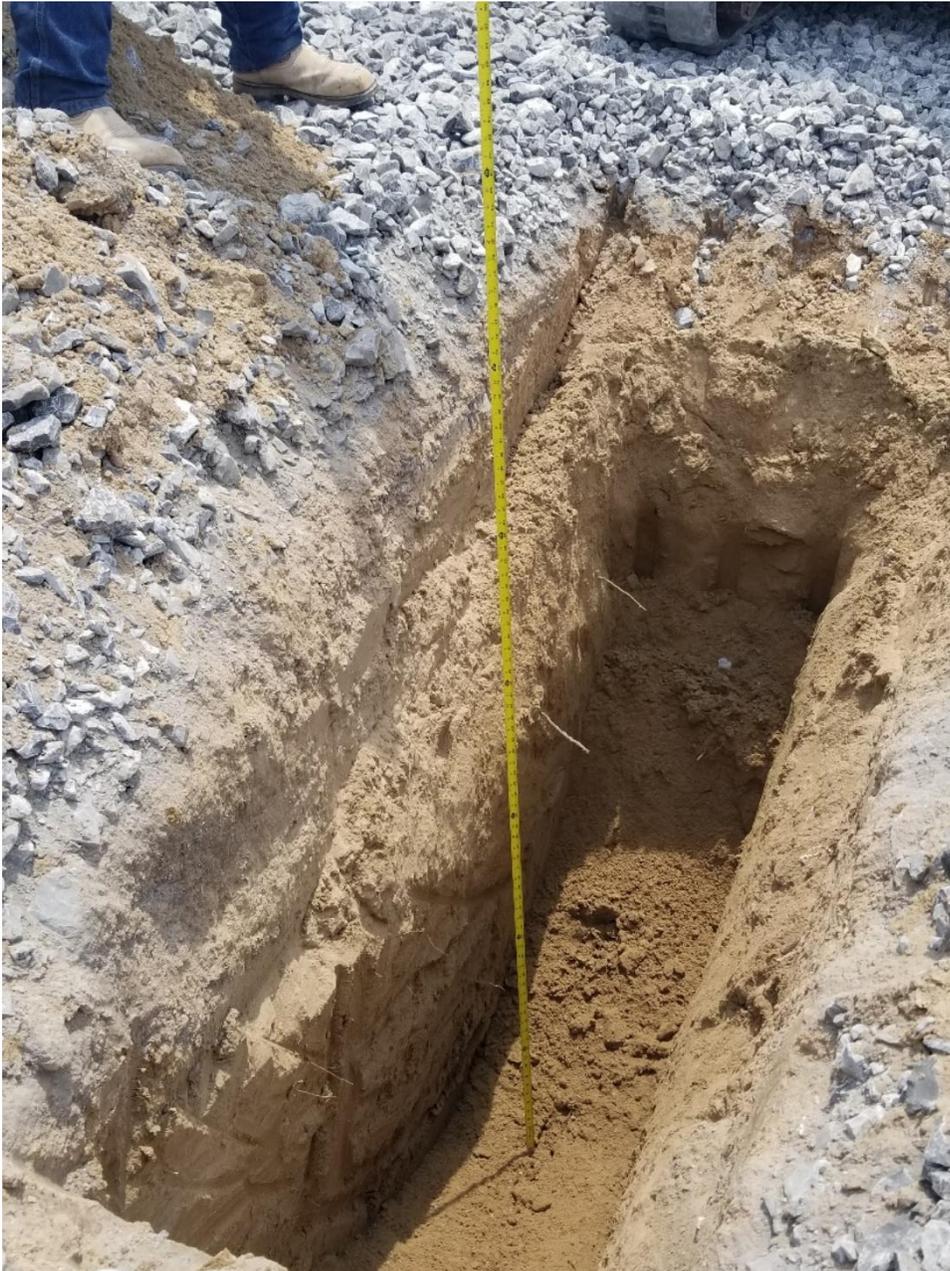
Photograph: 27

Description:
TP-5 excavation
showing depth
sounding and typical
soil conditions.

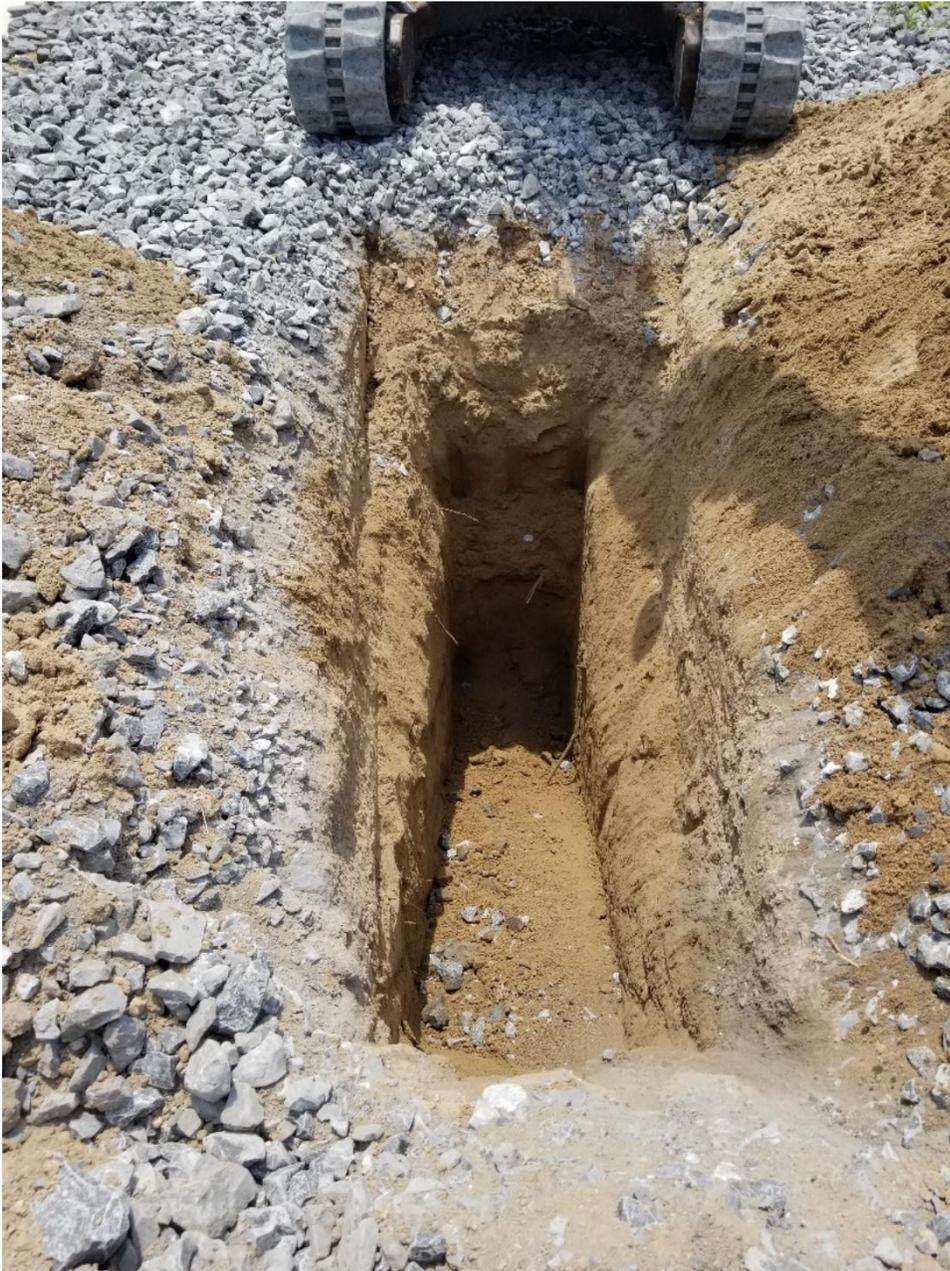
Photograph: 29

Description:
TP-5 showing typical
conditions for
excavated trench.

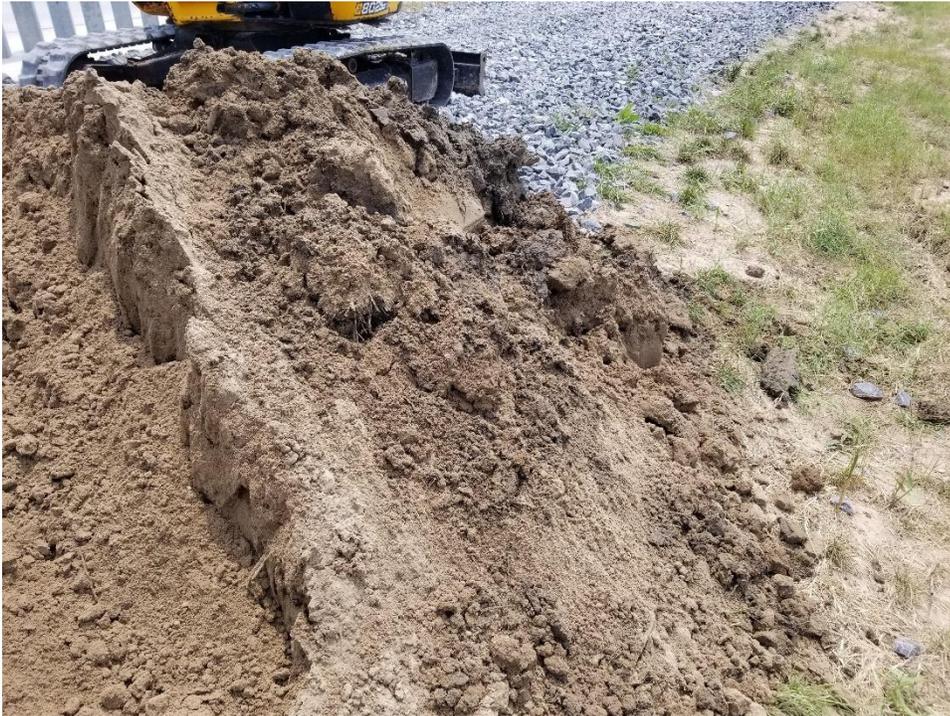
Photograph: 30

Description:
TP-5 excavated materials consisting of silty/sand clay and root matter below fill materials.

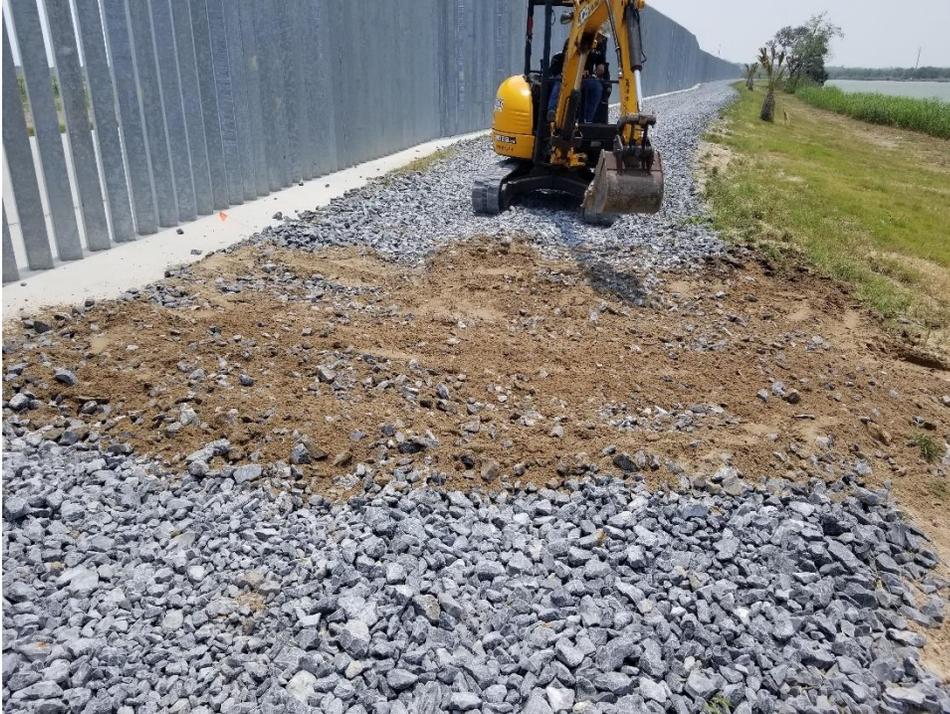
Photograph: 31

Description:
TP-5 looking southeast at backfilled trench.

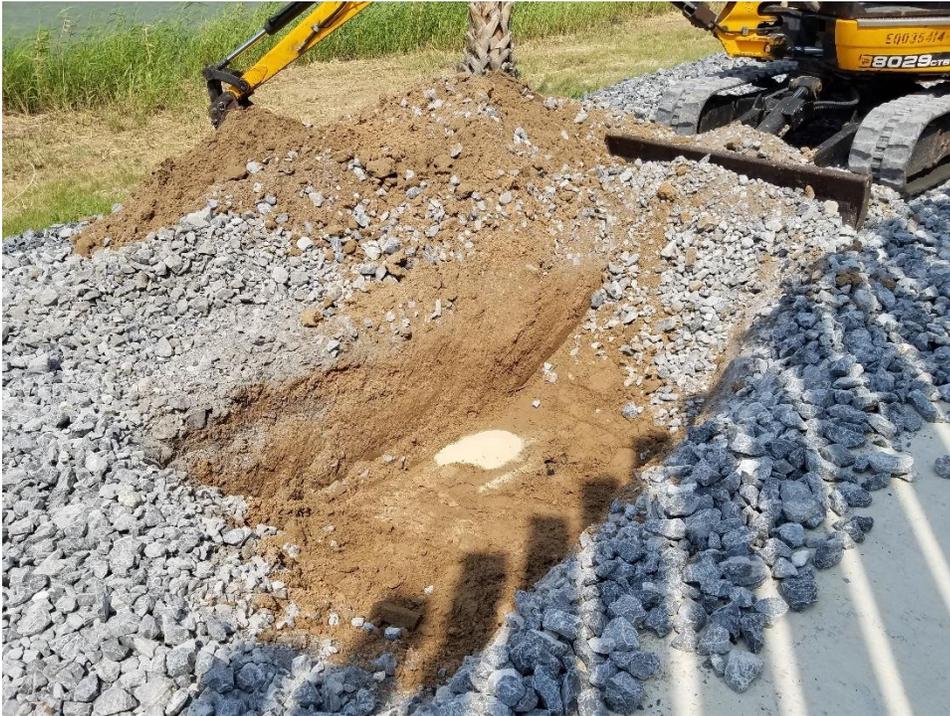
Photograph: 32

TP-6 excavation near STA 88+50 looking northwest showing typical conditions at 3 feet bgs after sand cone test.

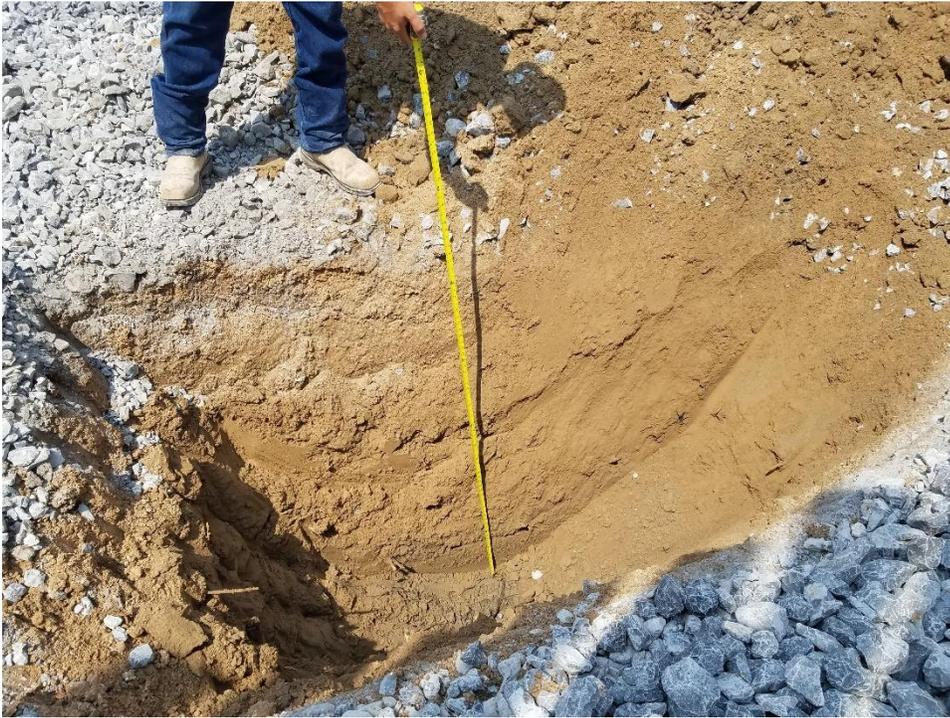
Photograph: 34

Description:
TP-6 excavation
sounding at 6 feet bgs
for Proctor sample.

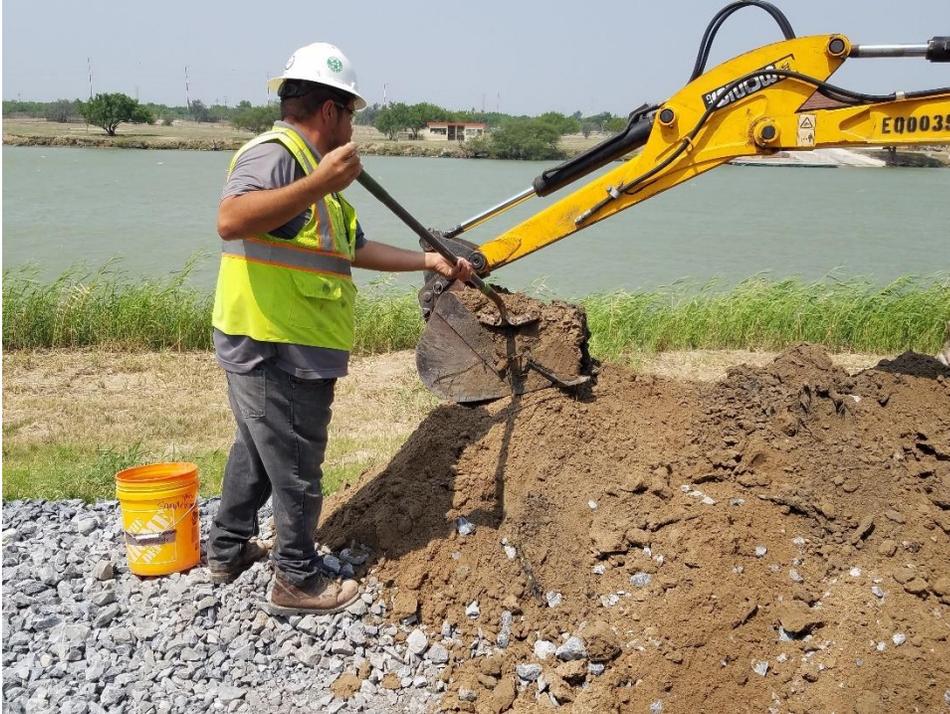
Photograph: 35

Description:
TP-6 Proctor sample
collection at 6 feet bgs.
