Engineering Evaluation of Bollard Fence

Rio Grande, Hidalgo County, Texas

United States of America v. Fisher Sand and Gravel Company, Civil Action No. 7:19-CV-403

August 2021

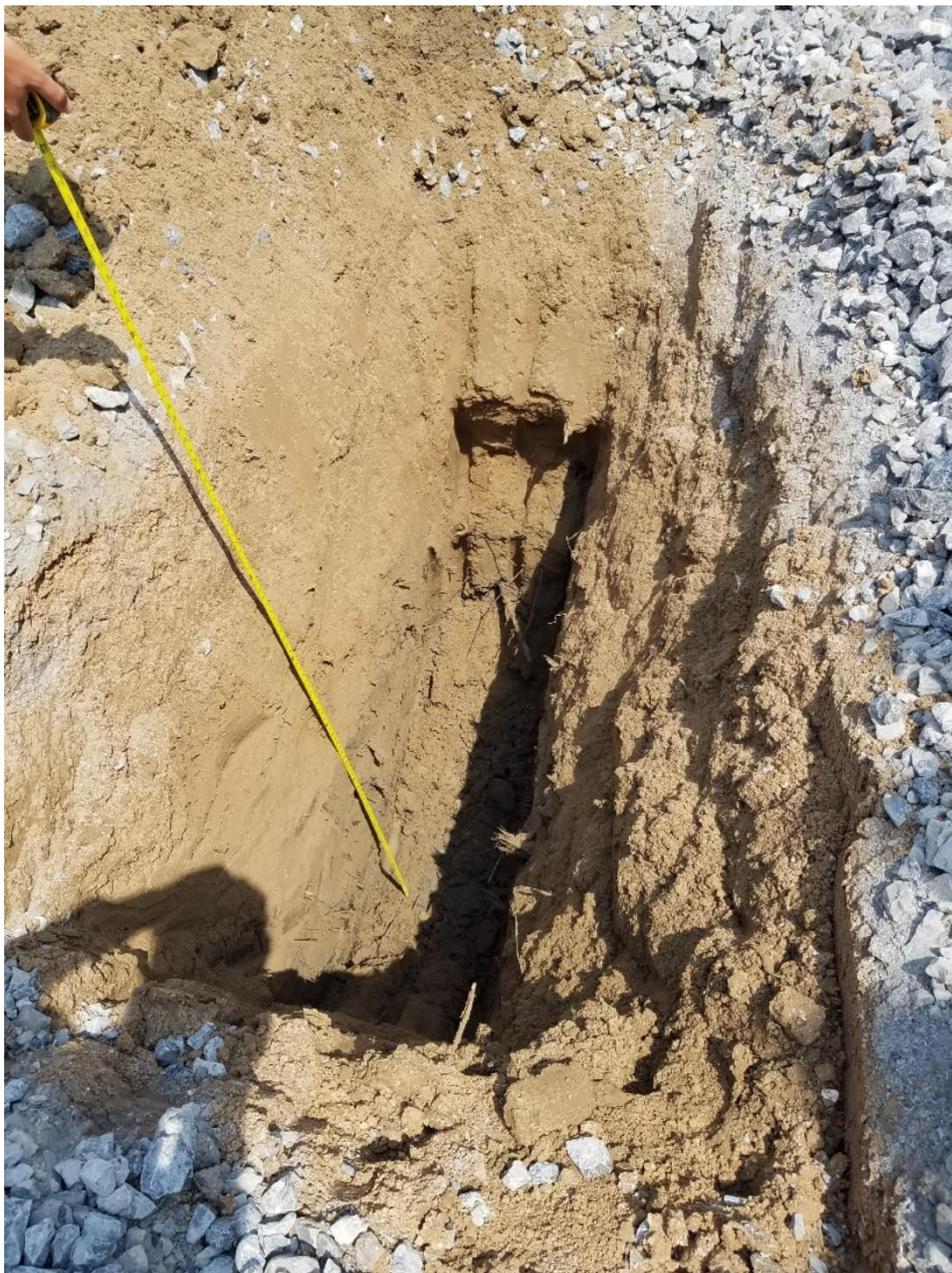
Photograph: 36

Description:
TP-6 excavation
sounding showing
typical soil conditions.

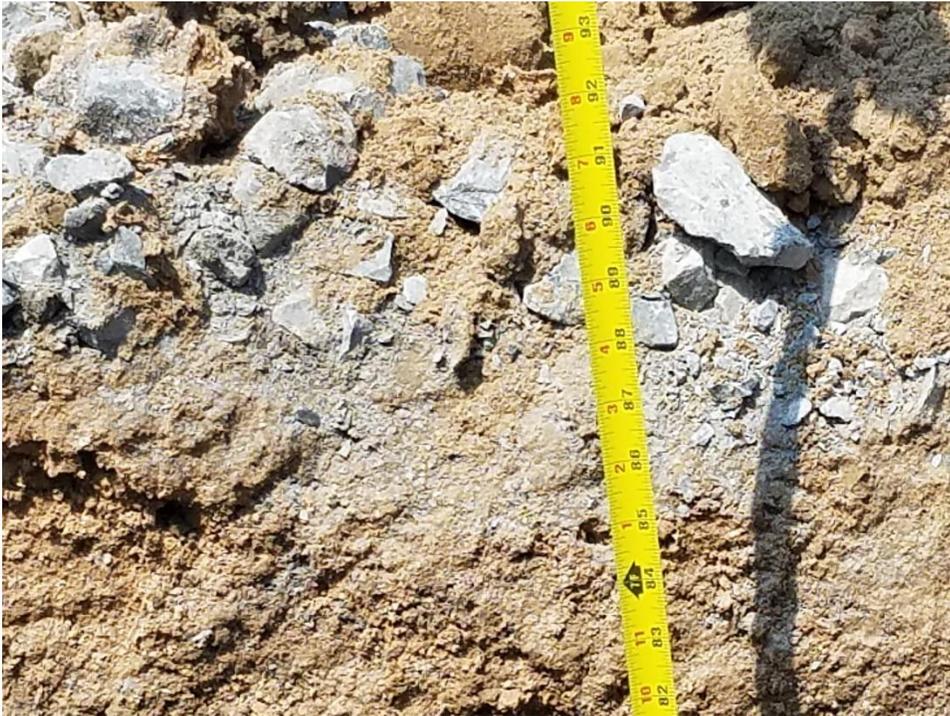
Photograph: 37

Description:
TP-6 excavation
sounding at 7 feet bgs.

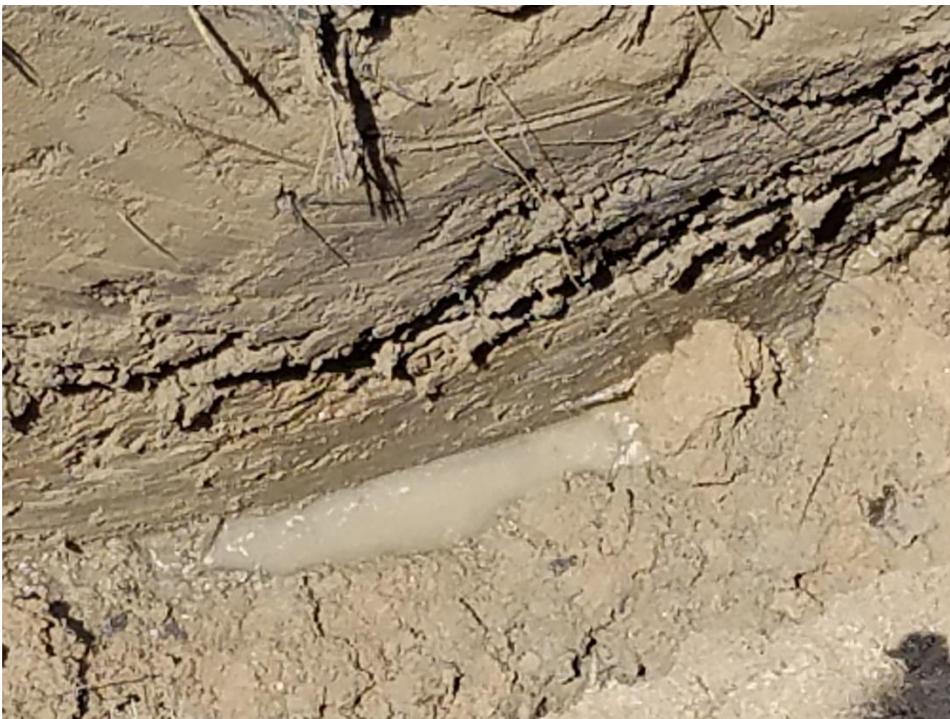
Photograph: 38

Description:
TP-6 groundwater entry
at bottom of trench,
around 7 feet bgs.

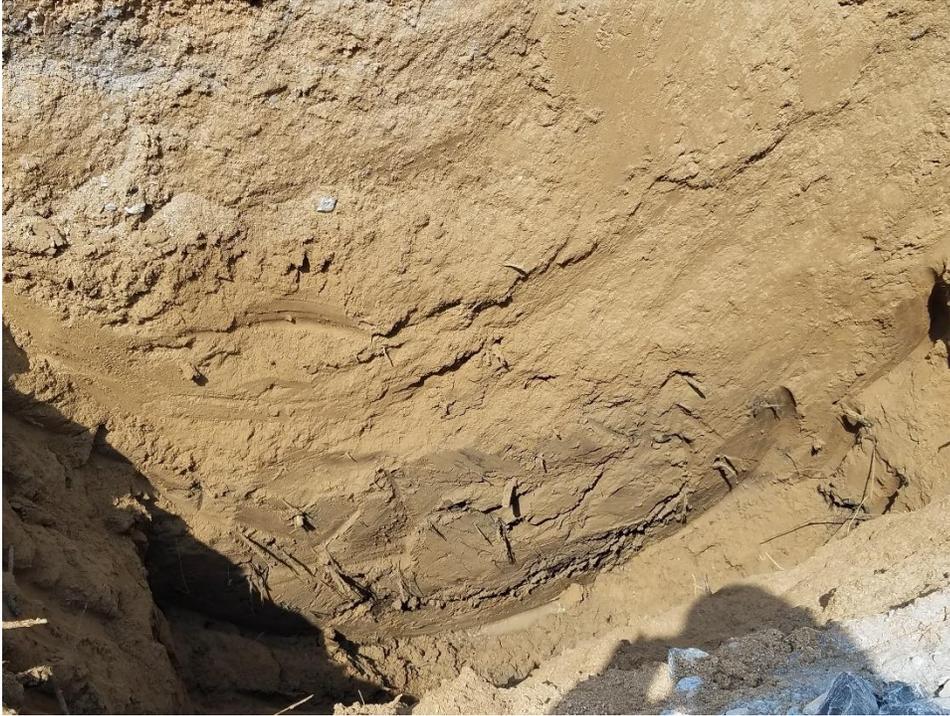
Photograph: 39

Description:
TP-6 excavation showing typical soil conditions with roots and groundwater intrusion to the trench.

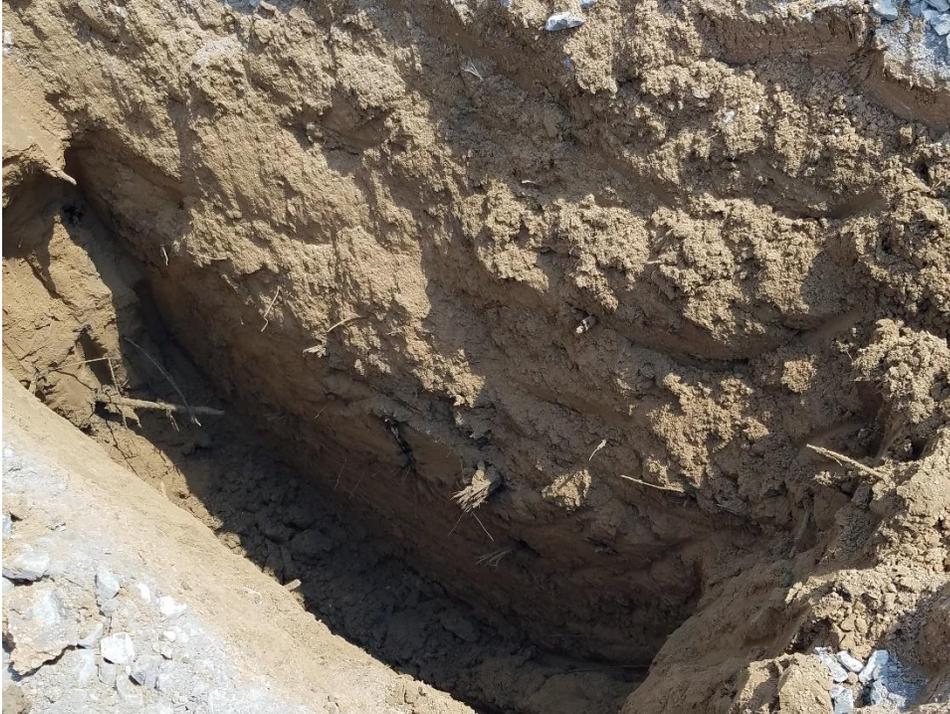
Photograph: 40

Description:
TP-6 excavation showing typical conditions for subgrade soil with roots below fill.

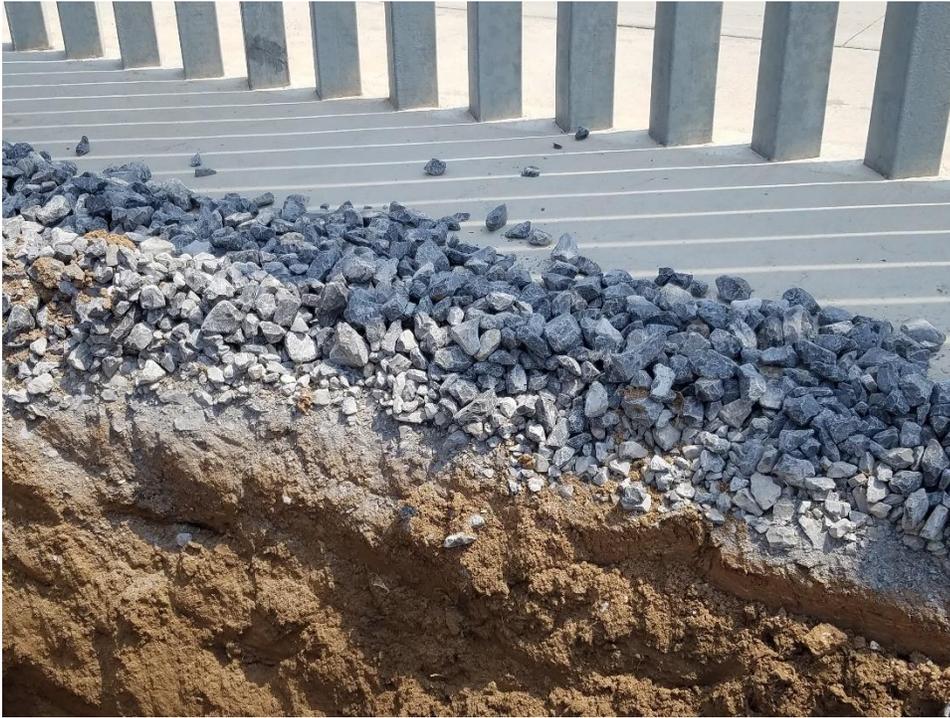
Photograph: 41

Description:
TP-6 excavation showing typical conditions for fill and subgrade soils.

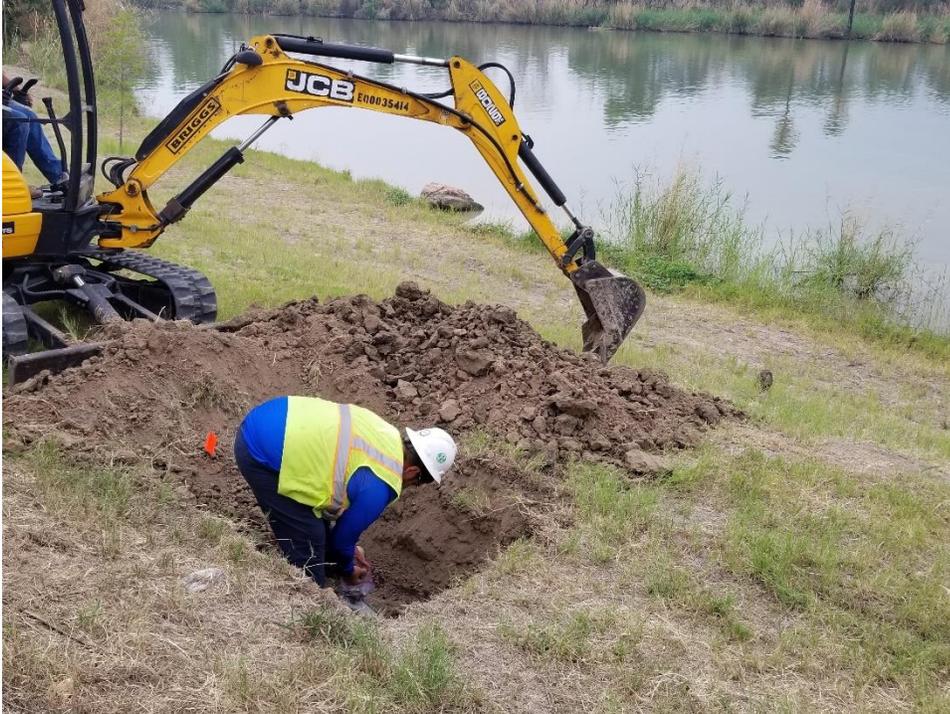
Photograph: 42

Description:
TP-7 excavation near STA 0+00 looking southeast at sand cone test depth of 3 feet bgs.

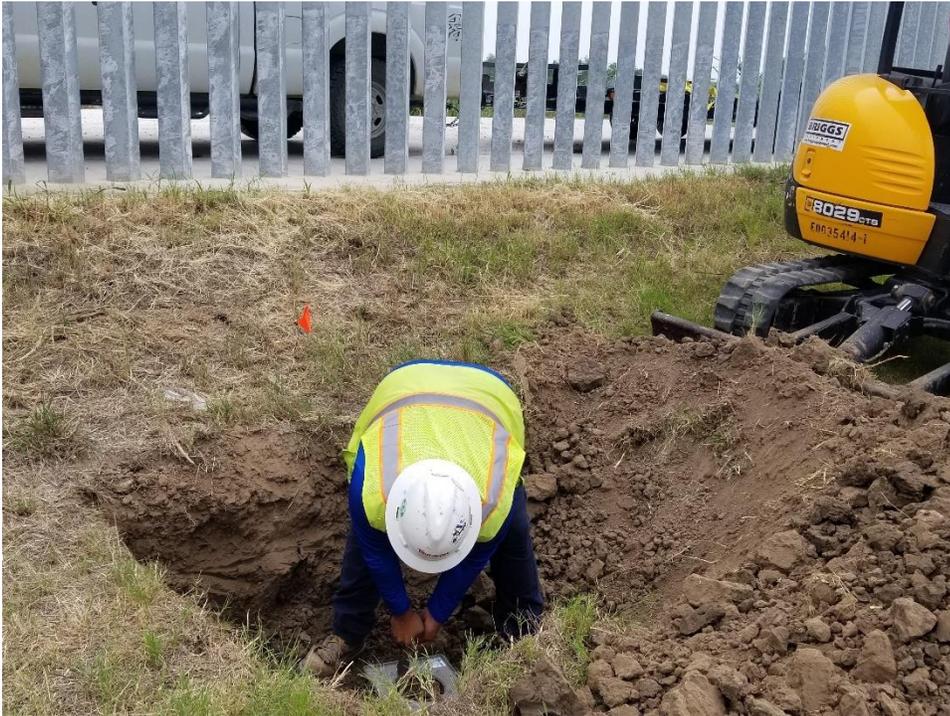
Photograph: 43

Description:
TP-7 excavation
showing sand cone test
at 3 feet bgs.

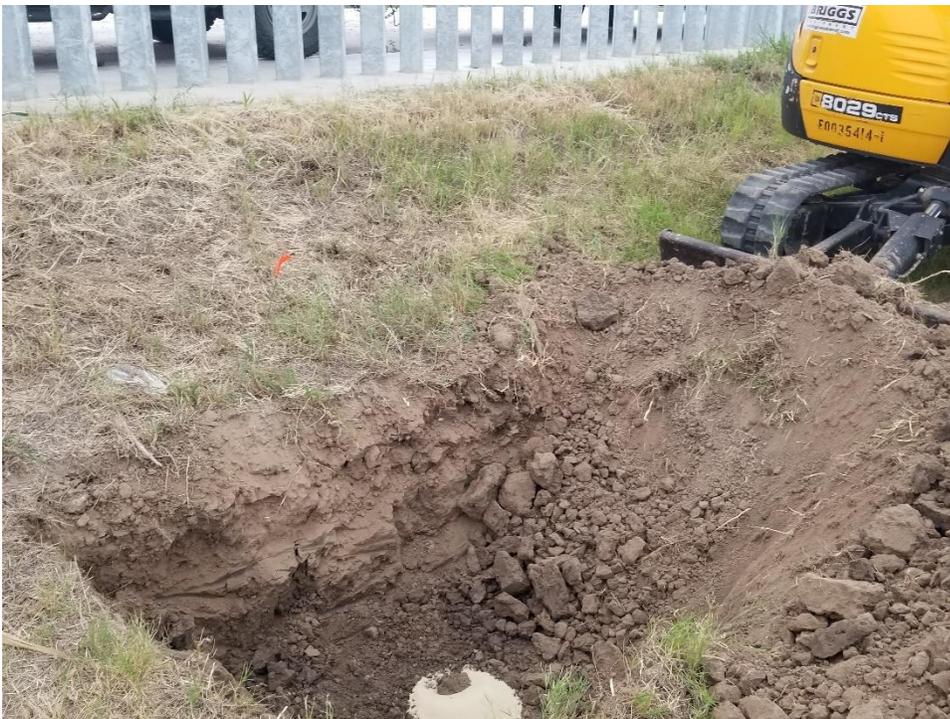
Photograph: 44

Description:
TP-7 showing soil
conditions after sand
cone test at depth of
Proctor sample
collection

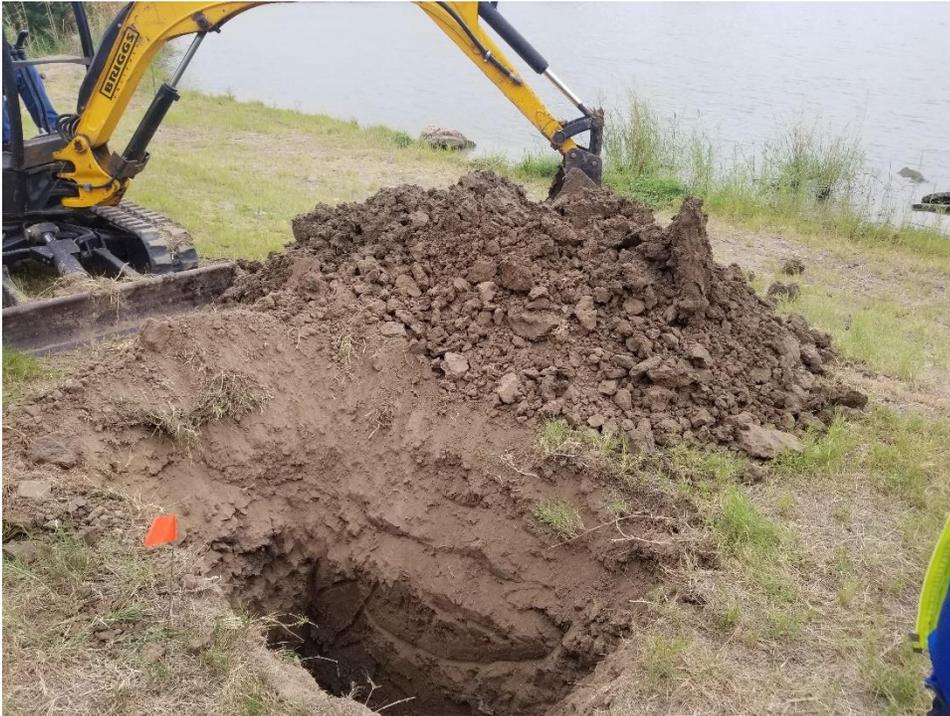
Photograph: 45

Description:
TP-7 excavation
looking southeast at
clayey soils from trench

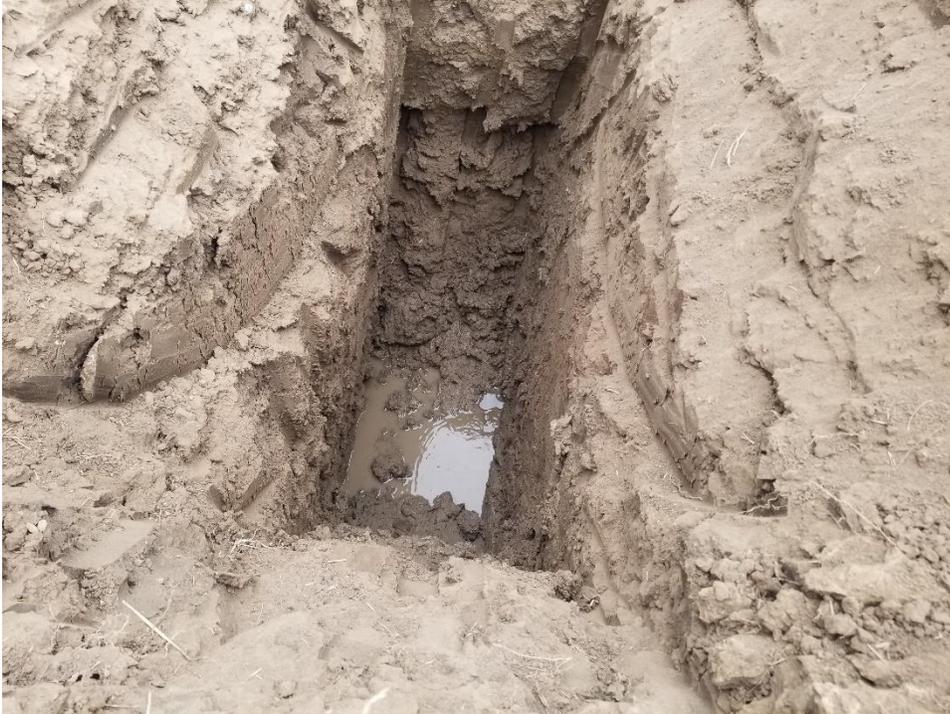
Photograph: 46

Description:
TP-7 excavation at
groundwater intrusion
at bottom of trench

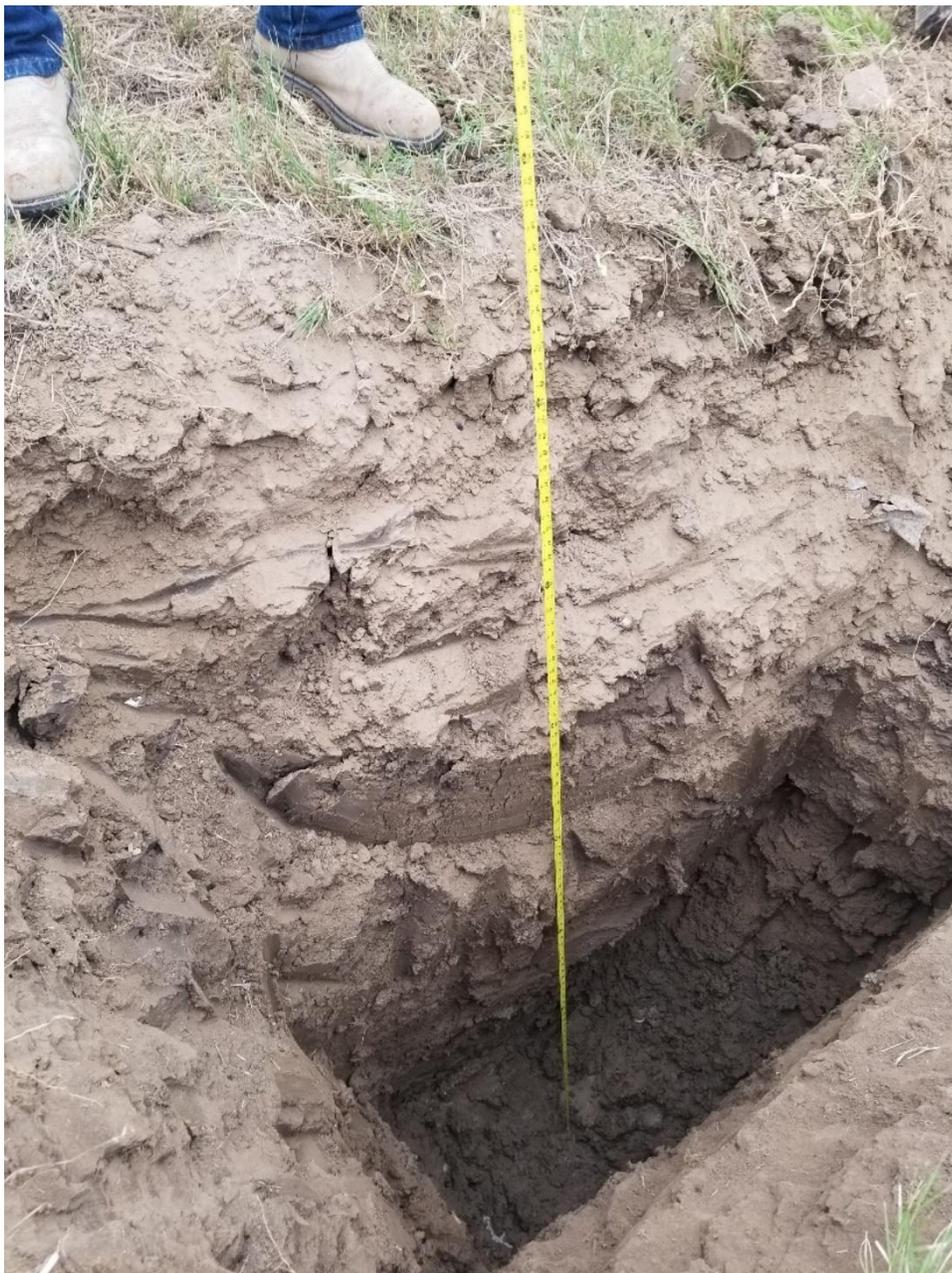
Photograph: 47

Description:
TP-7 excavation
sounding at bottom of
trench at 8 feet bgs

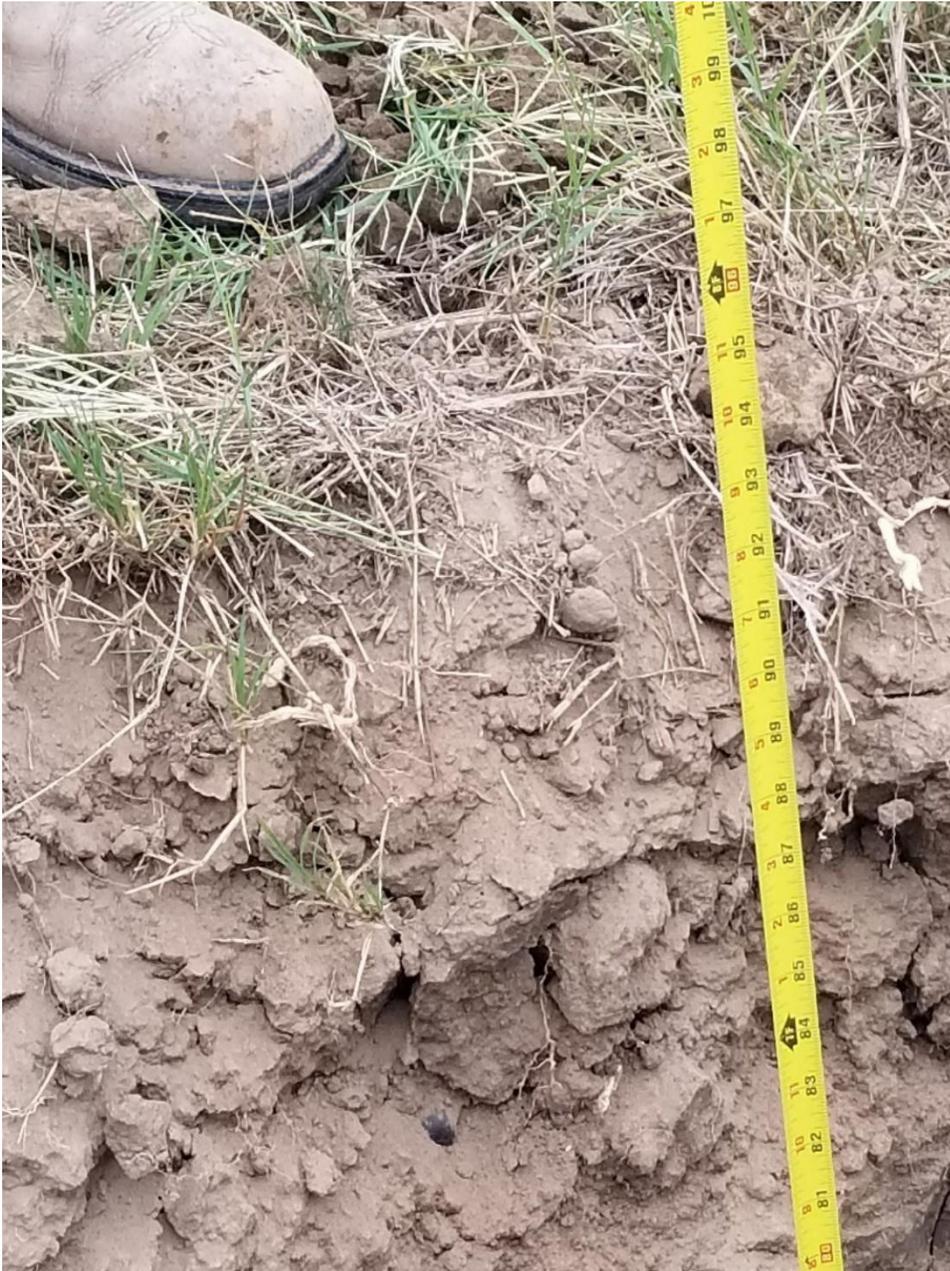
Photograph: 48

Description:
TP-7 excavation
sounding at bottom of
trench at 8 feet bgs

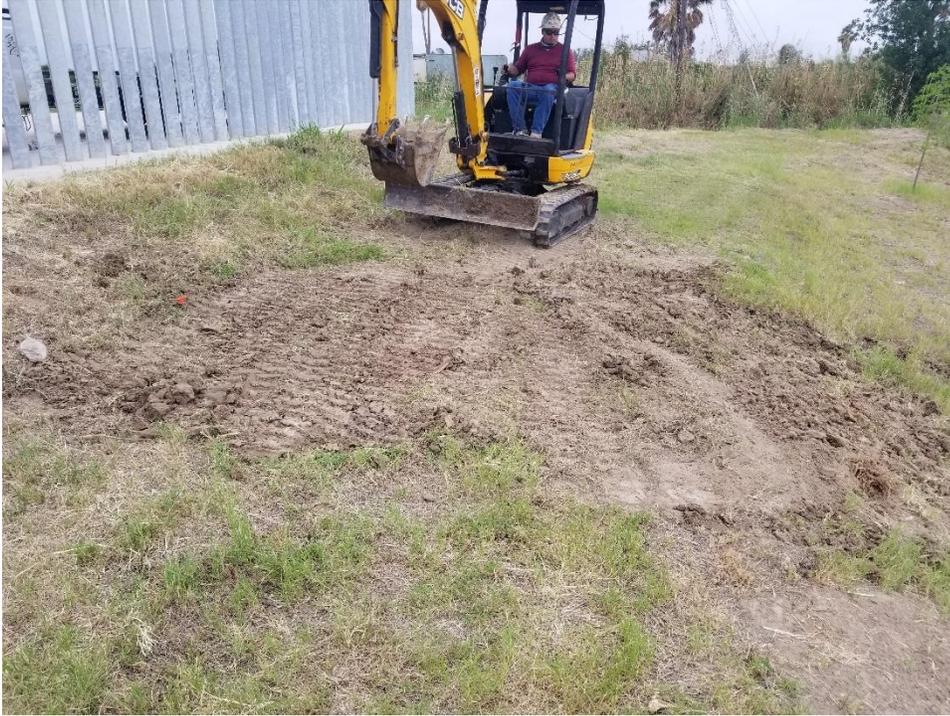
Photograph: 49

Description:
TP-7 looking southeast
at backfilled trench

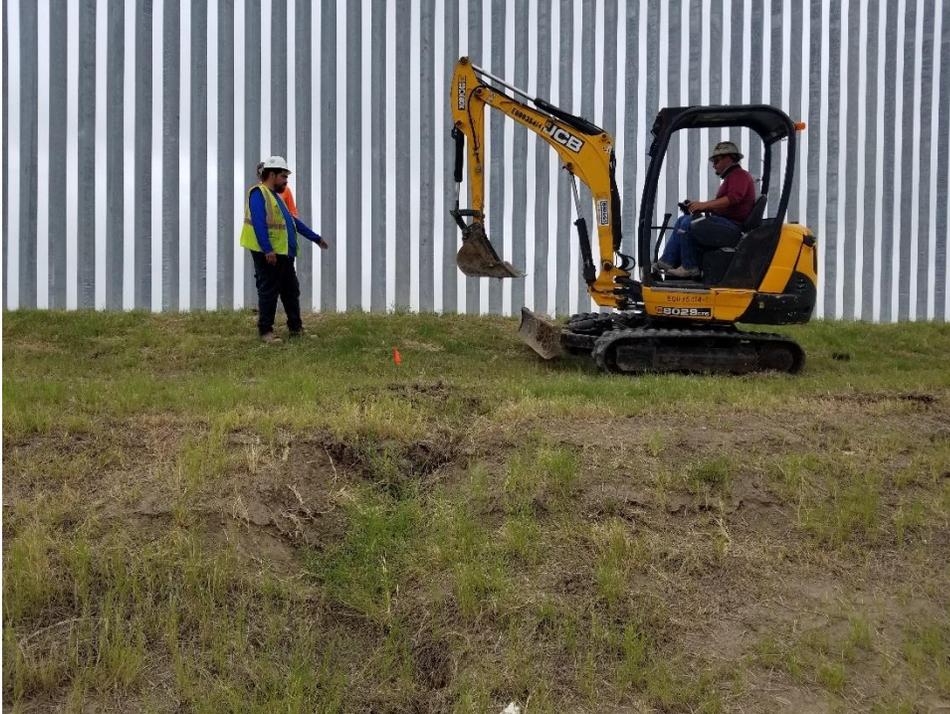
Photograph: 50

Description:
TP-8 location looking
northwest at erosion
gully that occurs due
to surface drainage

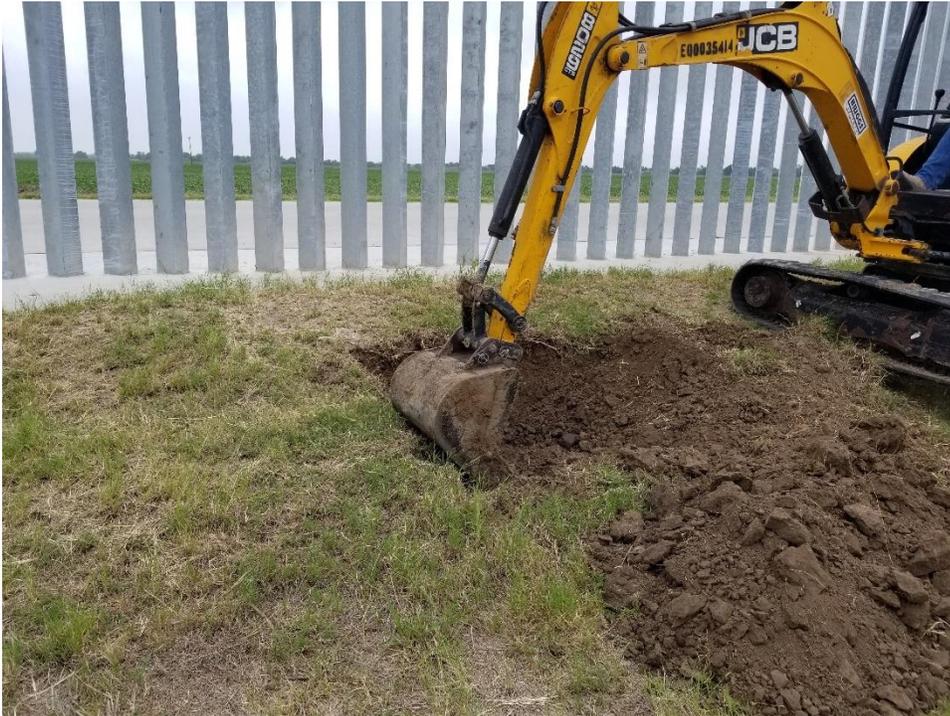
Photograph: 51

Description:
TP-8 excavation
looking northeast
showing approximate
depth of fill materials.

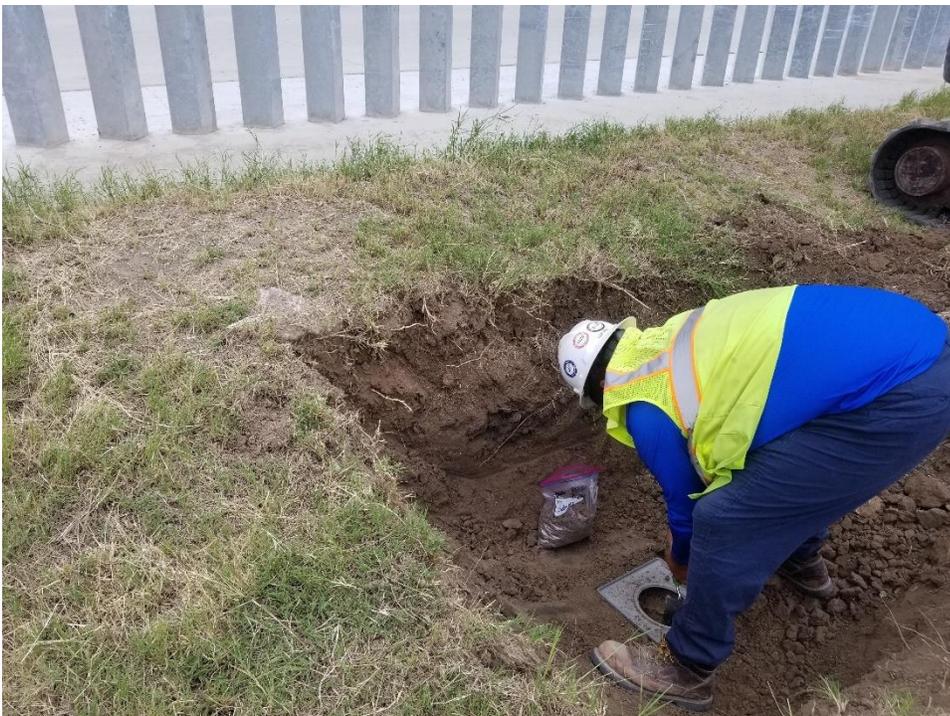
Photograph: 52

Description:
TP-8 excavation
looking at sand cone
test at 3 feet bgs.

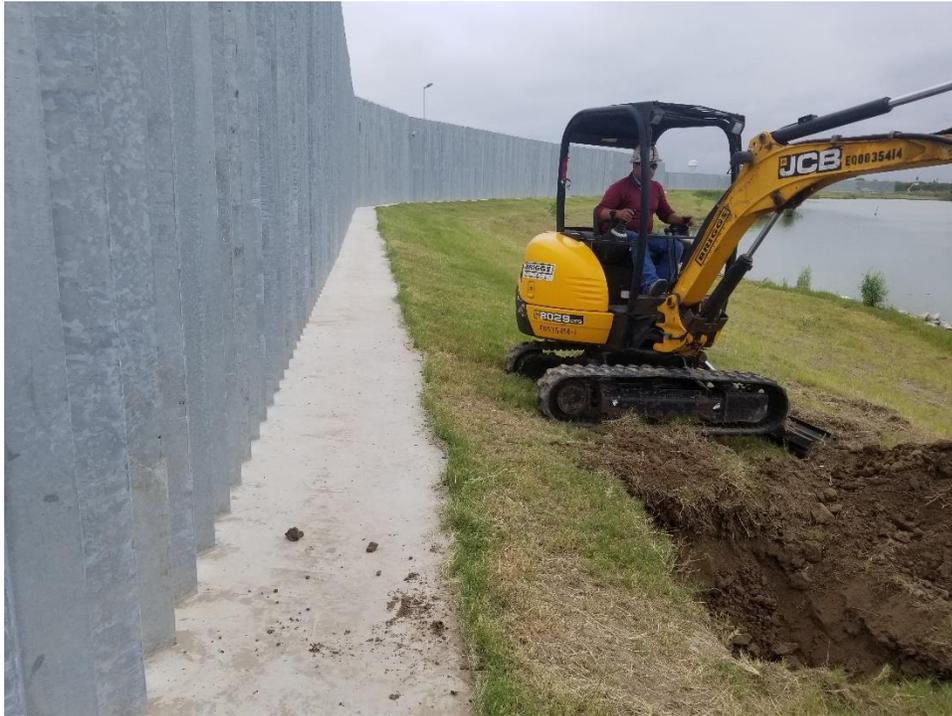
Photograph: 53

Description:
TP-8 excavation
looking northeast
showing soil conditions

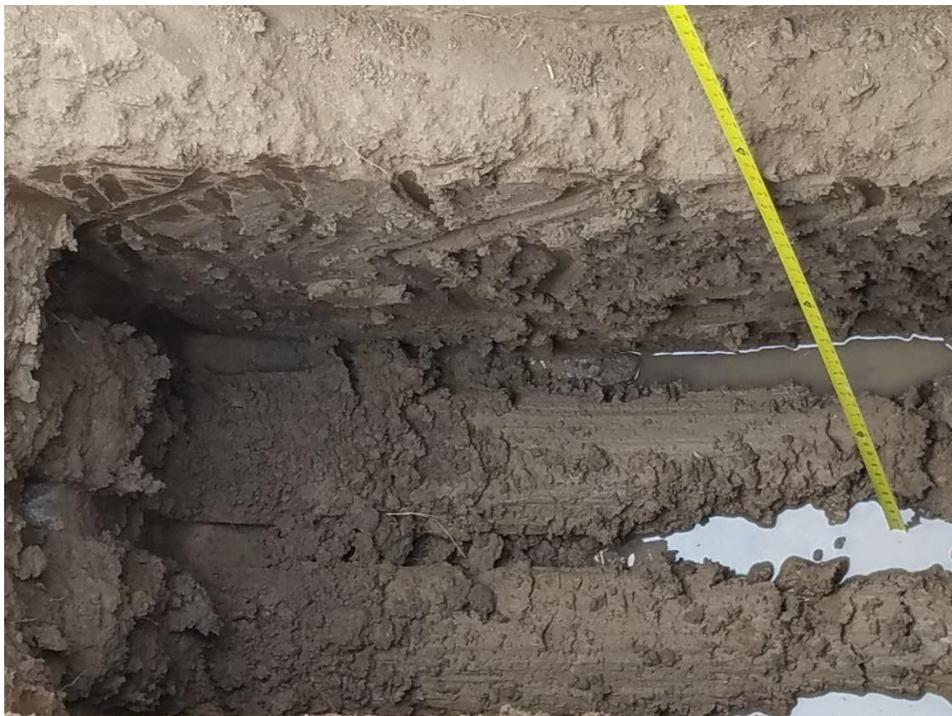
Photograph: 54

Description:
TP-8 excavation
sounding showing
groundwater at bottom
of trench at 9 feet bgs.

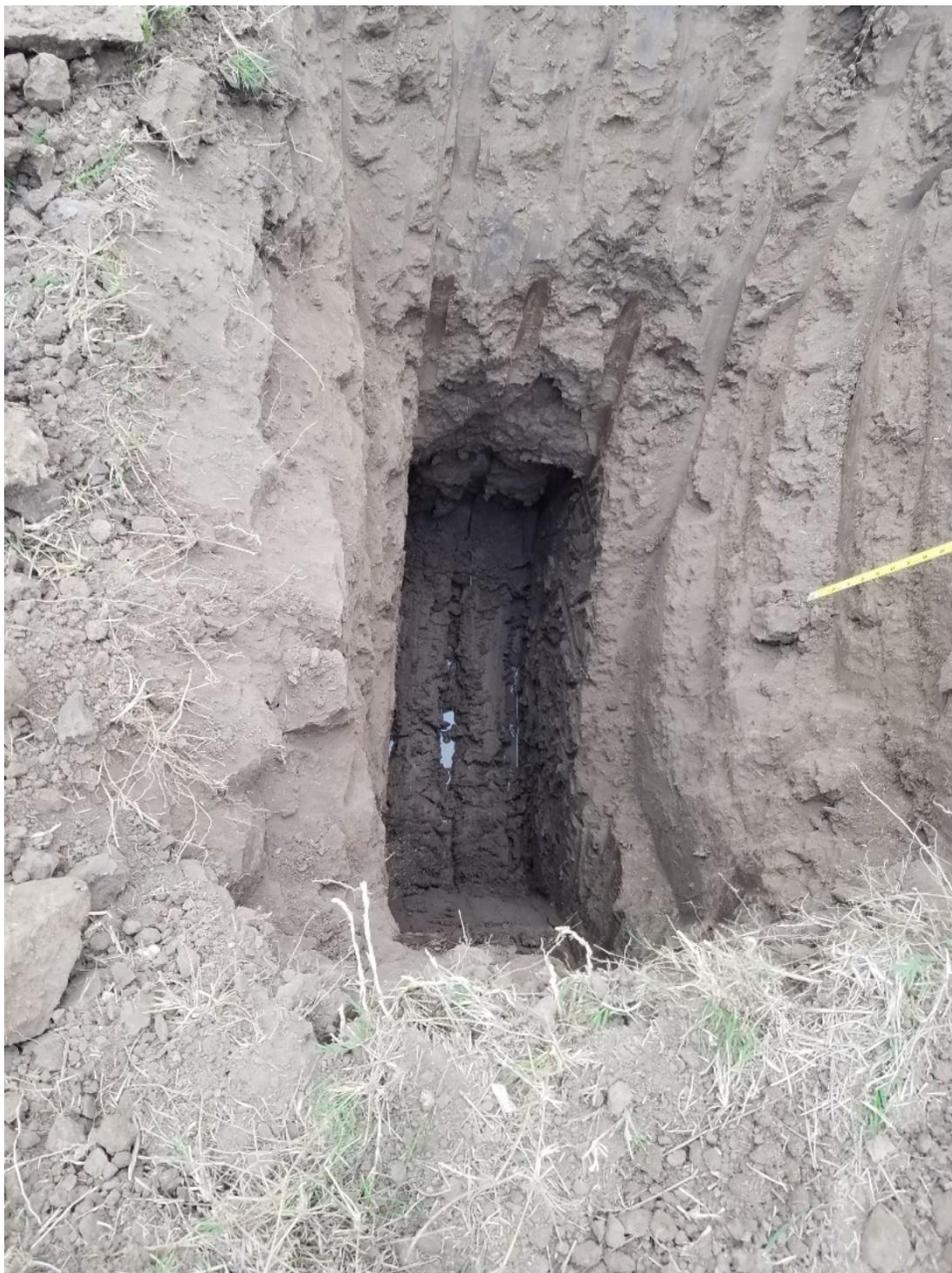
Photograph: 55

Description:
TP-8 excavation
showing soil and
groundwater conditions
at 9 feet bgs.

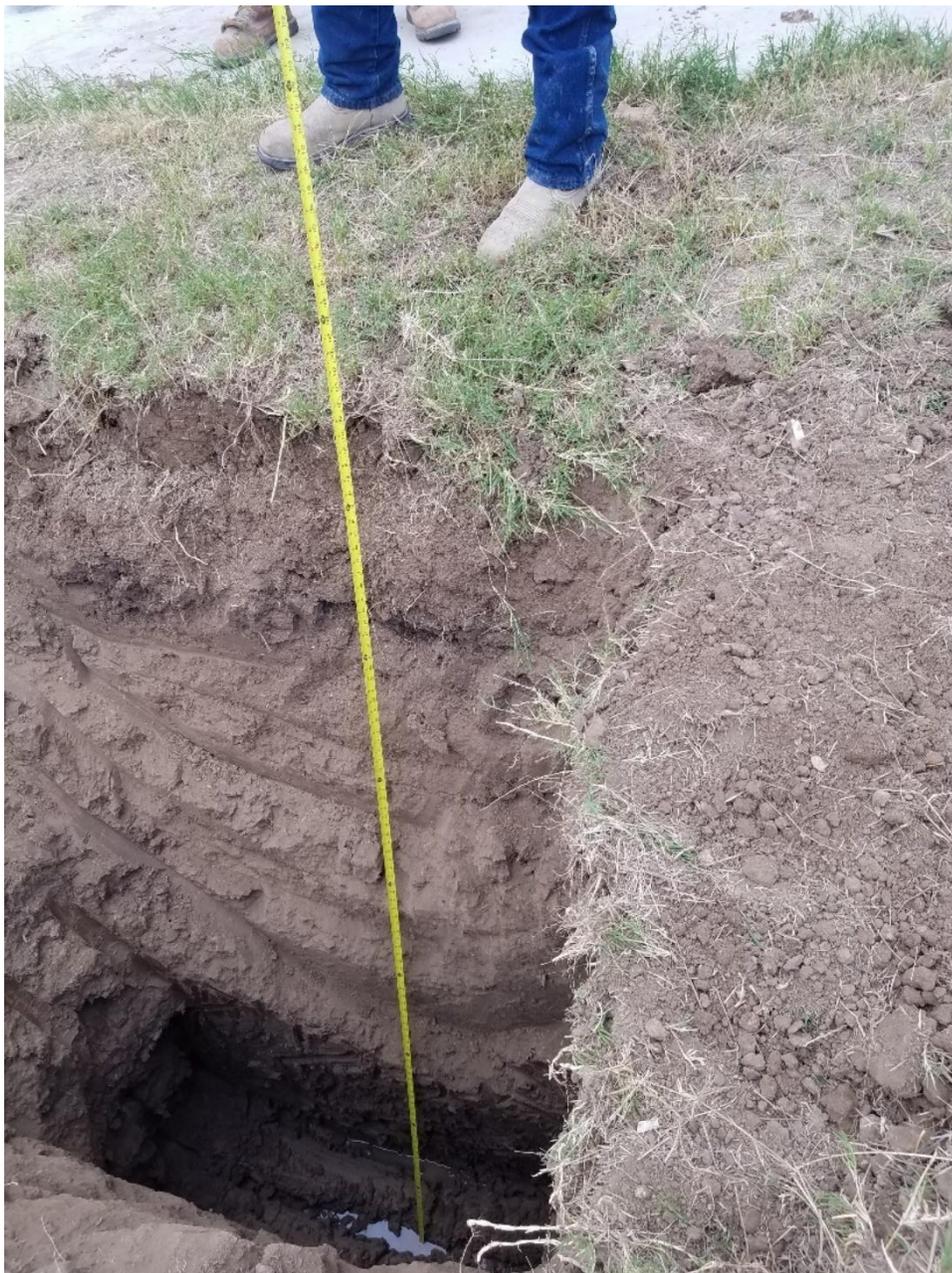
Photograph: 56

Description:
TP-8 excavation
showing soil conditions
at 9 feet bgs.

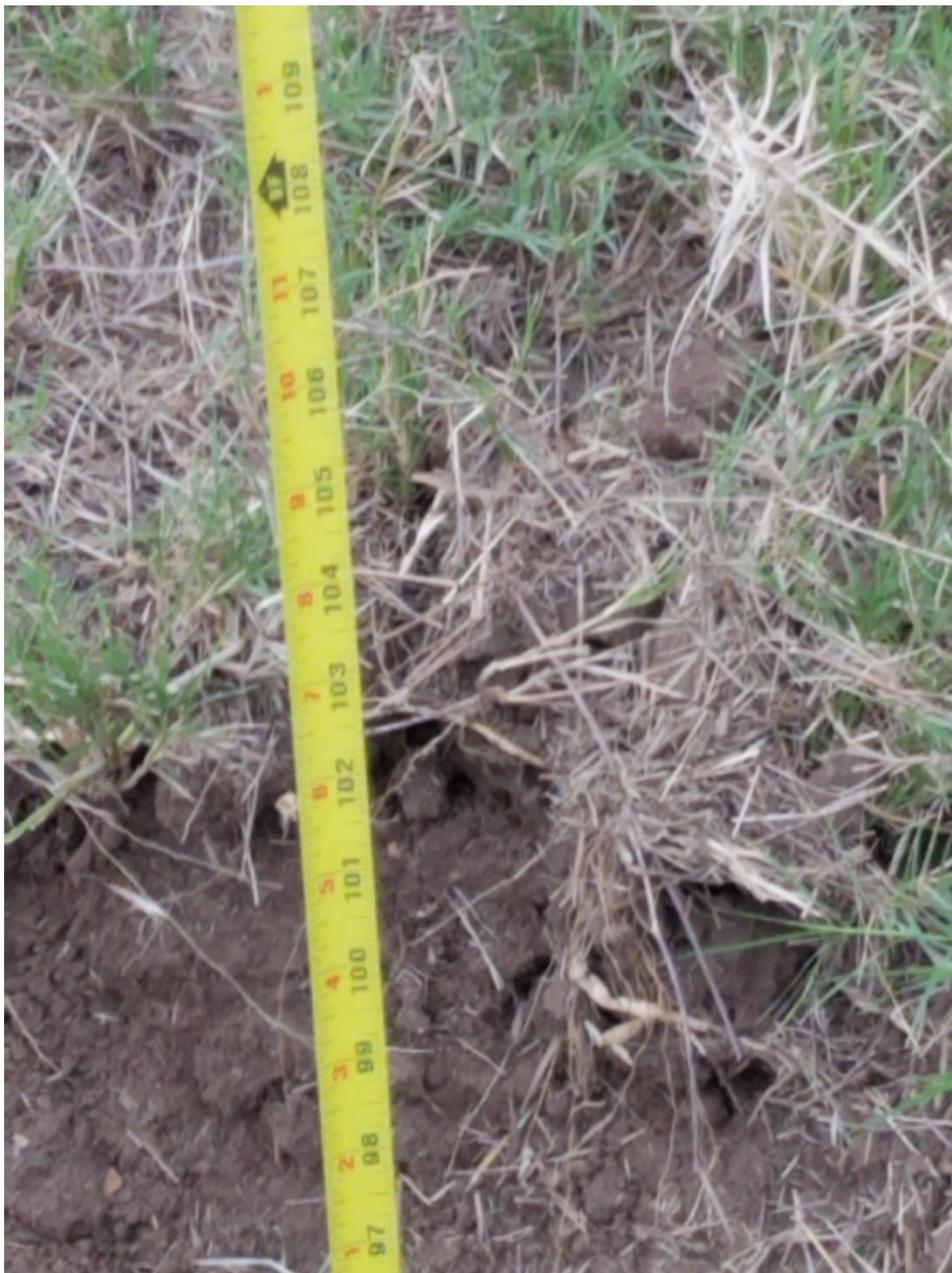
Photograph: 57

Description:
TP-8 excavation
sounding at 9 feet bgs.

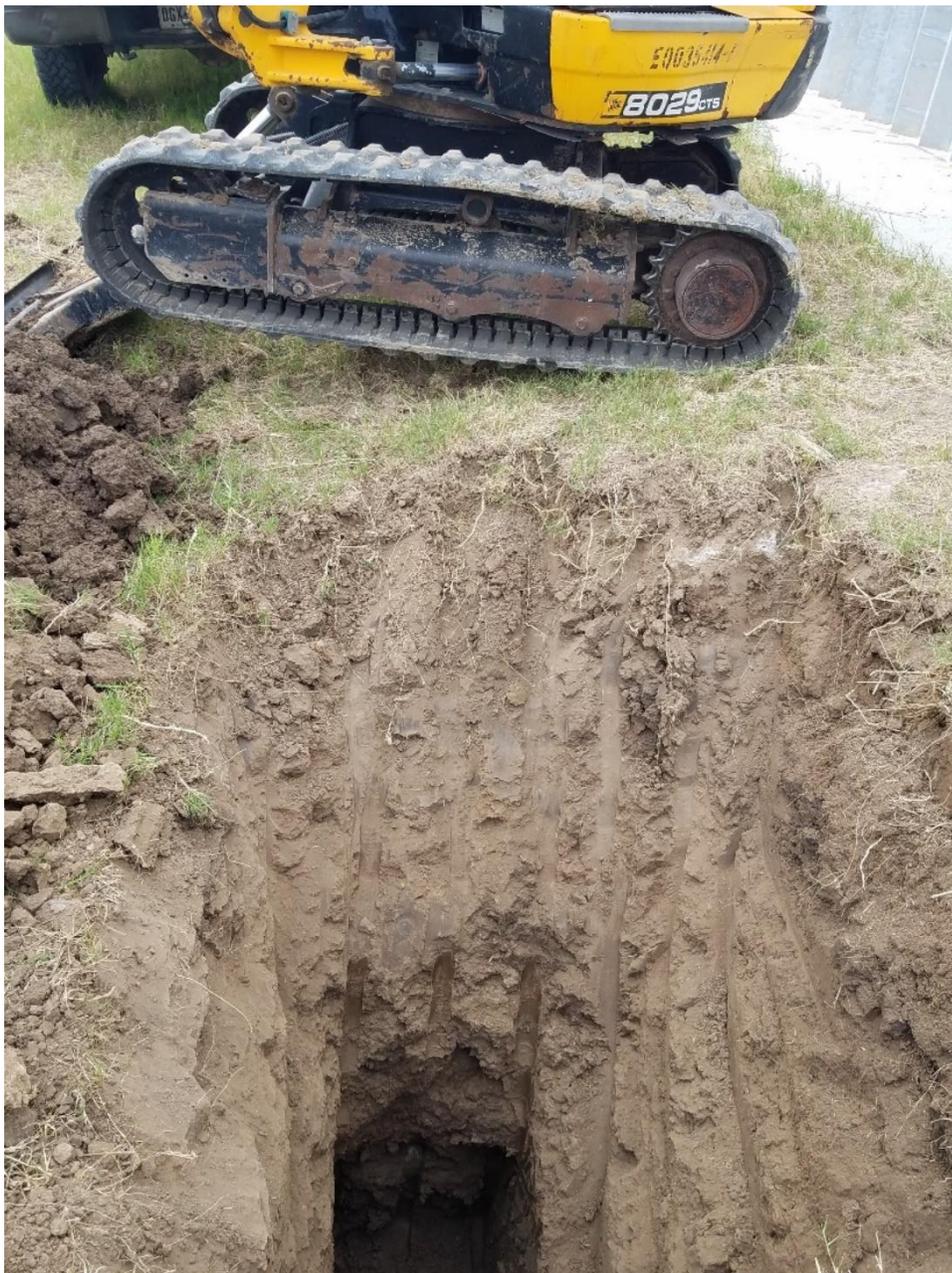
Photograph: 58

Description:
TP-8 excavation
showing soil conditions
at 9 feet bgs.

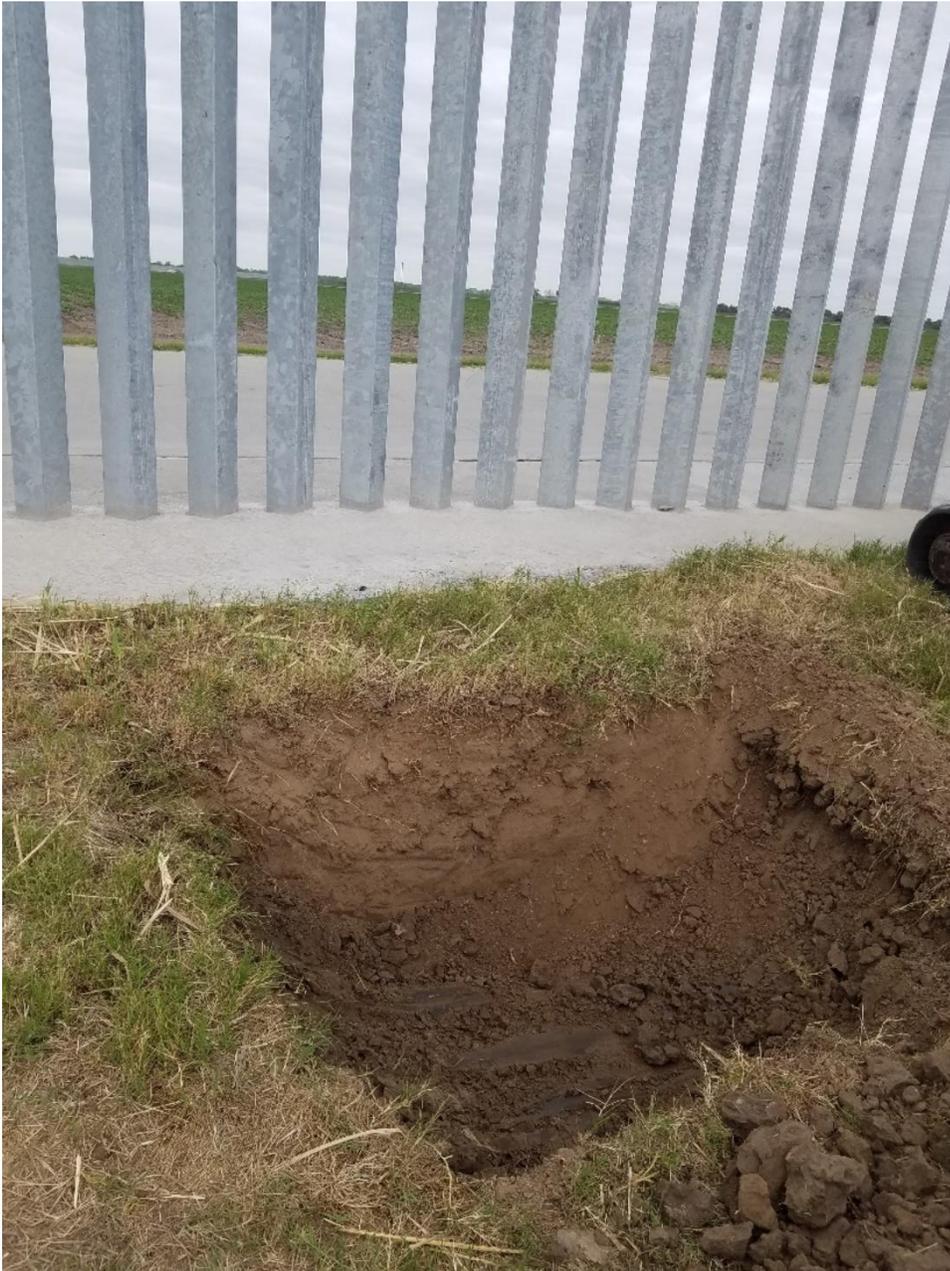
Photograph: 59

Description:
TP-9 excavation
looking northwest
showing soil conditions
at 3 feet bgs

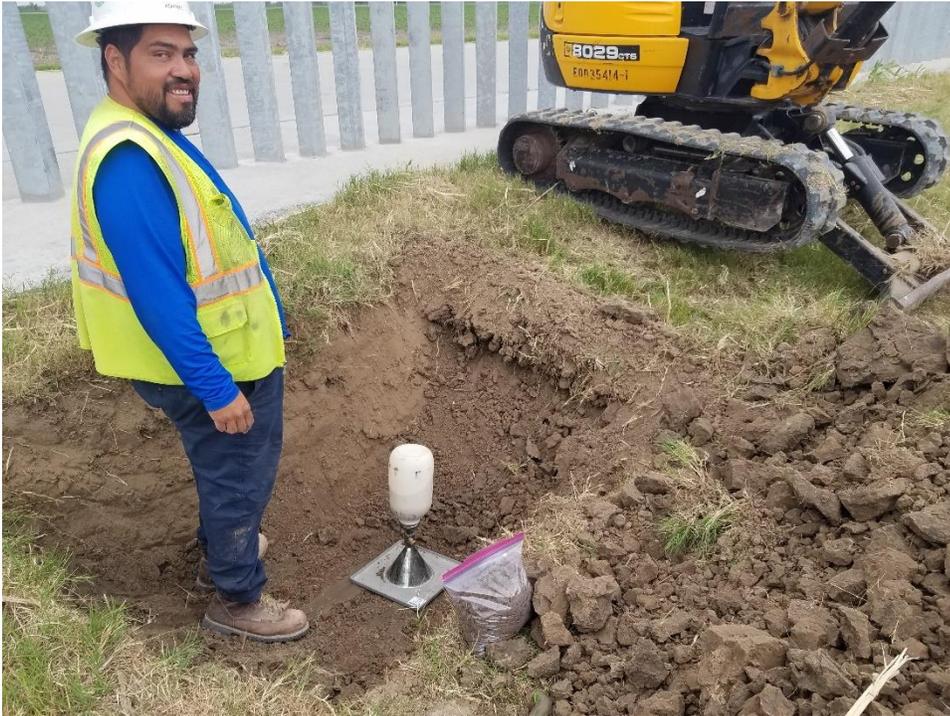
Photograph: 60

Description:
TP-9 excavation at 3 feet bgs showing the sand cone test

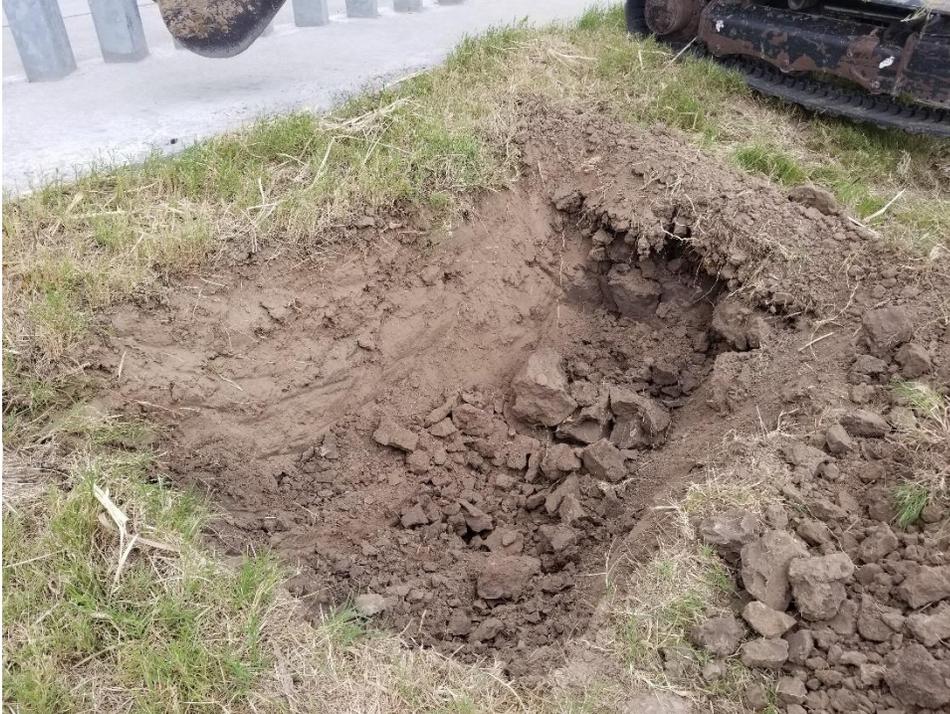
Photograph: 61

Description:
TP-9 excavation at 3 feet bgs showing the soil condition for Proctor sample
