Engineering Evaluation of Bollard Fence

Rio Grande, Hidalgo County, Texas

United States of America v. Fisher Sand and Gravel Company, Civil Action No. 7:19-CV-403

August 2021

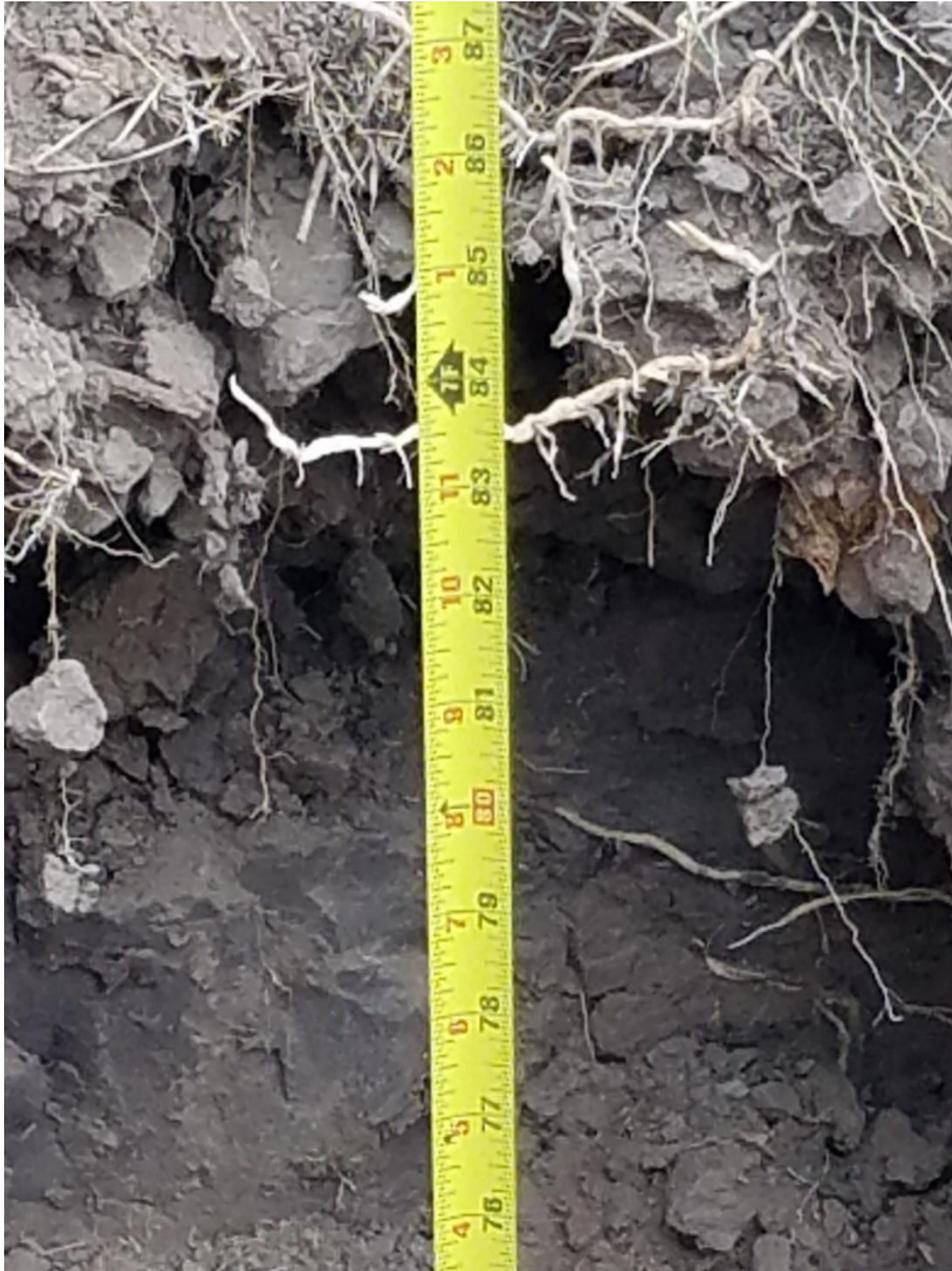
Photograph: 62

Description:
TP-9 excavation at sounding depth of 7.5 feet bgs showing root matter from grass

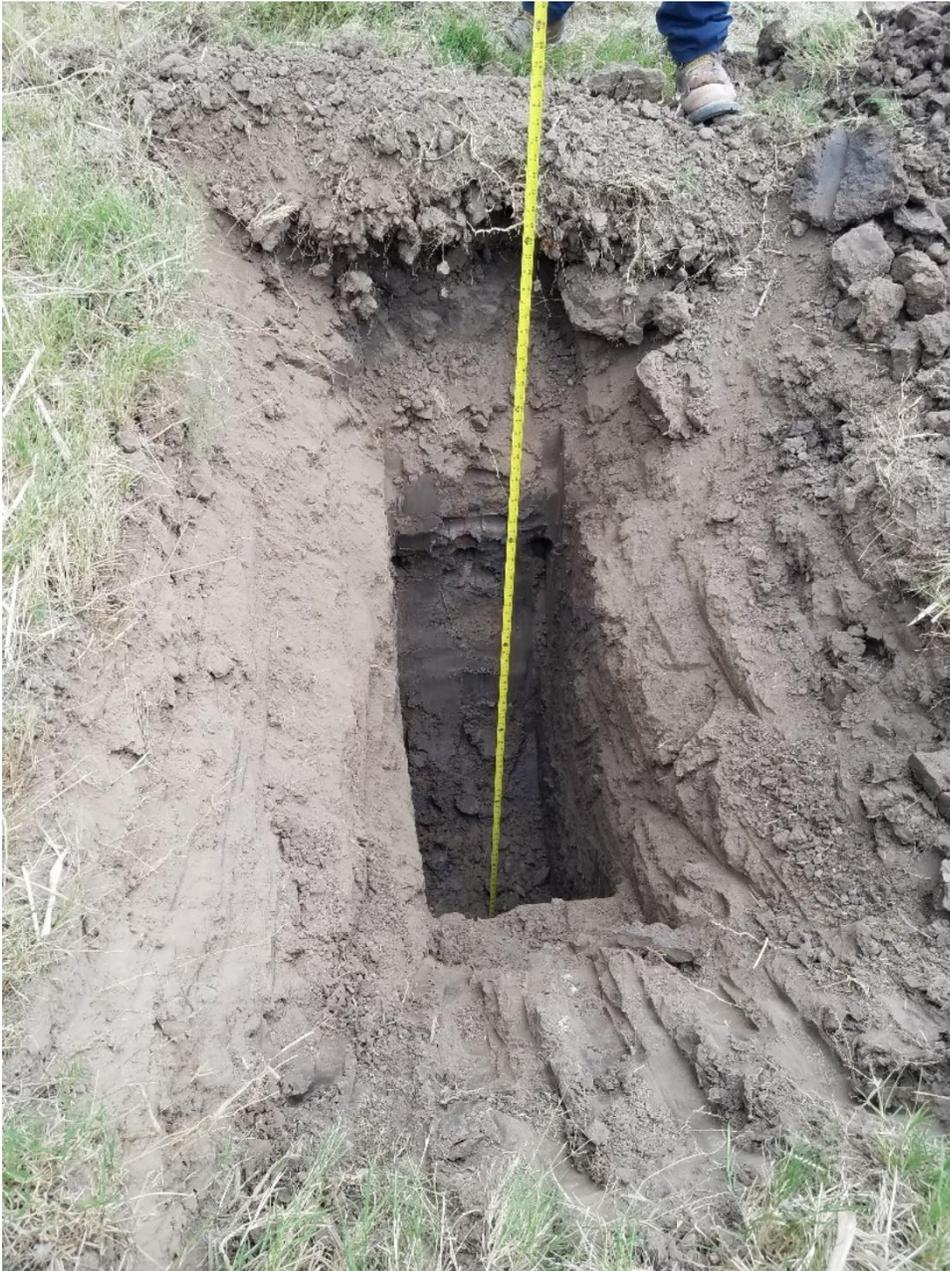
Photograph: 63

Description:
TP-9 excavation at sounding depth of 7.5 feet bgs showing soil conditions.

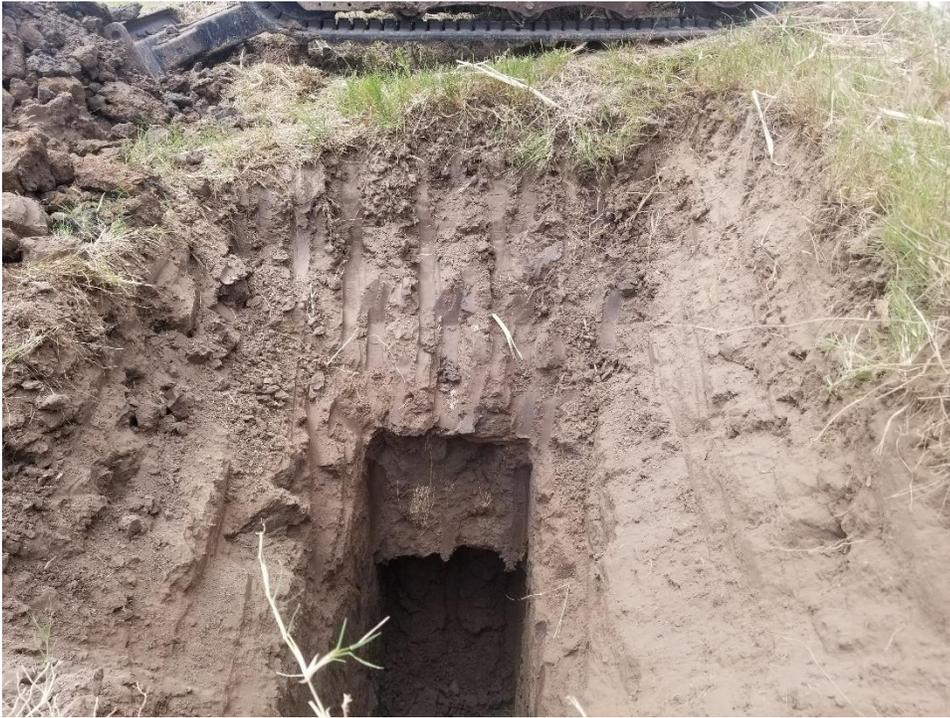
Photograph: 64

Description:
TP-9 excavation
showing soil conditions.

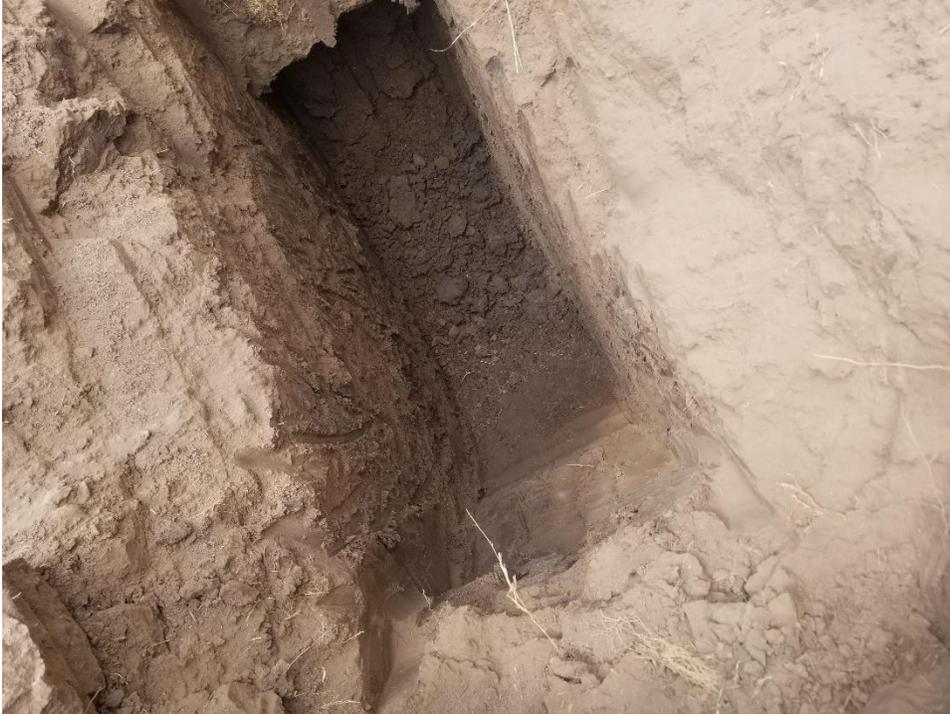
Photograph: 65

Description:
TP-9 excavation
showing soil conditions.

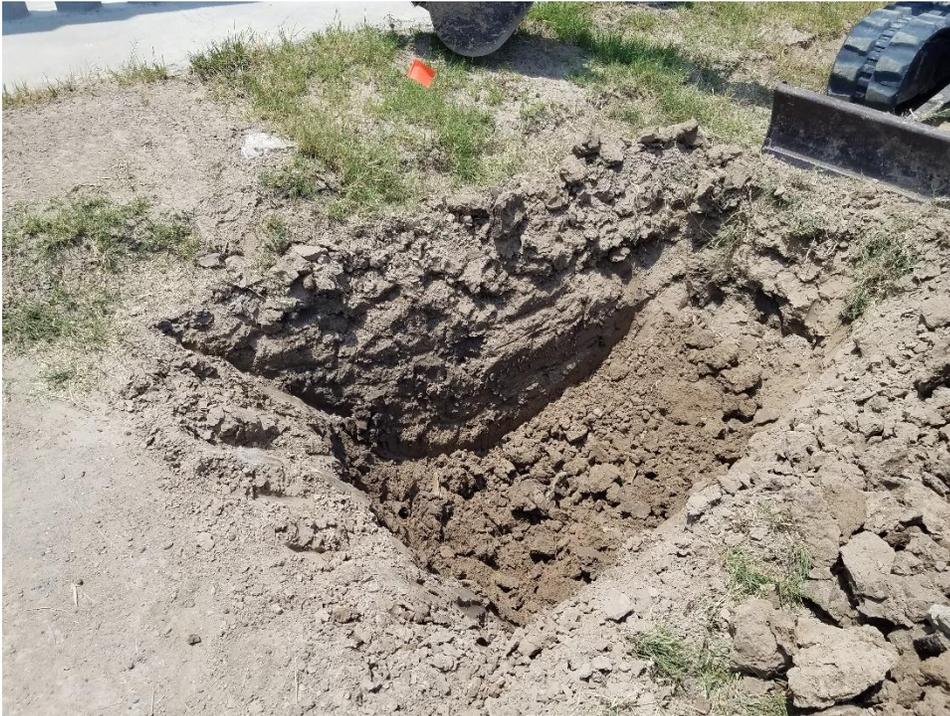
Photograph: 66

Description:
TP-10 excavation at 3 feet bgs showing the soil condition for Proctor sample

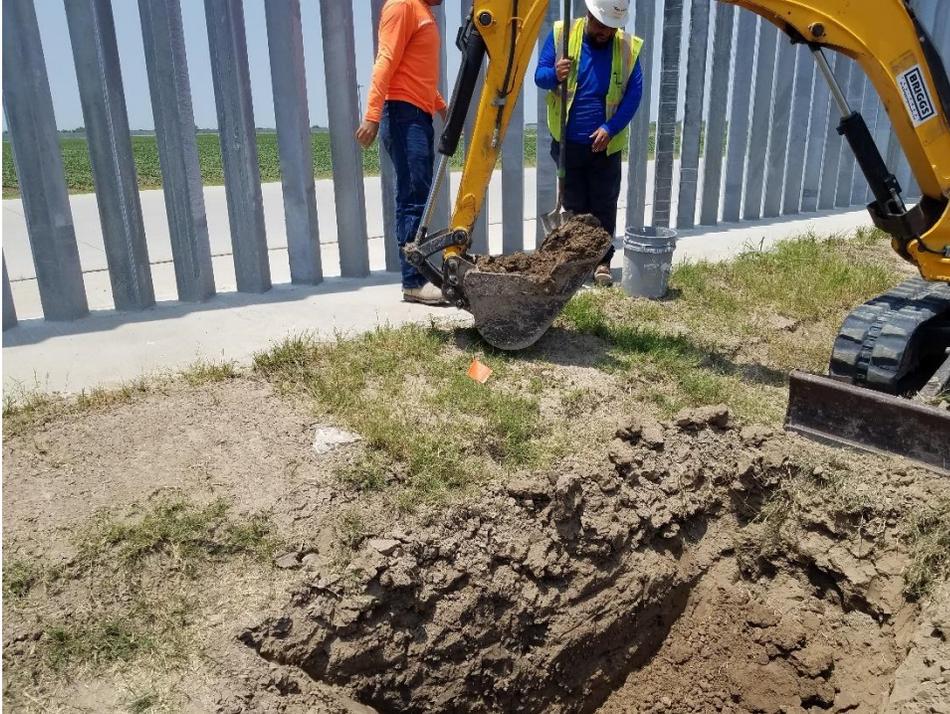
Photograph: 67

Description:
TP-10 excavation looking northwest at proctor sampling from depth of 3 feet bgs

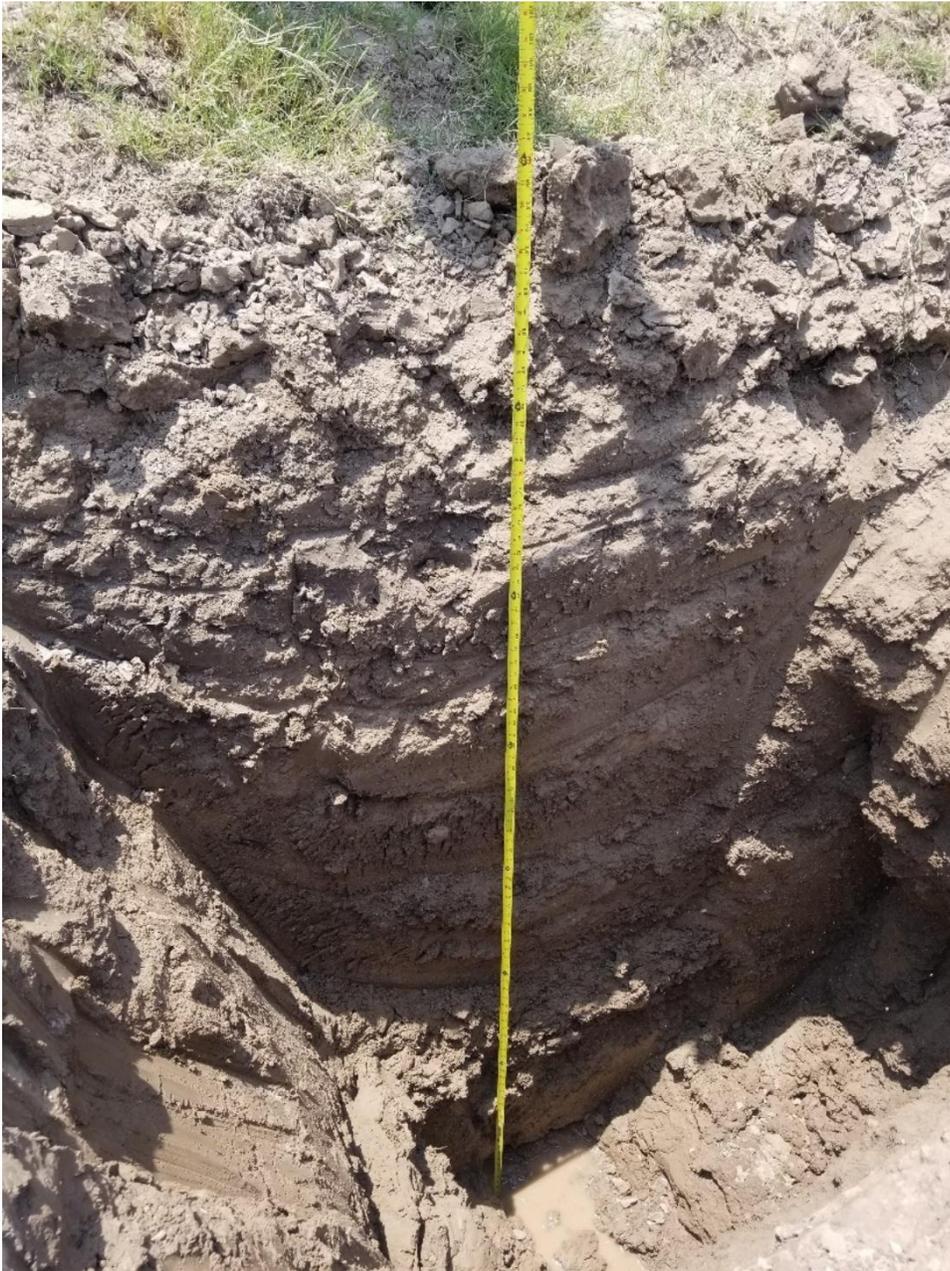
Photograph: 68

TP-10 excavation at sounding depth of 8 feet bgs showing soil and groundwater conditions

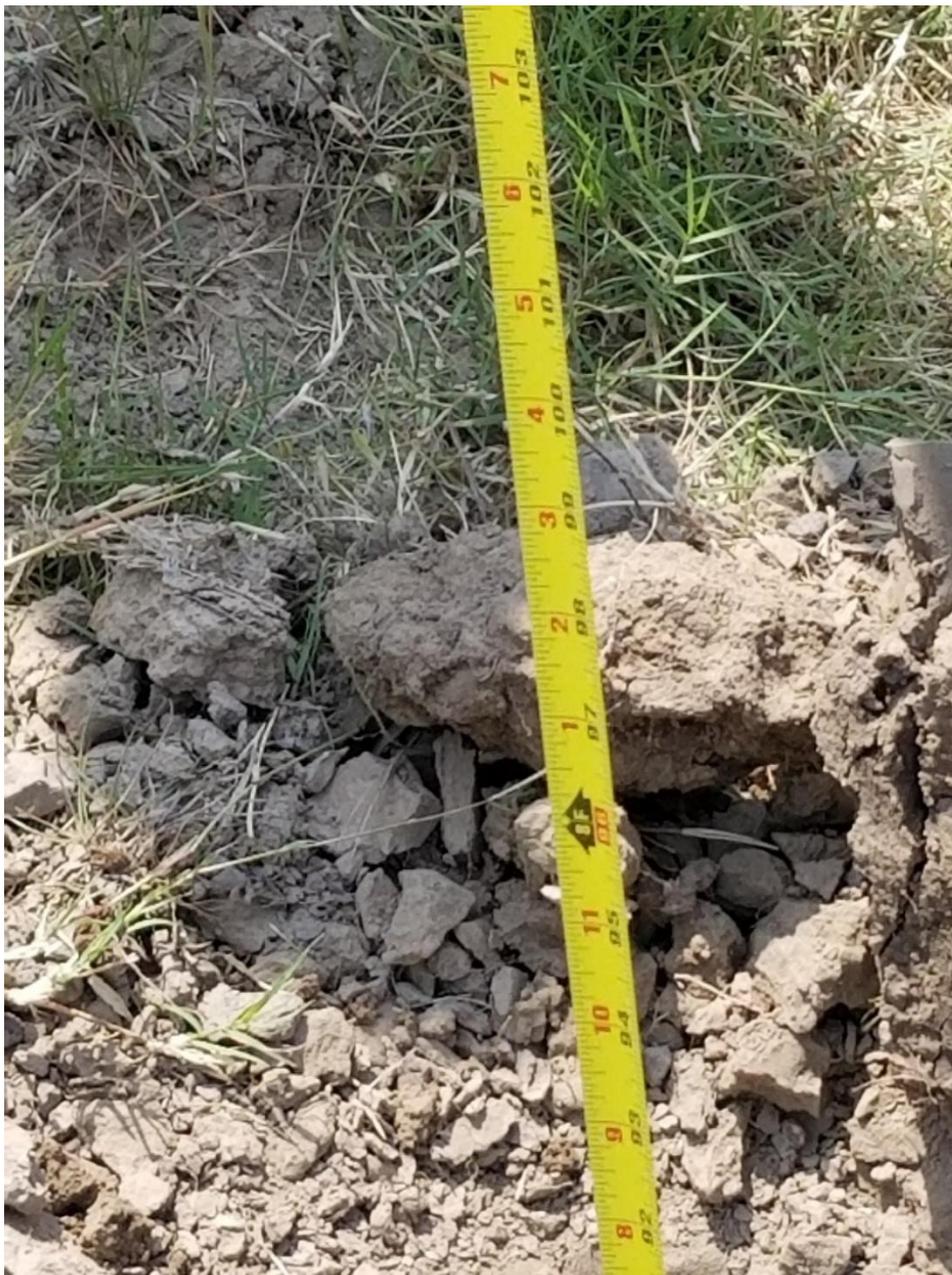
Photograph: 69

Description:
TP-10 excavation at
sounding depth of 8
feet bgs

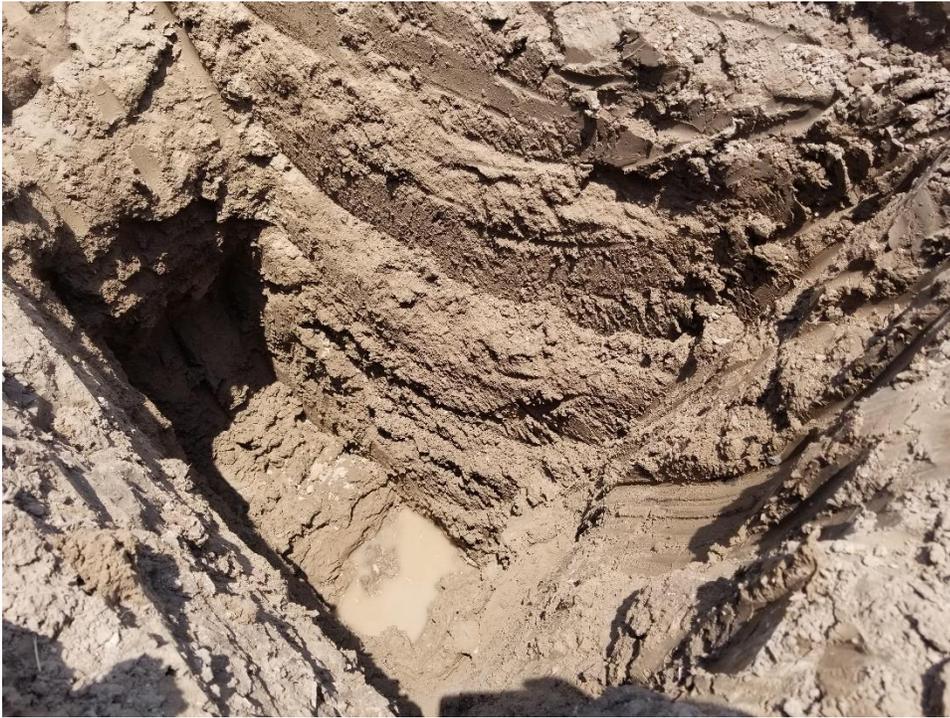
Photograph: 70

Description:
TP-10 excavation showing soil and groundwater conditions

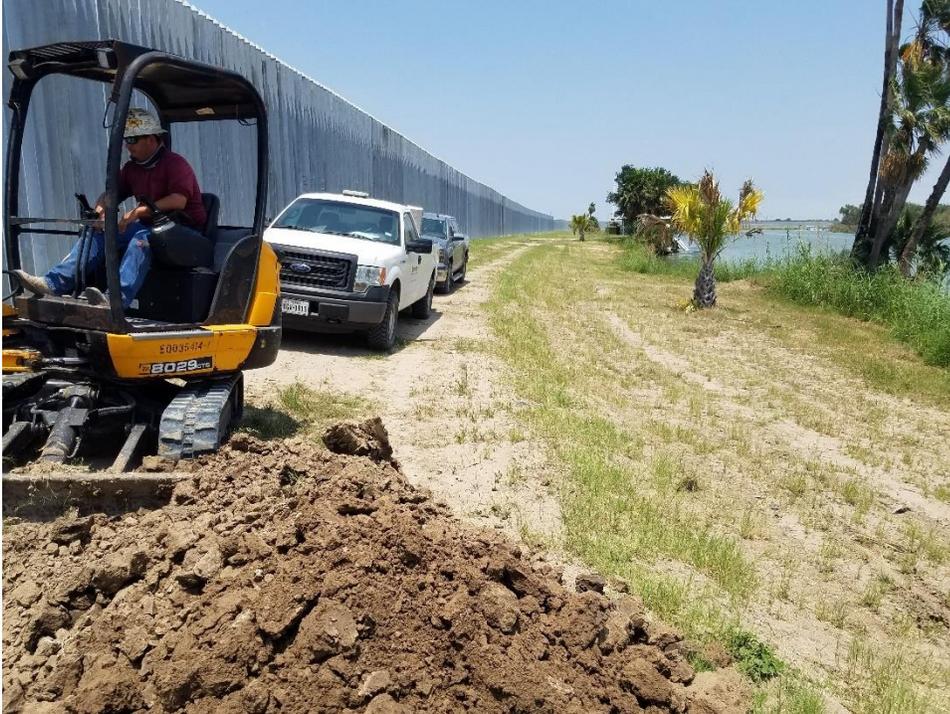
Photograph: 71

Description:
TP-10 excavation soil materials from trench excavation.

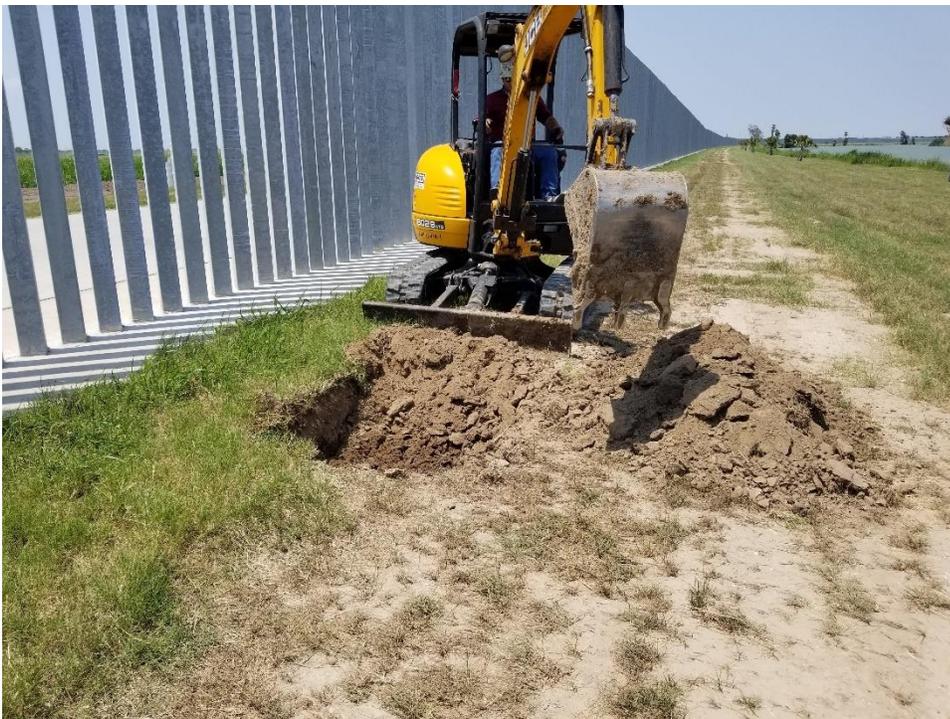
Photograph: 73

Description:
TP-11excavation
looking northeast

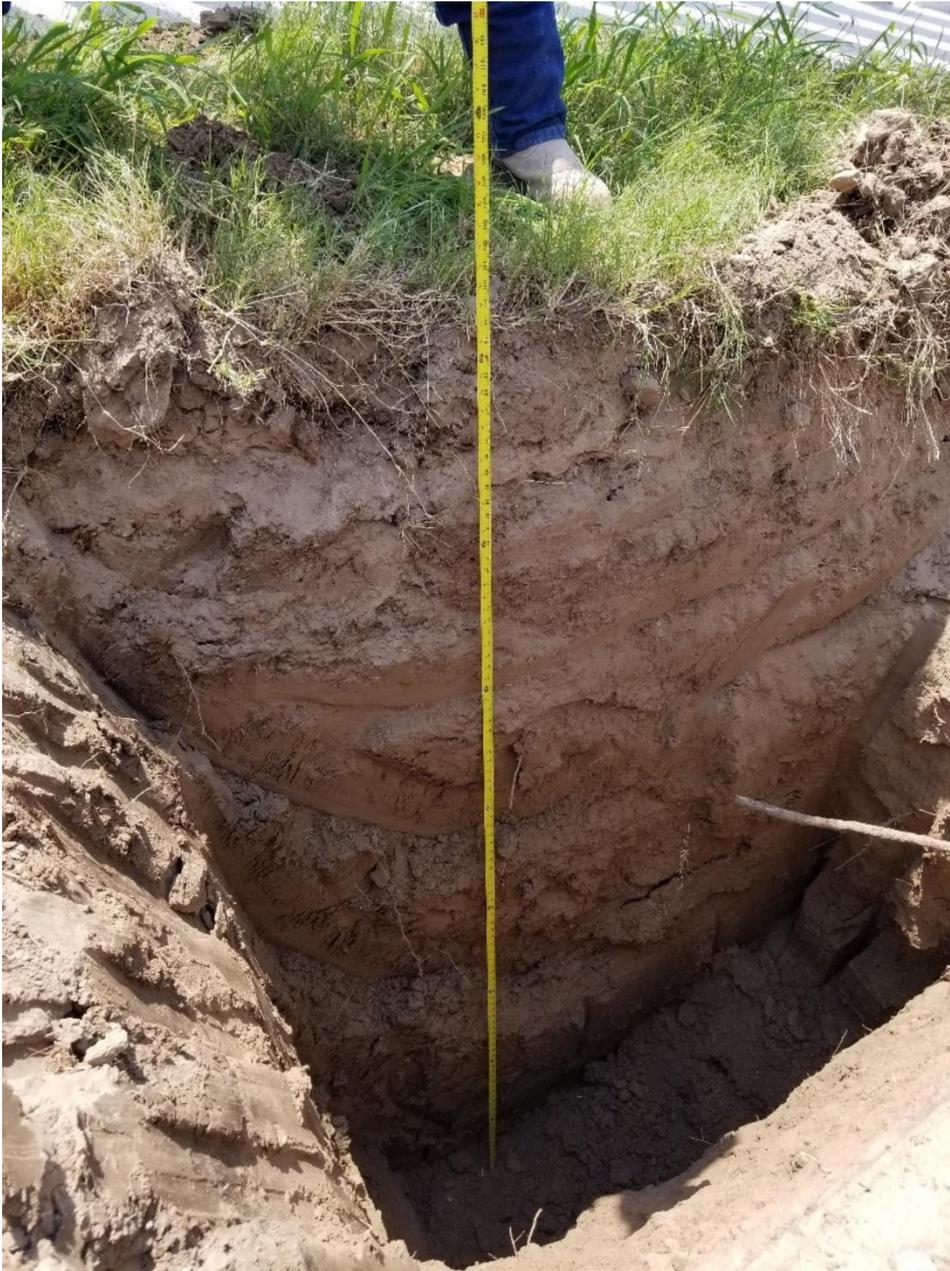
Photograph: 74

Description:
TP-11

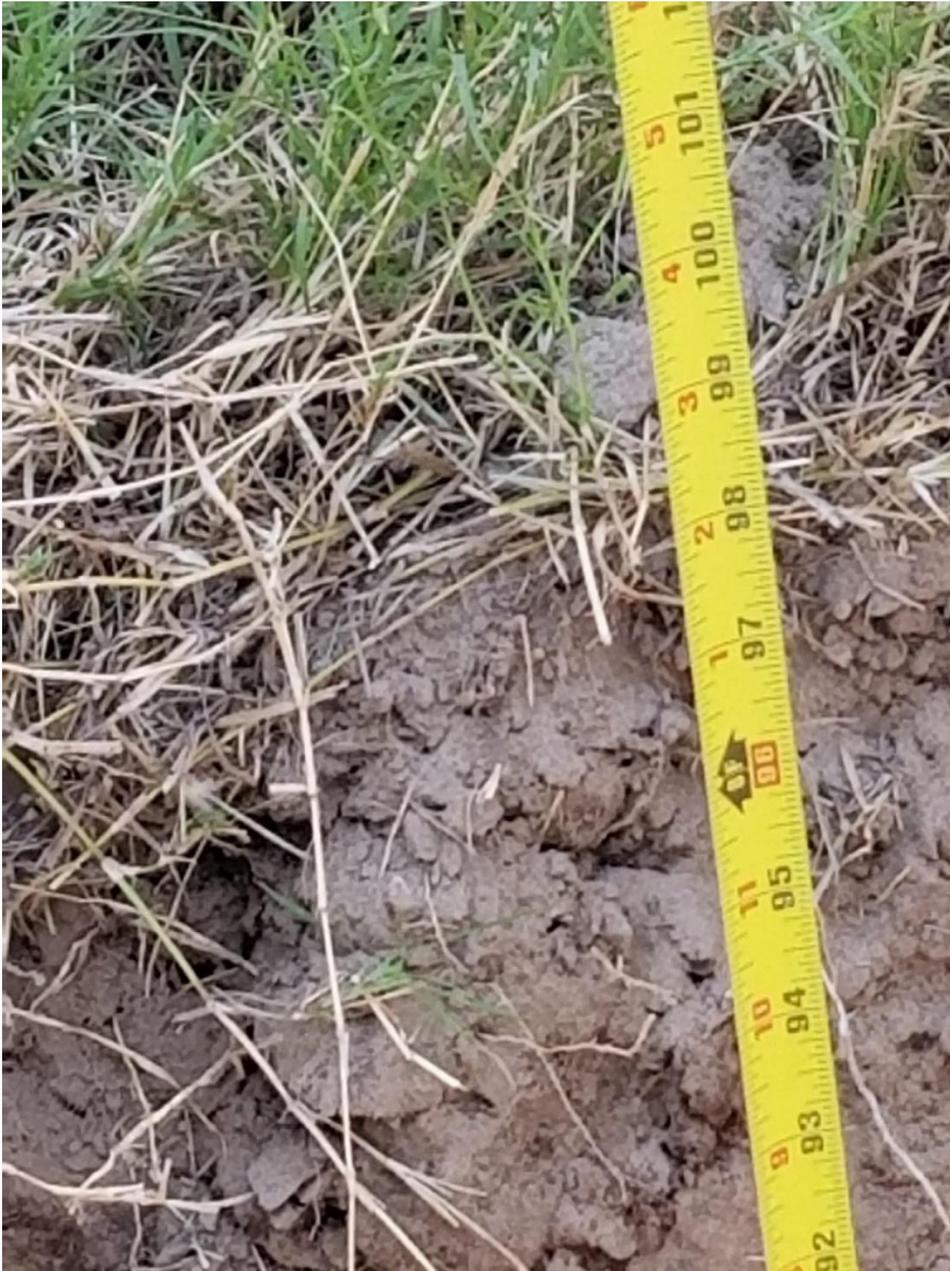
Photograph: 75

Description:
TP-11 excavation at
sounding depth of 8.5
feet bgs showing soil
conditions

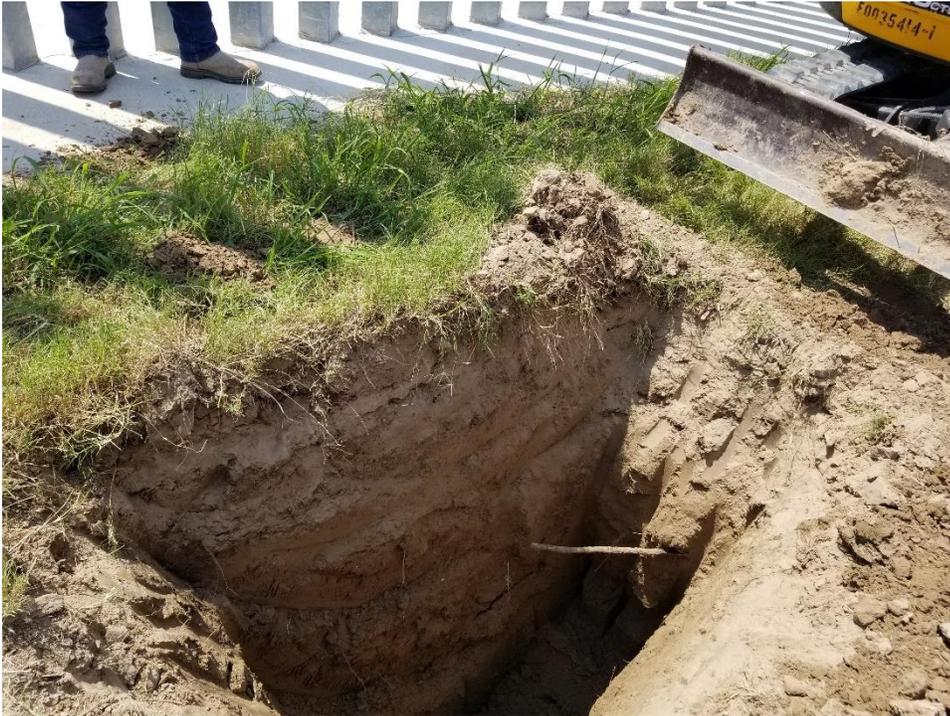
Photograph: 76

Description:
TP-11 excavation
looking northwest
showing soil conditions.

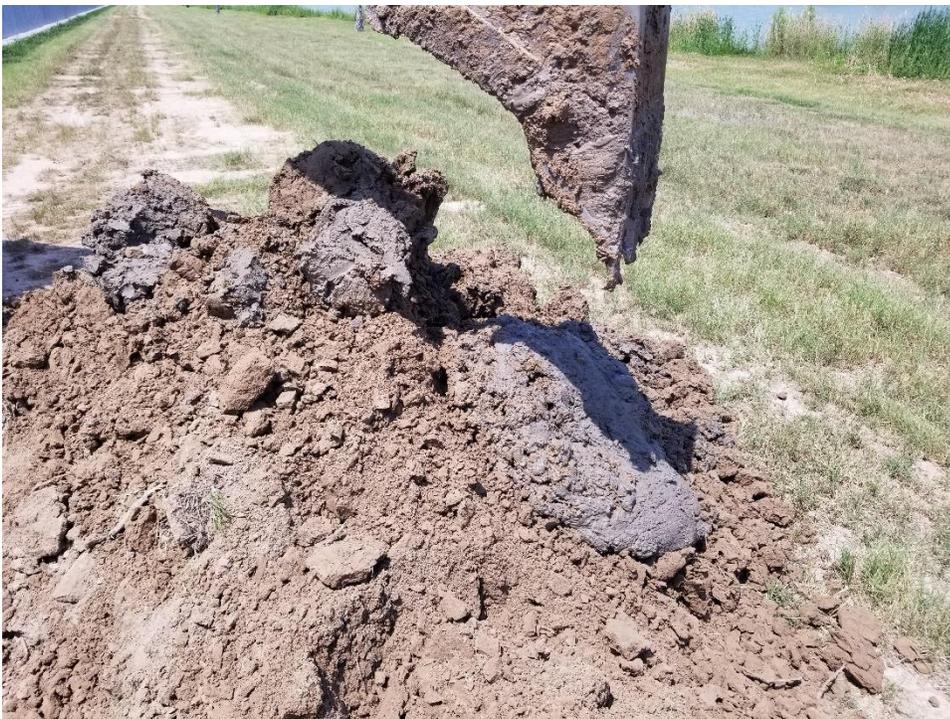
Photograph: 77

Description:
TP-11 excavation soil
materials show wet
condition when
groundwater intrudes
into trench

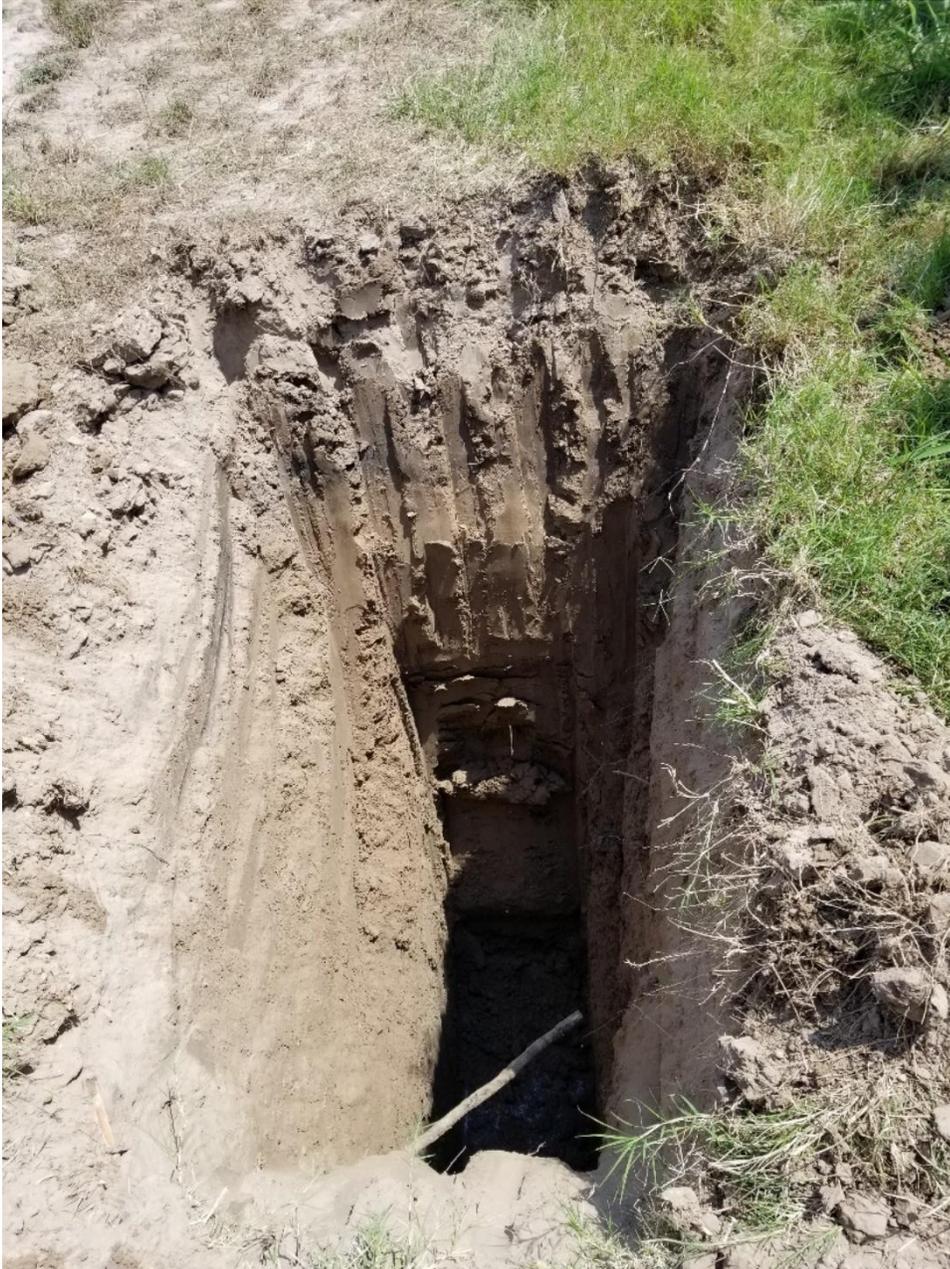
Photograph: 78

Description:
TP-11 excavation
showing soil and
groundwater conditions.

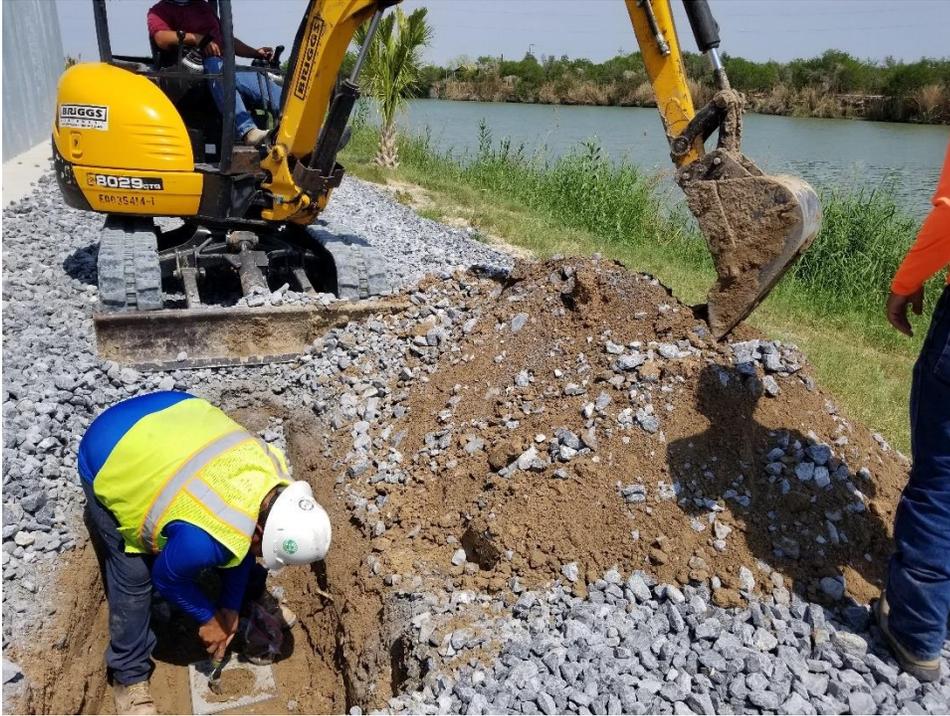
Photograph: 79

Description:
TP-12 excavation at 3 feet bgs showing sand cone test and soil conditions.

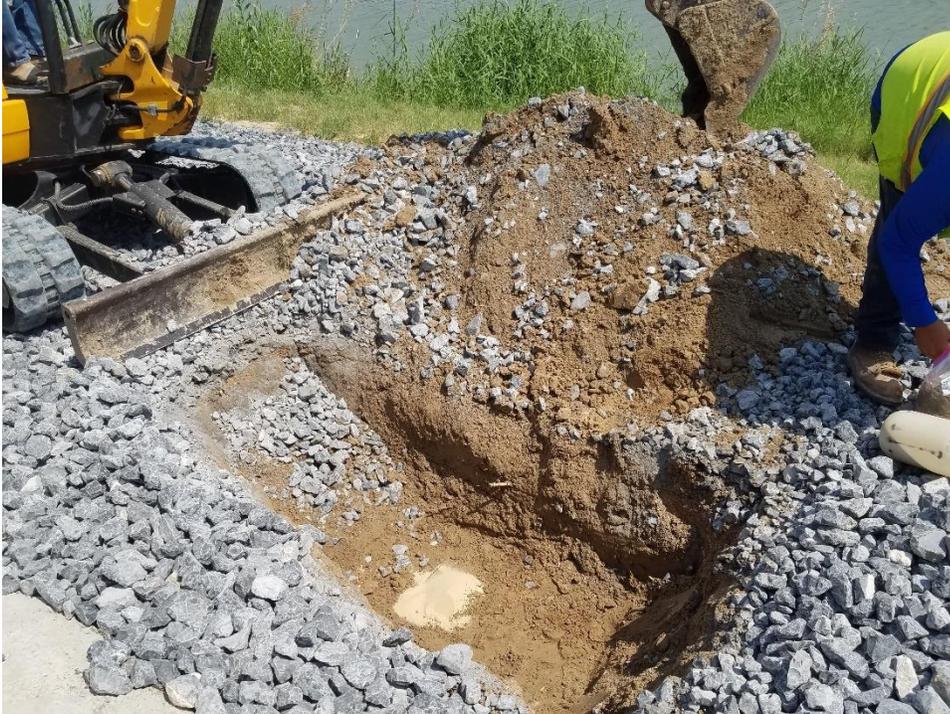
Photograph: 80

Description:
TP-12 excavation at 3 feet bgs showing sand cone test and soil conditions.

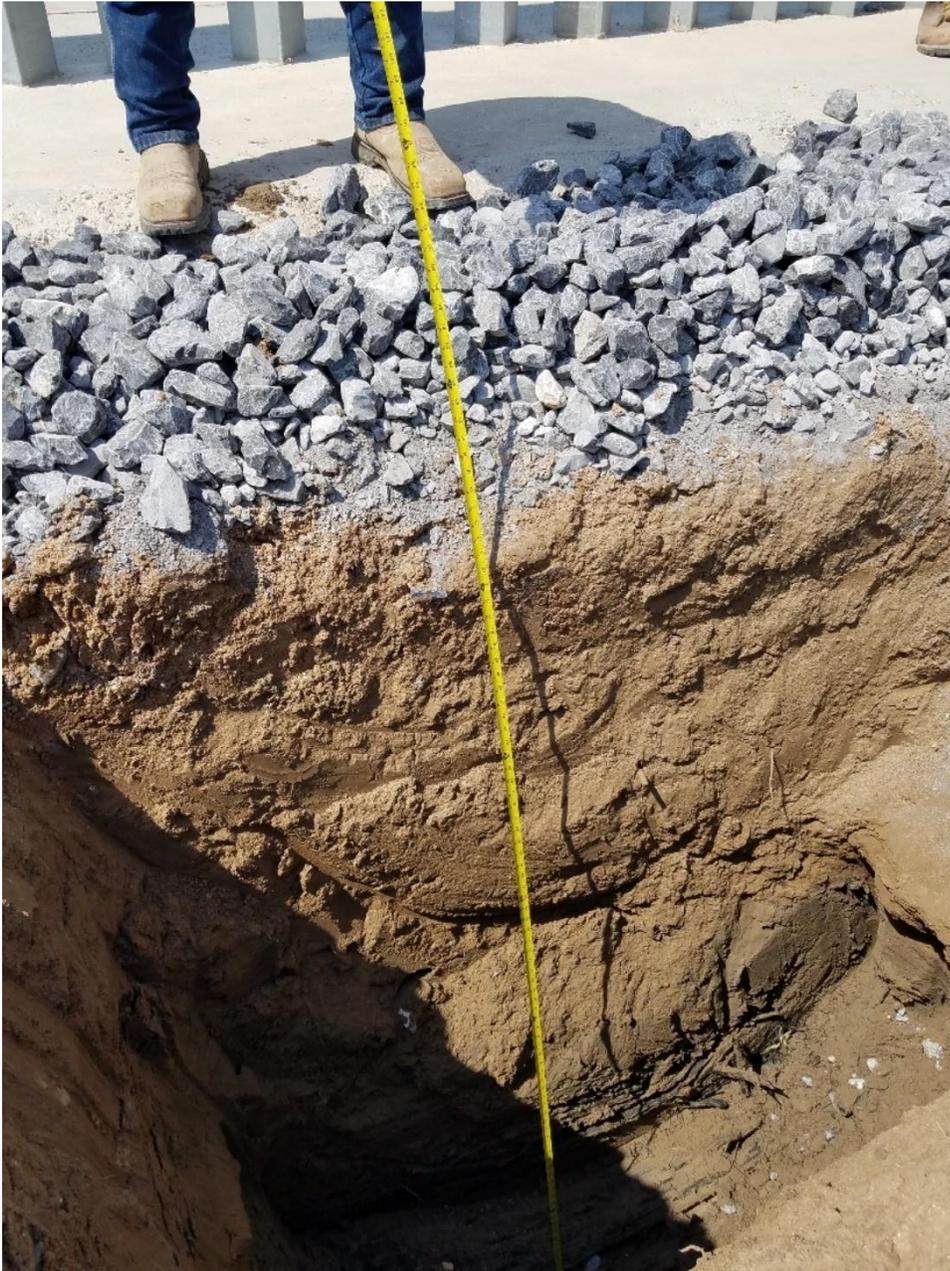
Photograph: 81

TP-12 excavation at sounding depth of 7.5 feet bgs showing soil conditions.

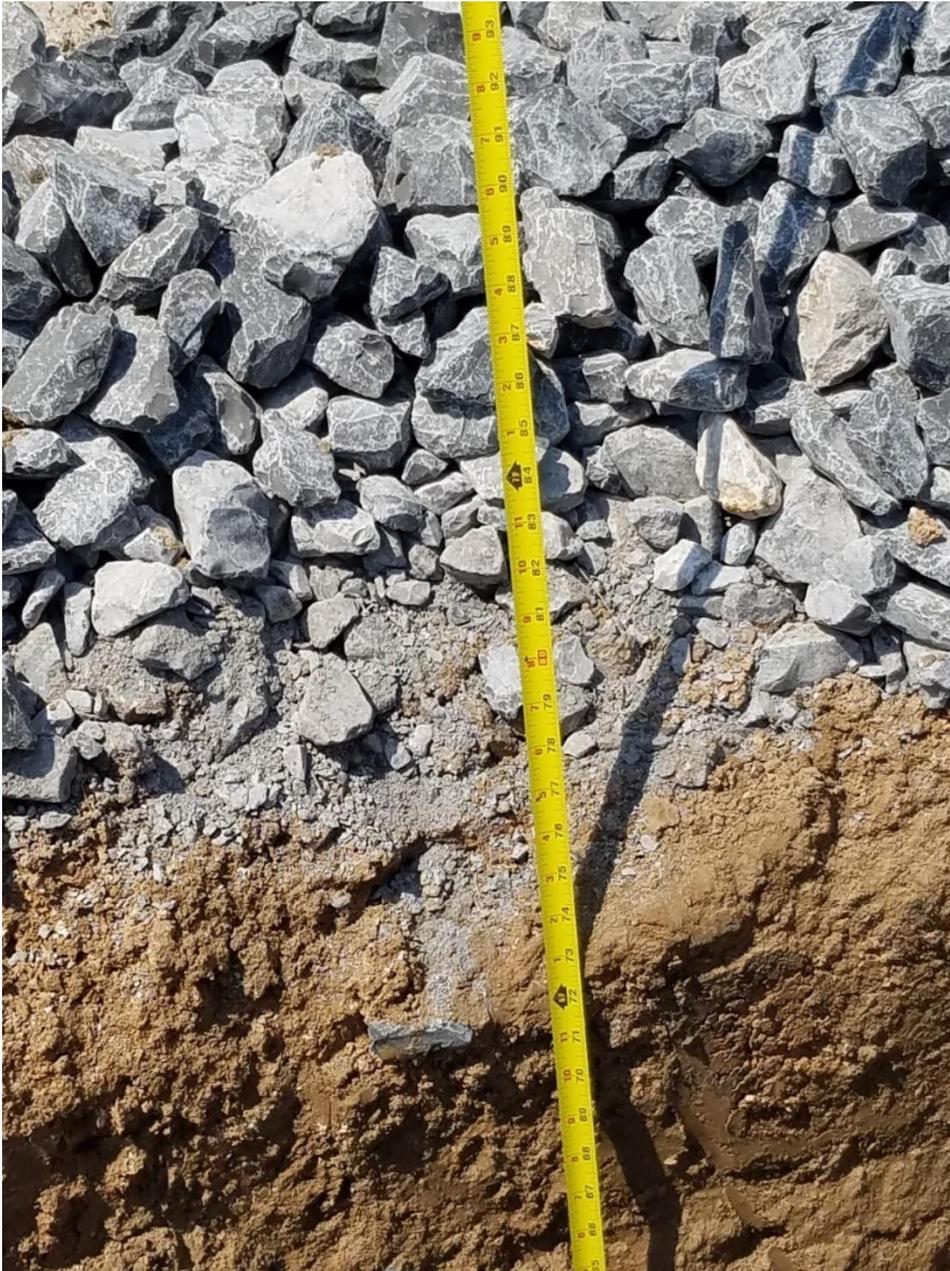
Photograph: 82

Description:
TP-12 excavation at sounding depth of 7.5 feet bgs showing soil conditions.

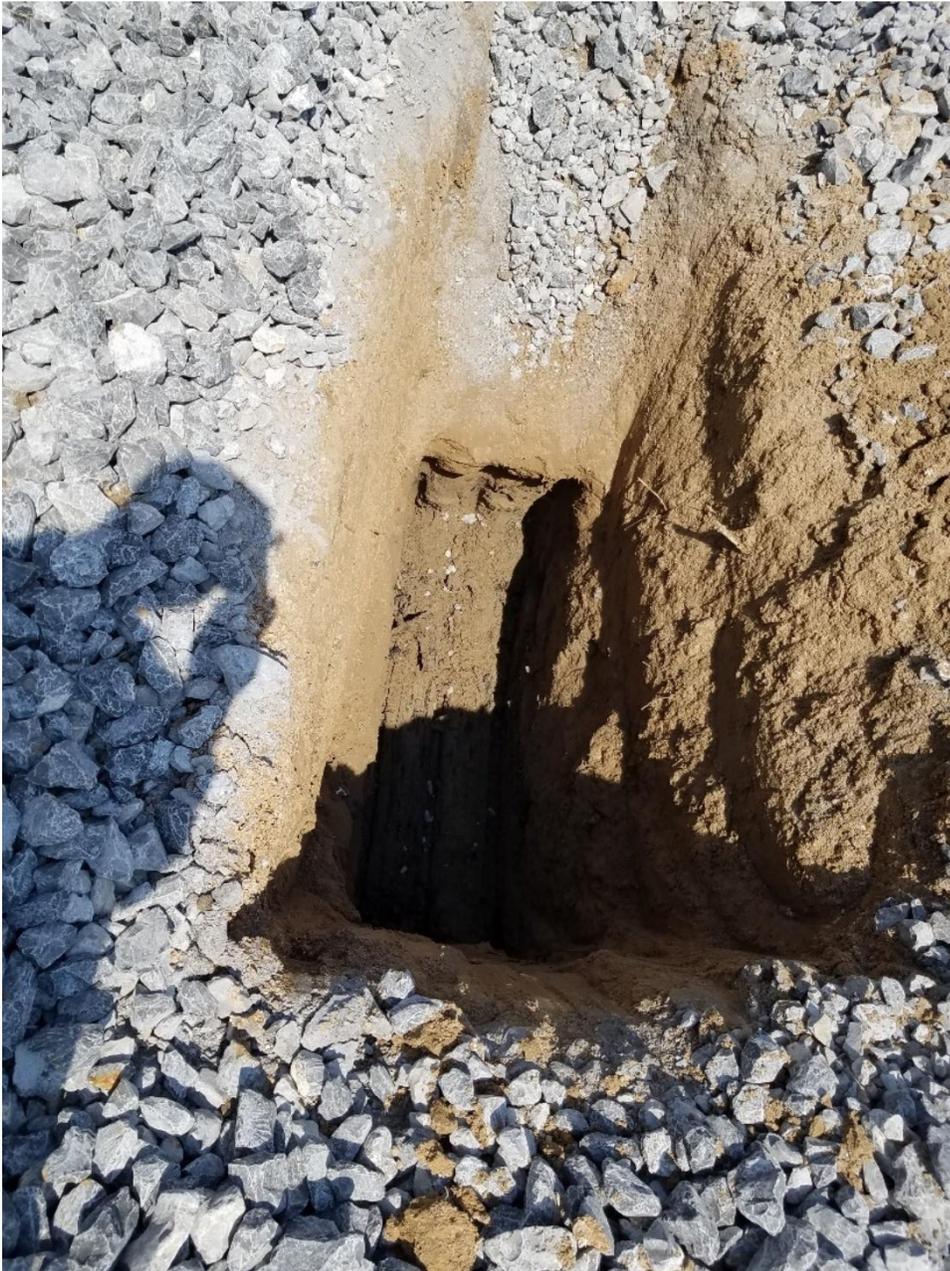
Photograph: 83

Description:
TP-12 excavation
showing soil conditions.
